# 2022 Systemwide Safety and Capacity Study

June 30, 2023

Maine Turnpike Authority  
2360 Congress Street  
Portland, ME 04102

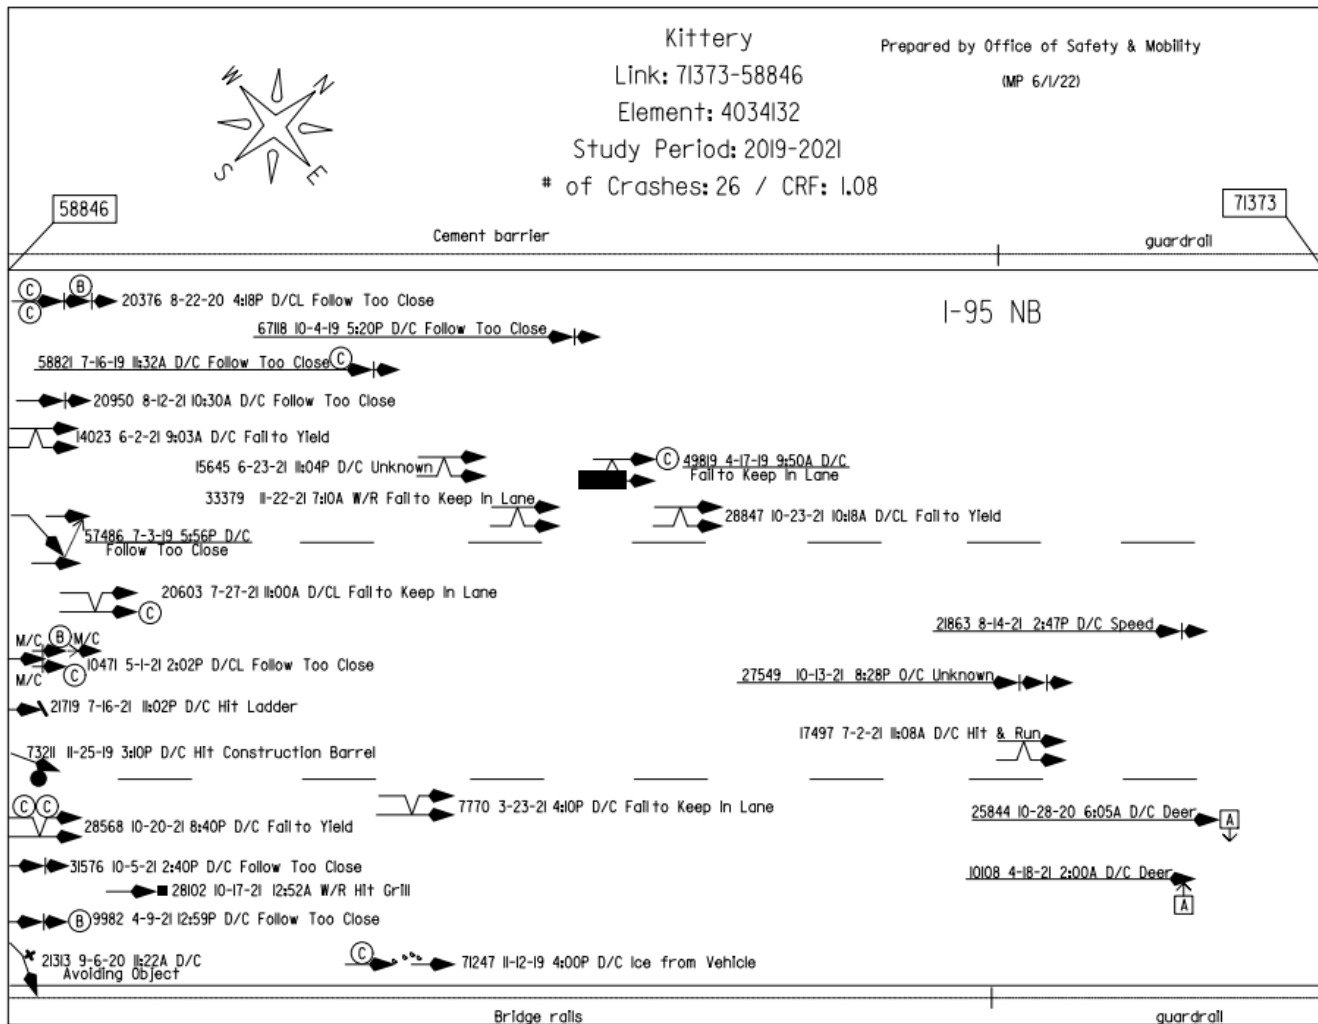
**Figure 2: 2019 – 2021 NB Crash Diagram**

As shown in **Figure 2**, there were 26 crashes resulting in a 30.8% injury rate during this analysis period.

- Nearly 70% of the crashes occurred in 2021, during the peak summer and fall months when volumes were highest
- 73% of crashes were rear-end – sideswipe type crashes
- Of the recorded causes, crashes were most often a result of vehicles following too closely (7), not staying in their lane (4), and failing to yield (3)
- Injury crashes in this location follow the same patterns as overall crashes, with the most severe crashes caused by vehicles following too closely

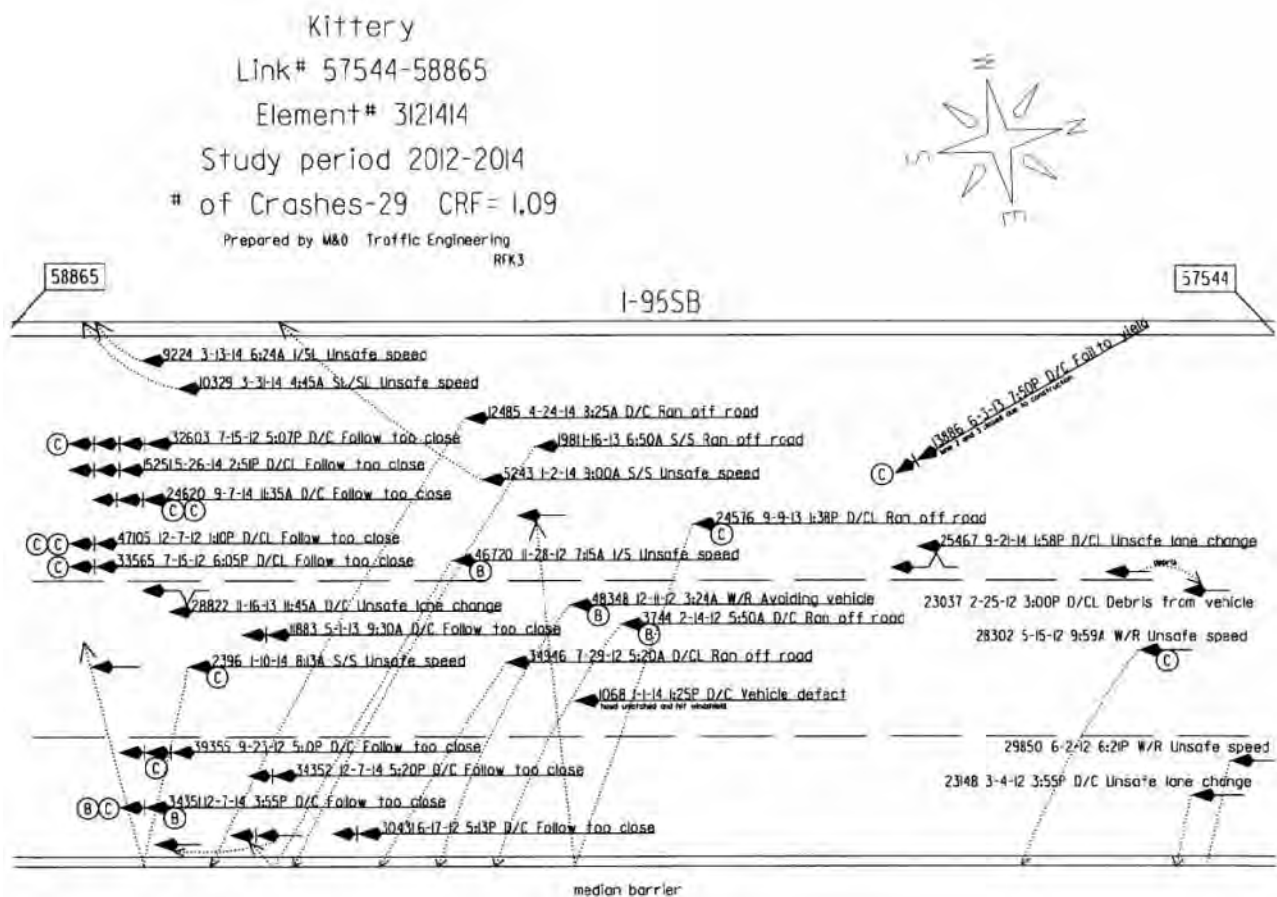
**Figure 3: 2012 – 2014 SB Crash Diagram**

As shown in the diagram, there were 29 crashes resulting in a 44.8% injury rate during this analysis period.

- 34% of crashes occurred on a Sunday
- 52% of crashes were rear-end – sideswipe type crashes
- Of the recorded causes, crashes were most often a result of vehicles following too closely (10), unsafe speed (6), and running off the road (4)
- Injuries were most frequent in crashes caused by vehicles following too closely

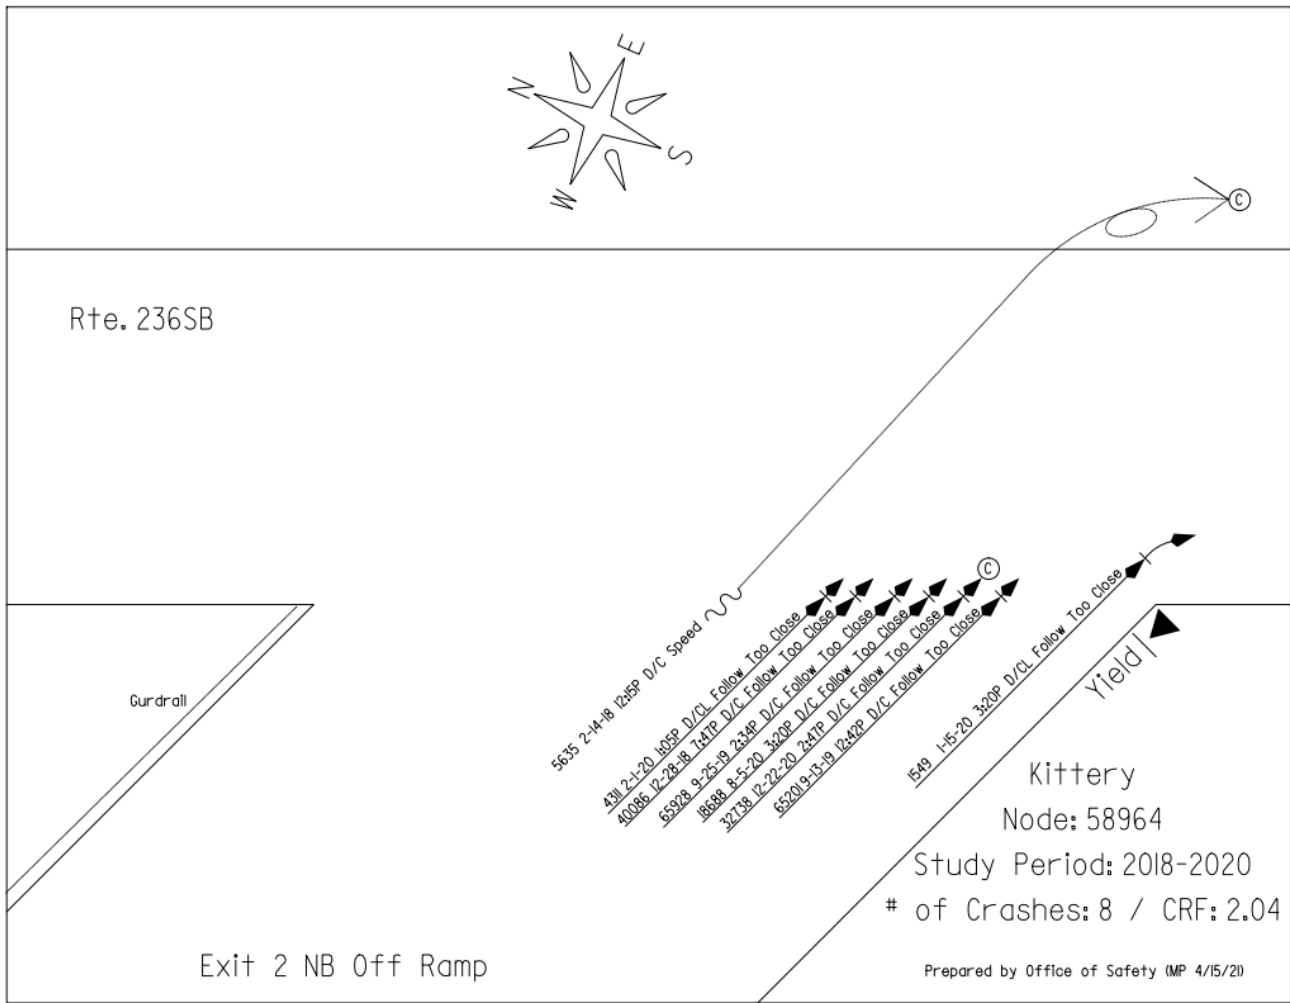
**Figure 3: 2018 – 2020 NB Crash Diagram**

As shown in **Figure 3**, there were 8 crashes resulting in a 12.5% injury rate.

- All crashes but one were caused by vehicles following to close trying to enter Route 236.
- All crashes but one were rear-end – sideswipe type crashes

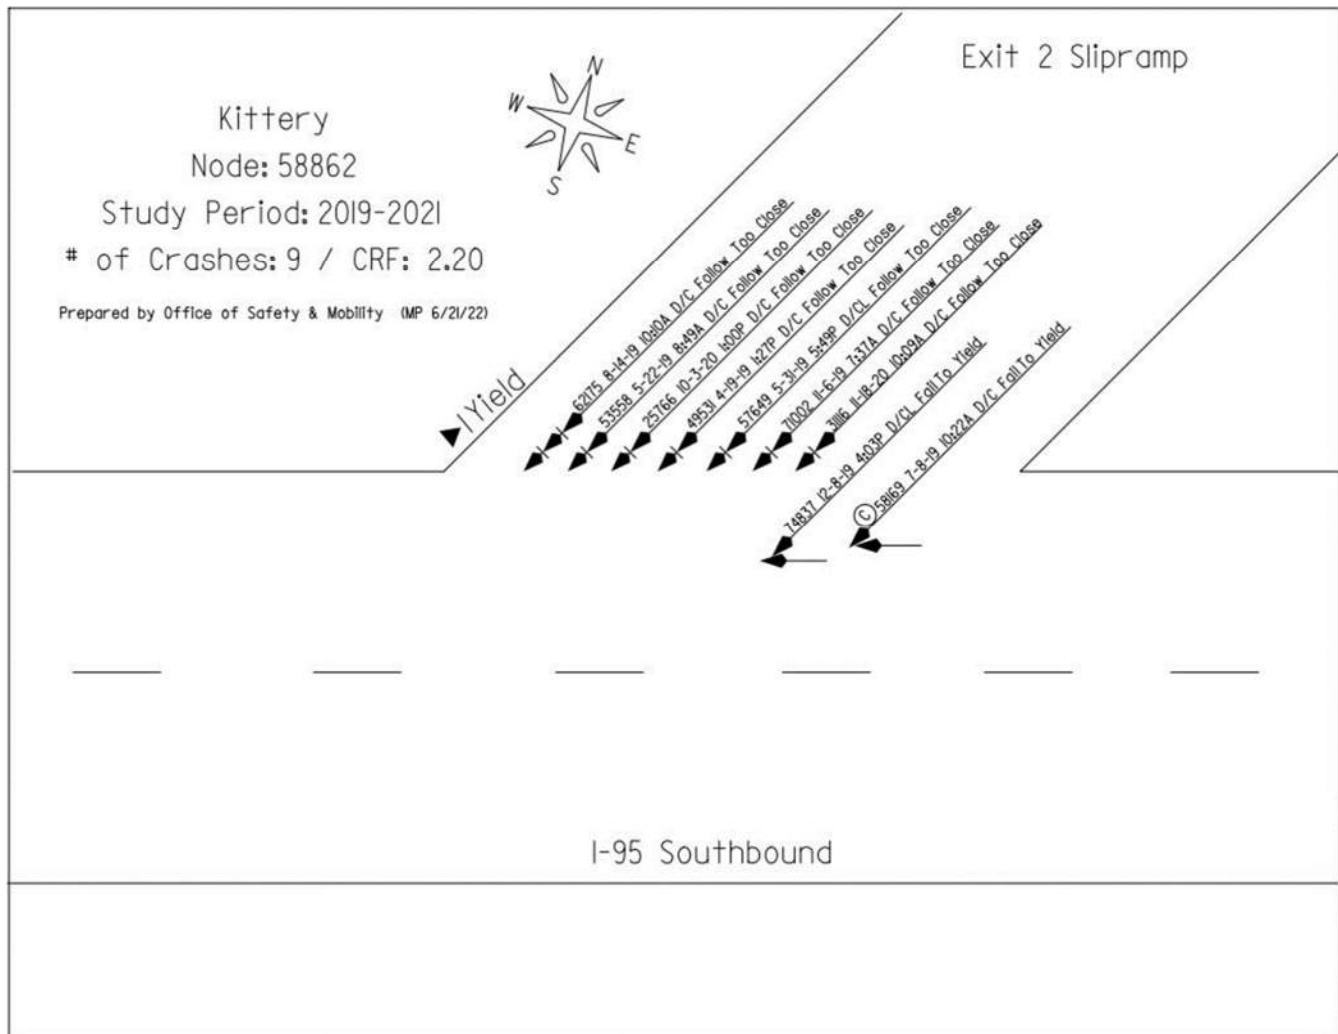
**Figure 2: 2019-2021 Southbound Exit 2 On Ramp Merge Crash Diagram**

As shown in **Figure 2**, there were 9 crashes resulting in a 11.1% injury rate during this analysis period.

- The crashes during the most recent HCL period were almost exclusively as a result of following too close along the slip ramp (9 crashes)
- The other two crashes were a result of failure to yield
- These crash types are typical in areas of high congestion such as this, especially at yield-controlled movements where vehicles are trying to identify mainline gaps.
- One of these crashes resulted in injury
- While it was nearly an even split between crashes at this location occurring during the morning or afternoon, lighting does not appear to be an impacting factor as all crashes occurred during typical daylight hours

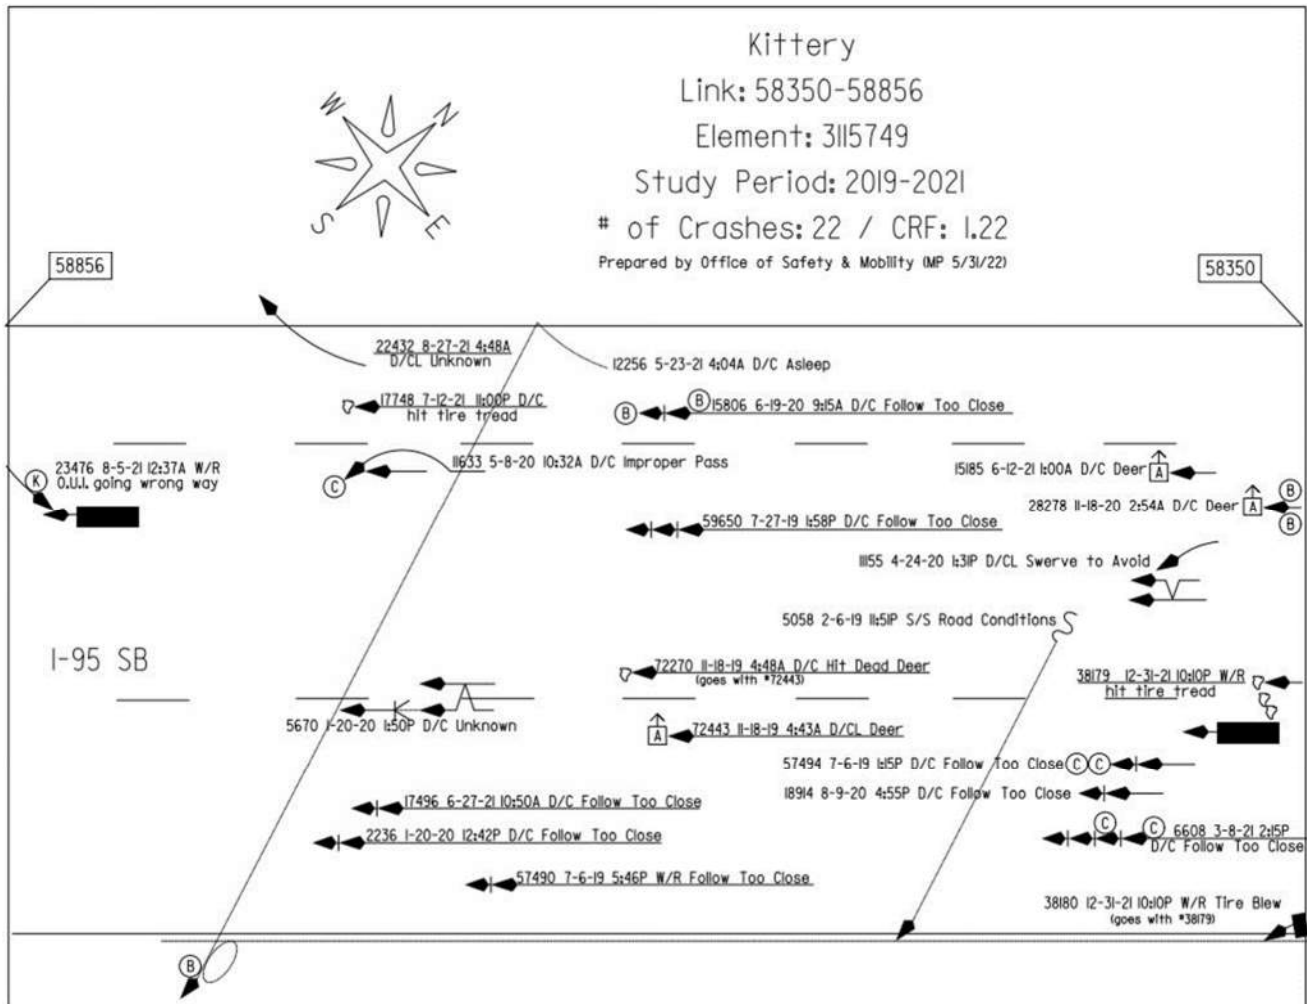
**Figure 3: 2019-2021 I-95 SB Just North of C-D Split Crash Diagram**

As shown in **Figure 3**, there were 22 crashes resulting in a 31.8% injury rate during this analysis period.

- 8 of the crashes included in the diagram (36%) were a result of vehicles following too close, which is a typical crash cause in locations of high congestion
- 6 crashes (27%) were a result of drivers hitting animals or debris in the roadway
- There was 1 fatality included in this HCL diagram, which was caused by a driver under the influence driving the wrong way on the Turnpike
- The majority of these crashes occurred during the summer months which is when there is the highest percentage of unfamiliar drivers traveling for recreational purposes

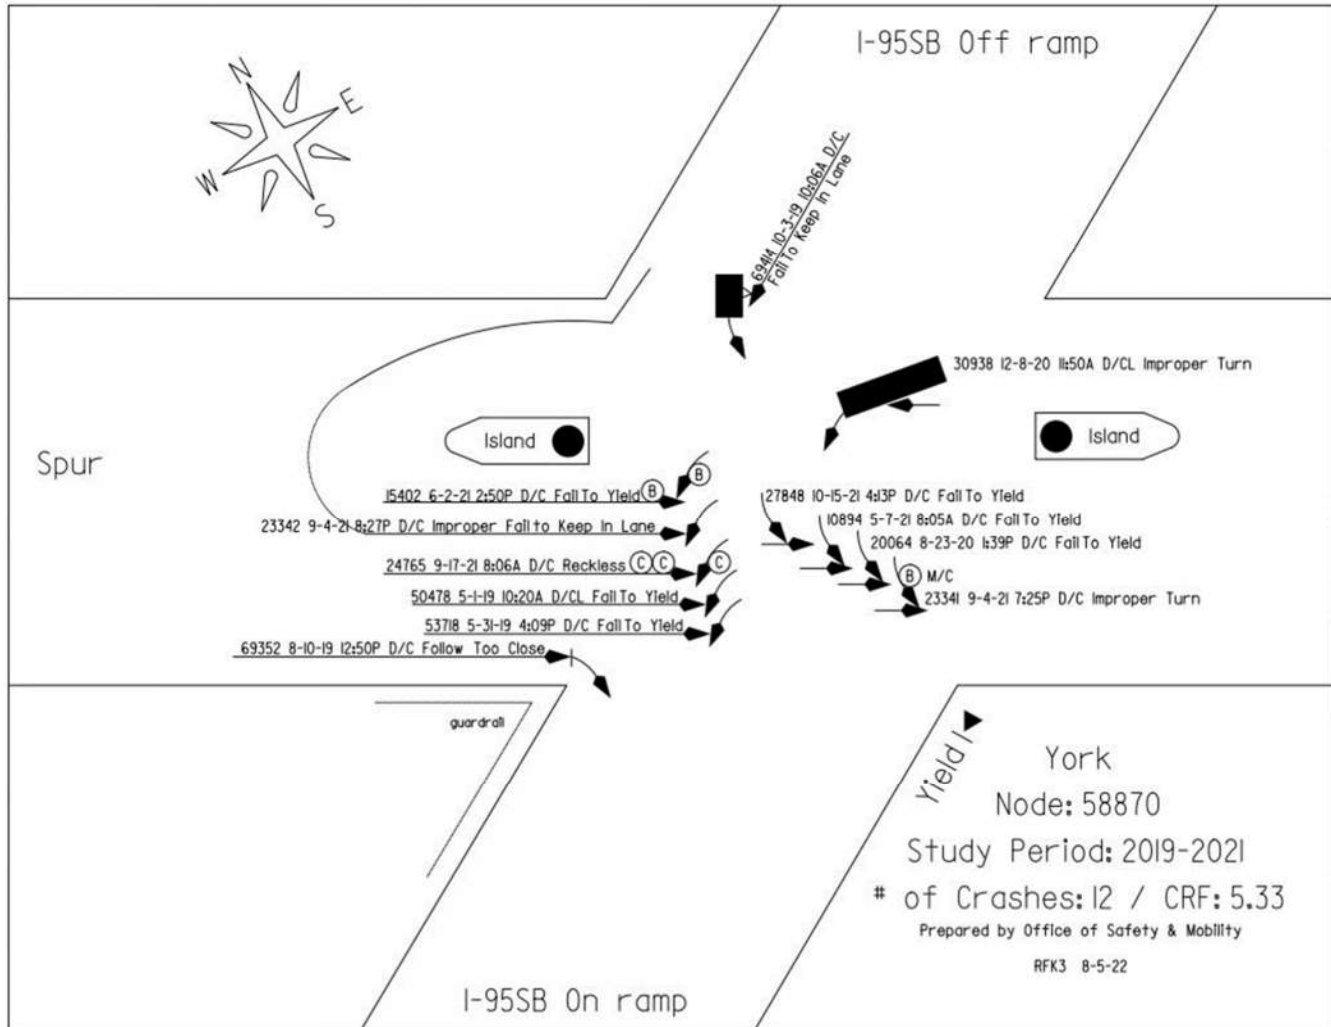
**Figure 2: 2019-2021 Exit 7 Southbound Ramps Intersection Crash Diagram**

As shown in **Figure 2**, there were 12 crashes resulting in a 25% injury rate during this analysis period.

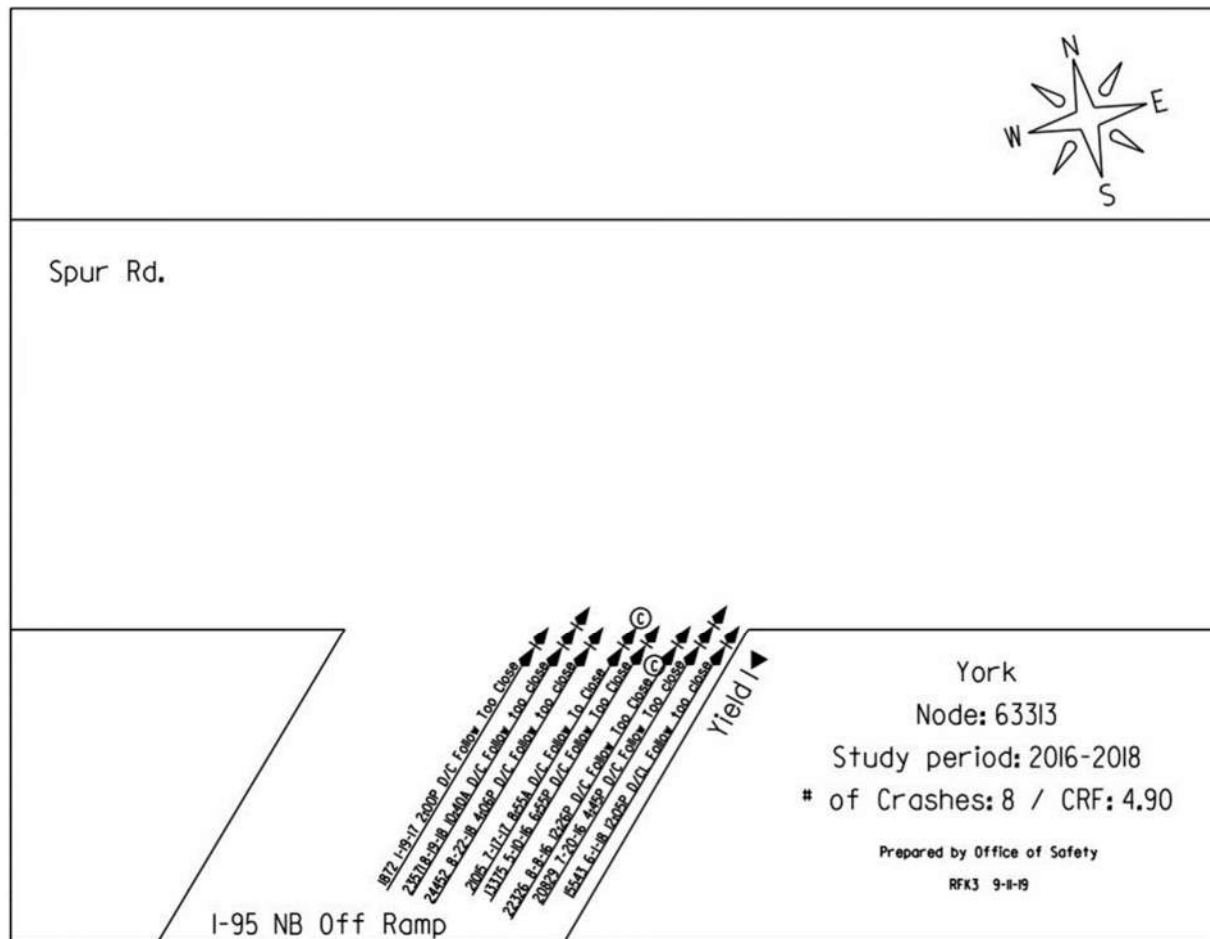
**Figure 3: 2016-2018 Exit 7 Northbound Off Slip Ramp Lane Merge Crash Diagram**

As shown in **Figure 3**, there were 8 crashes resulting in a 25% injury rate during this analysis period.

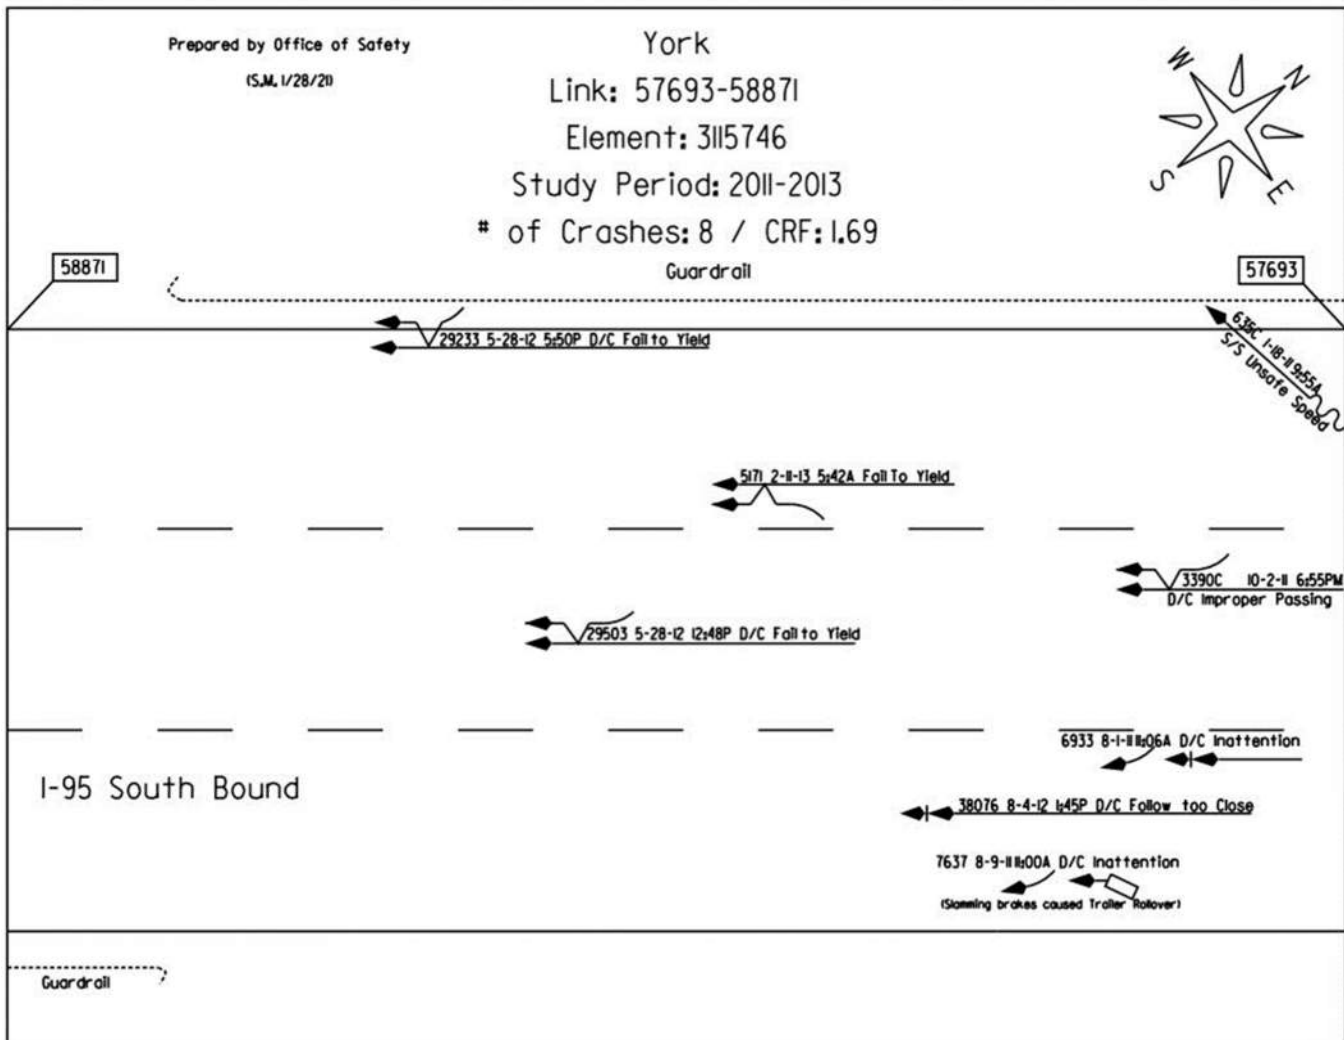
**Figure 3: 2011-2013 South of Old York Toll Plaza SB Crash Diagram**

As shown in **Figure 3**, there were 8 crashes resulting in a 0% injury rate during this analysis period.

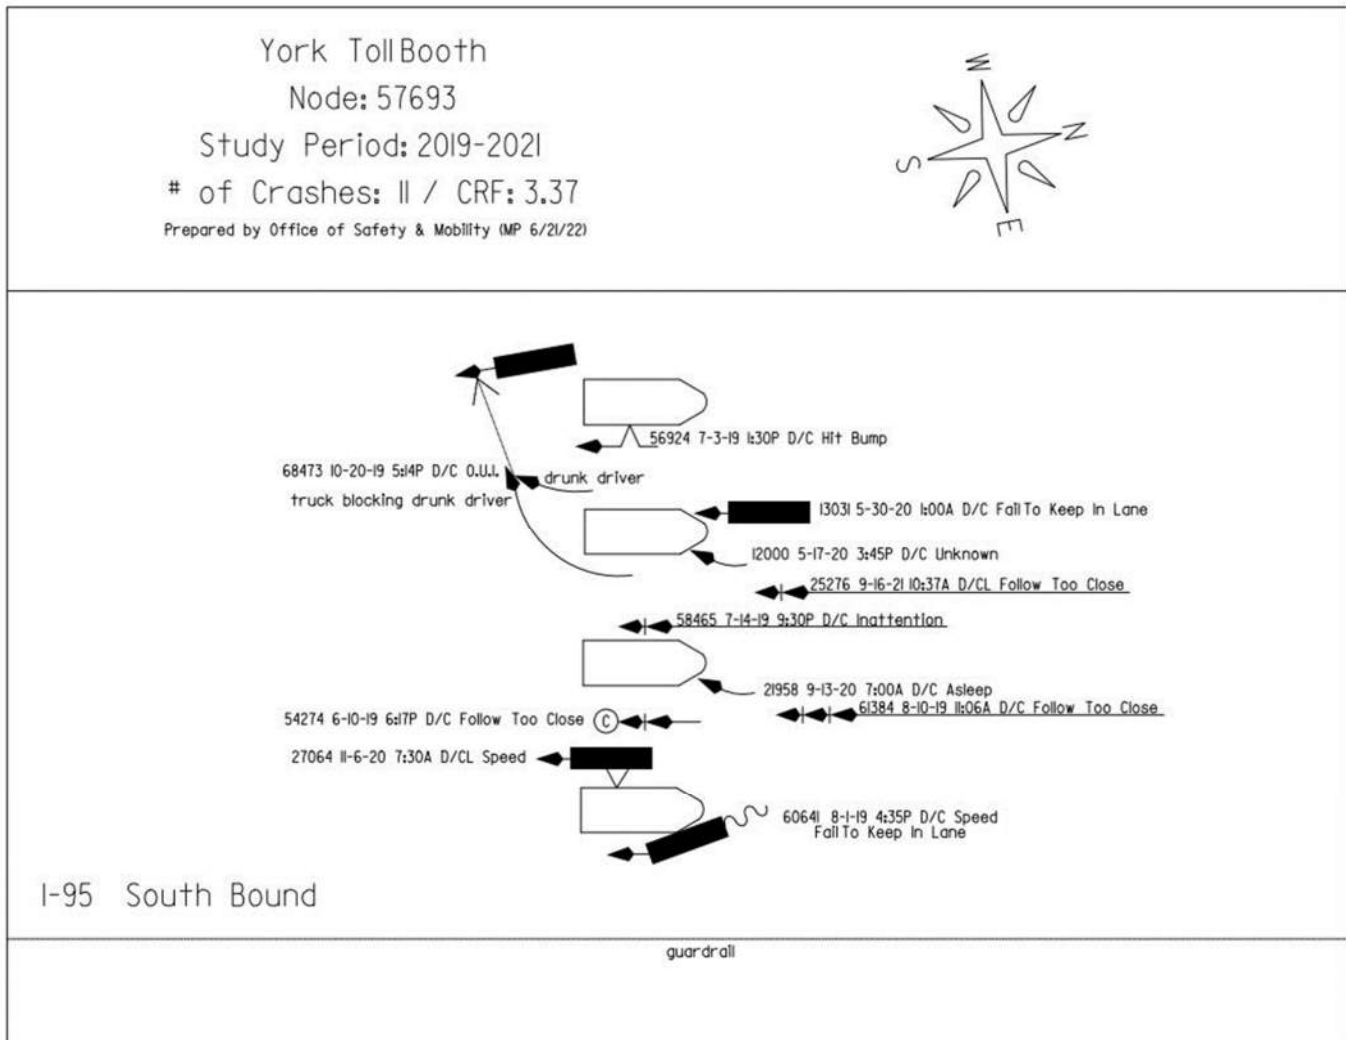
**Figure 4: 2019-2021 Old York Toll SB Crash Diagram**

As shown in **Figure 4**, there were 11 crashes resulting in a 9.1% injury rate during this analysis period.

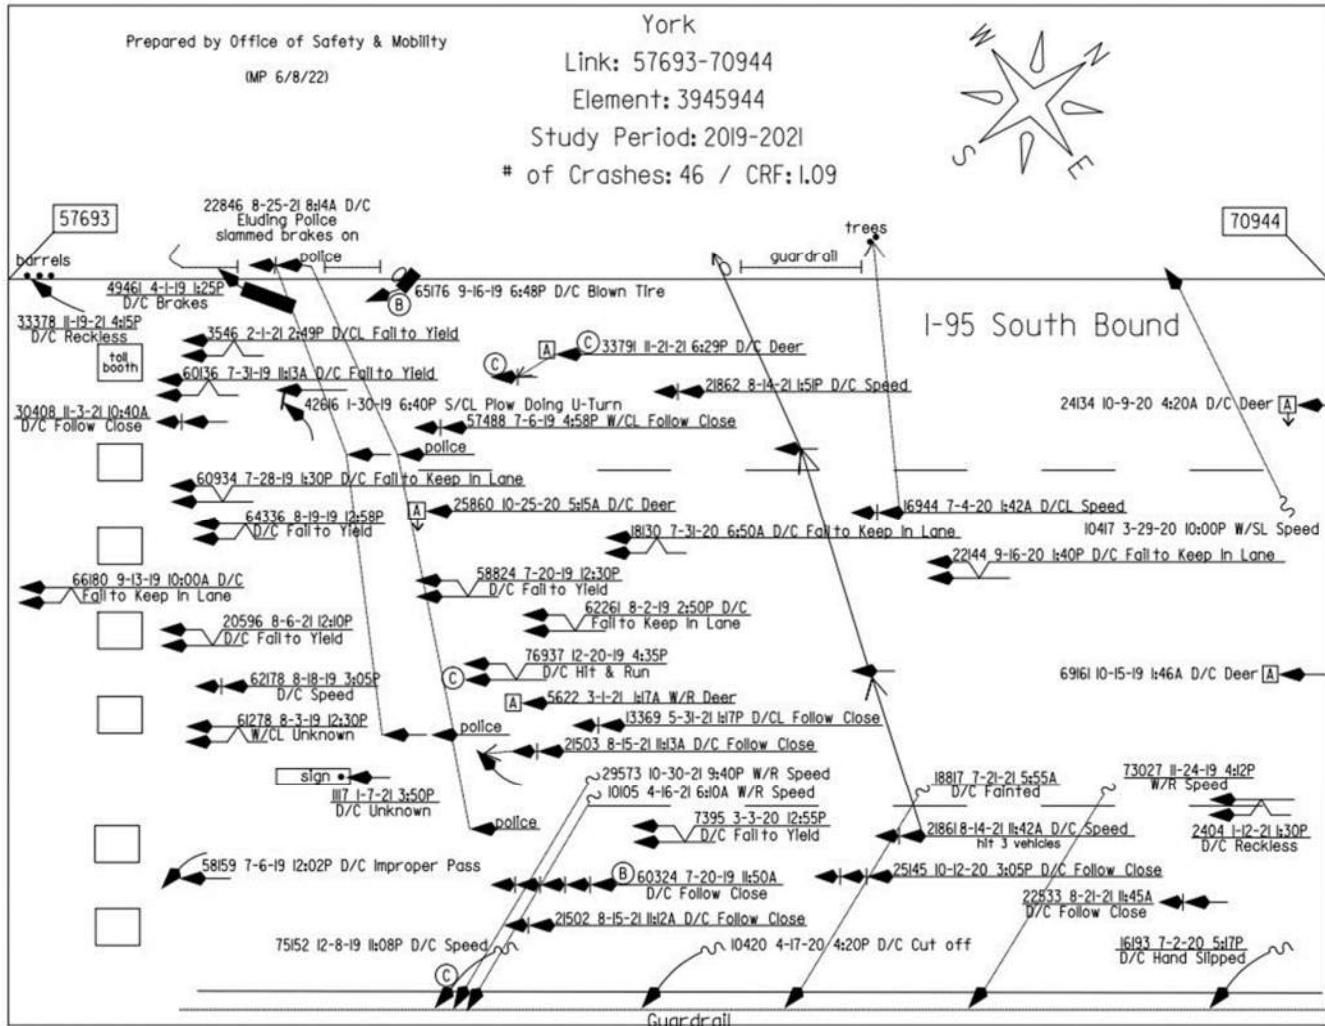
**Figure 5: 2019-2021 North of Old York Toll Plaza Crash Diagram**

As shown in **Figure 5**, there were 46 crashes resulting in a 13% injury rate during this analysis period.

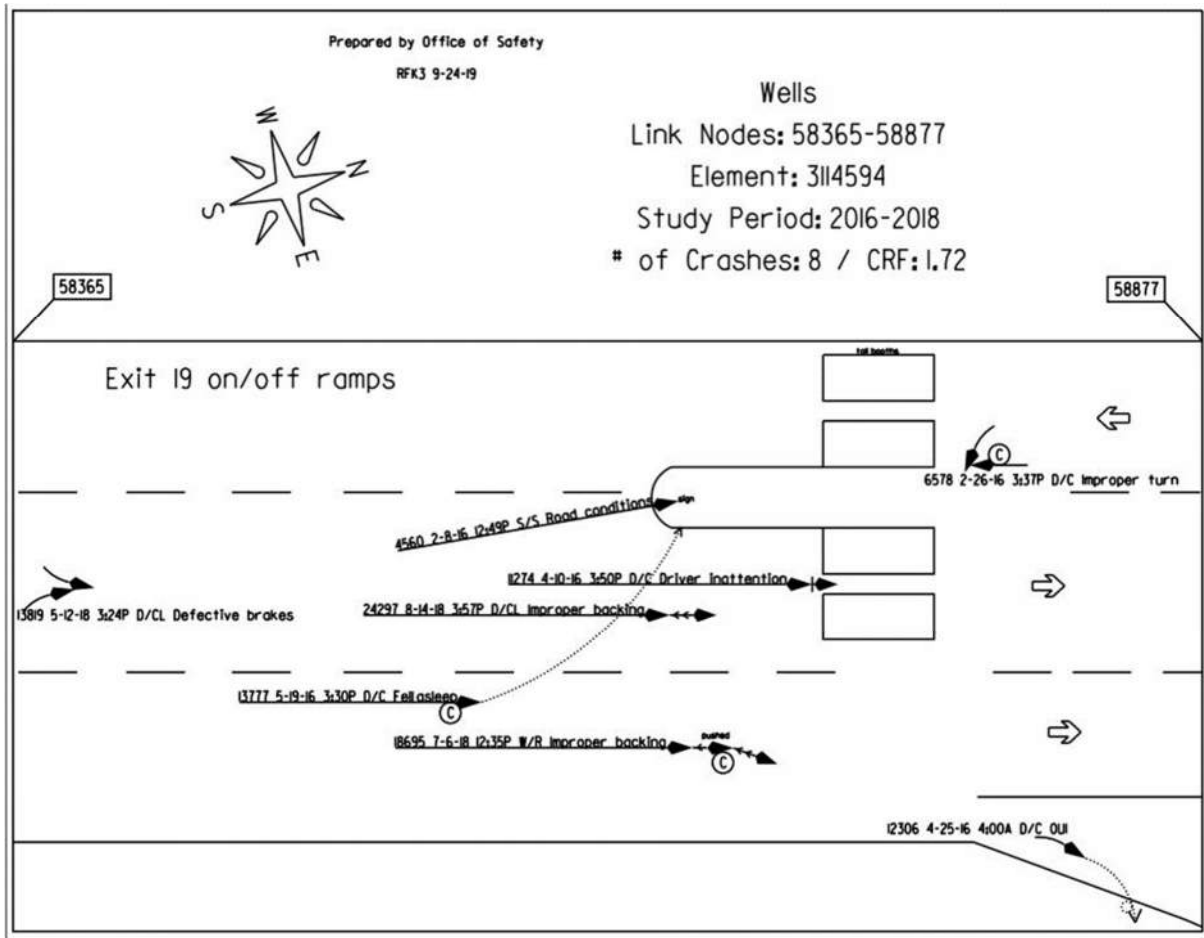
**Figure 2: 2016-2018 Exit 19 Toll Plaza Crash Diagram**

As shown in **Figure 2**, there were 8 crashes resulting in a 37.5% injury rate during this analysis period.

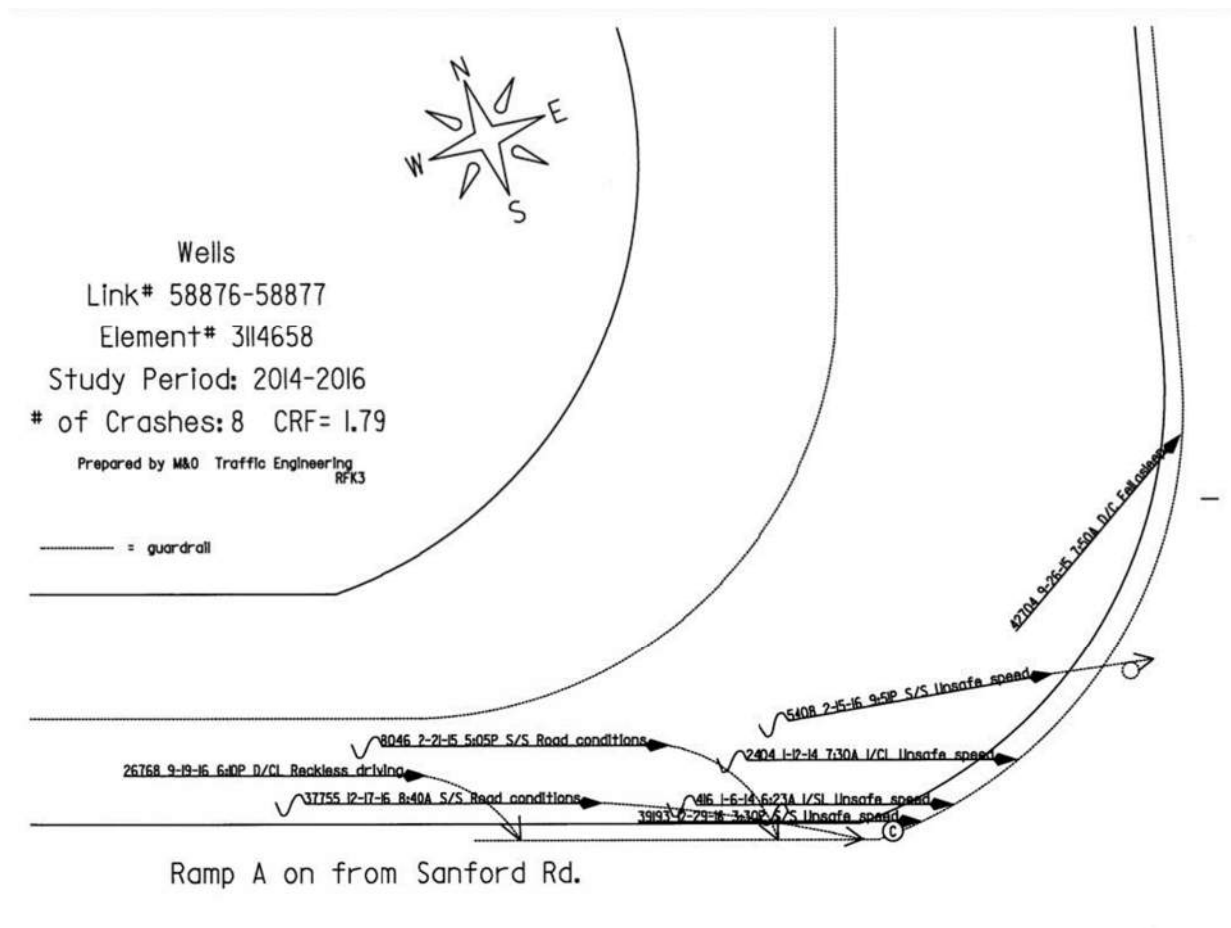
**Figure 3: 2014-2016 Northbound on Ramp Crash Diagram**

As shown in **Figure 3**, there were 8 crashes resulting in a 12.5% injury rate during this analysis period.

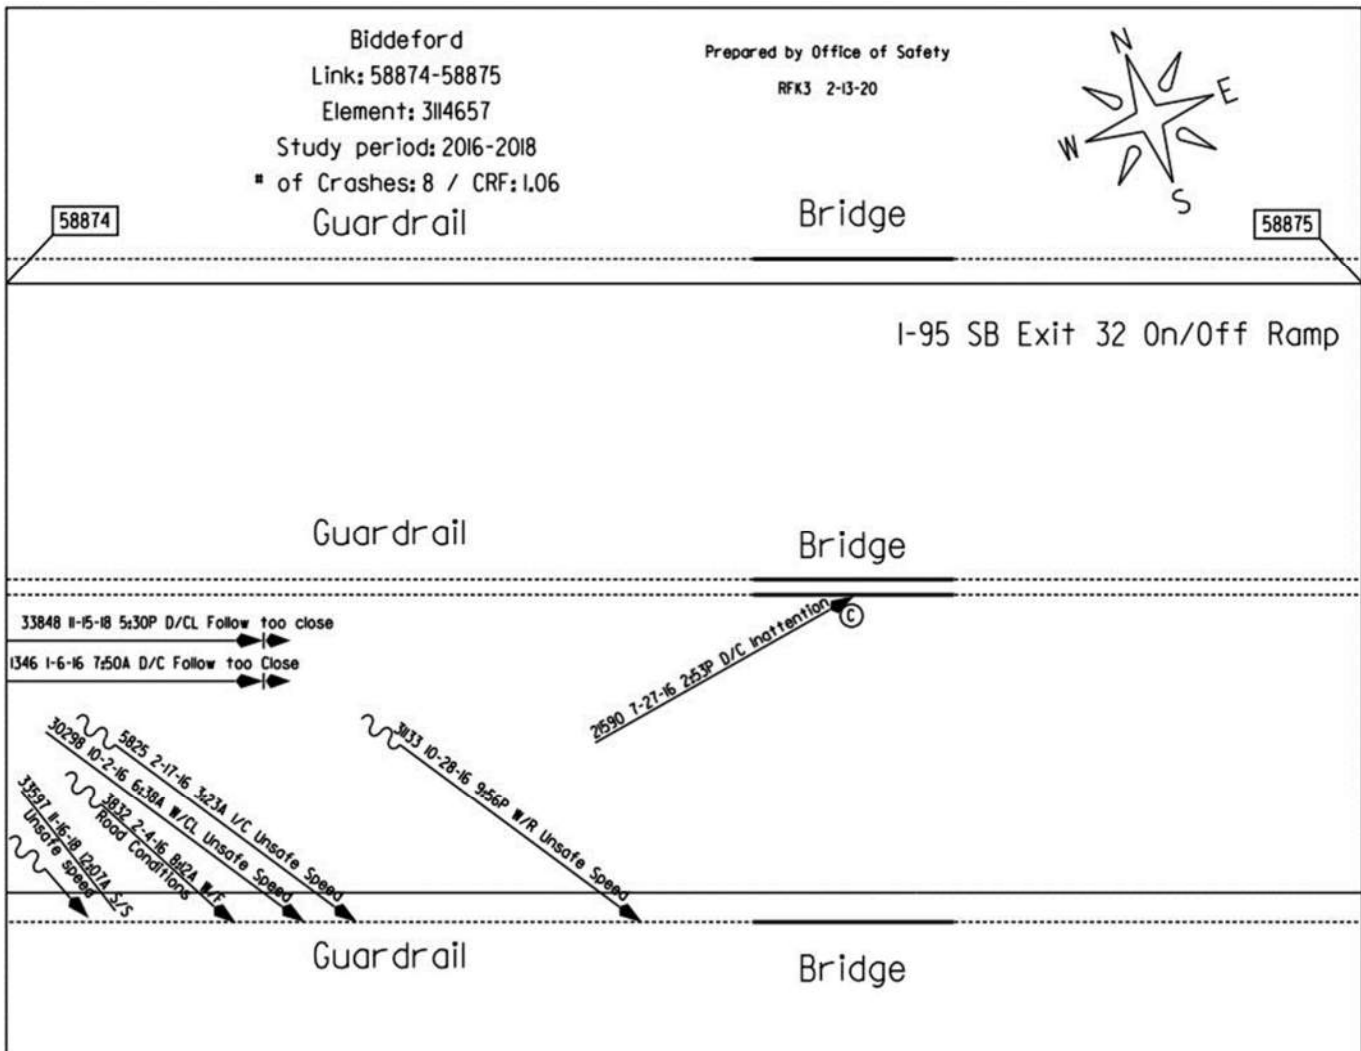
**Figure 4: 2016-2018 Exit 32 SB Off Ramp Crash Diagram**

As shown in **Figure 4**, there were 8 crashes resulting in a 12.5% injury rate during this analysis period.

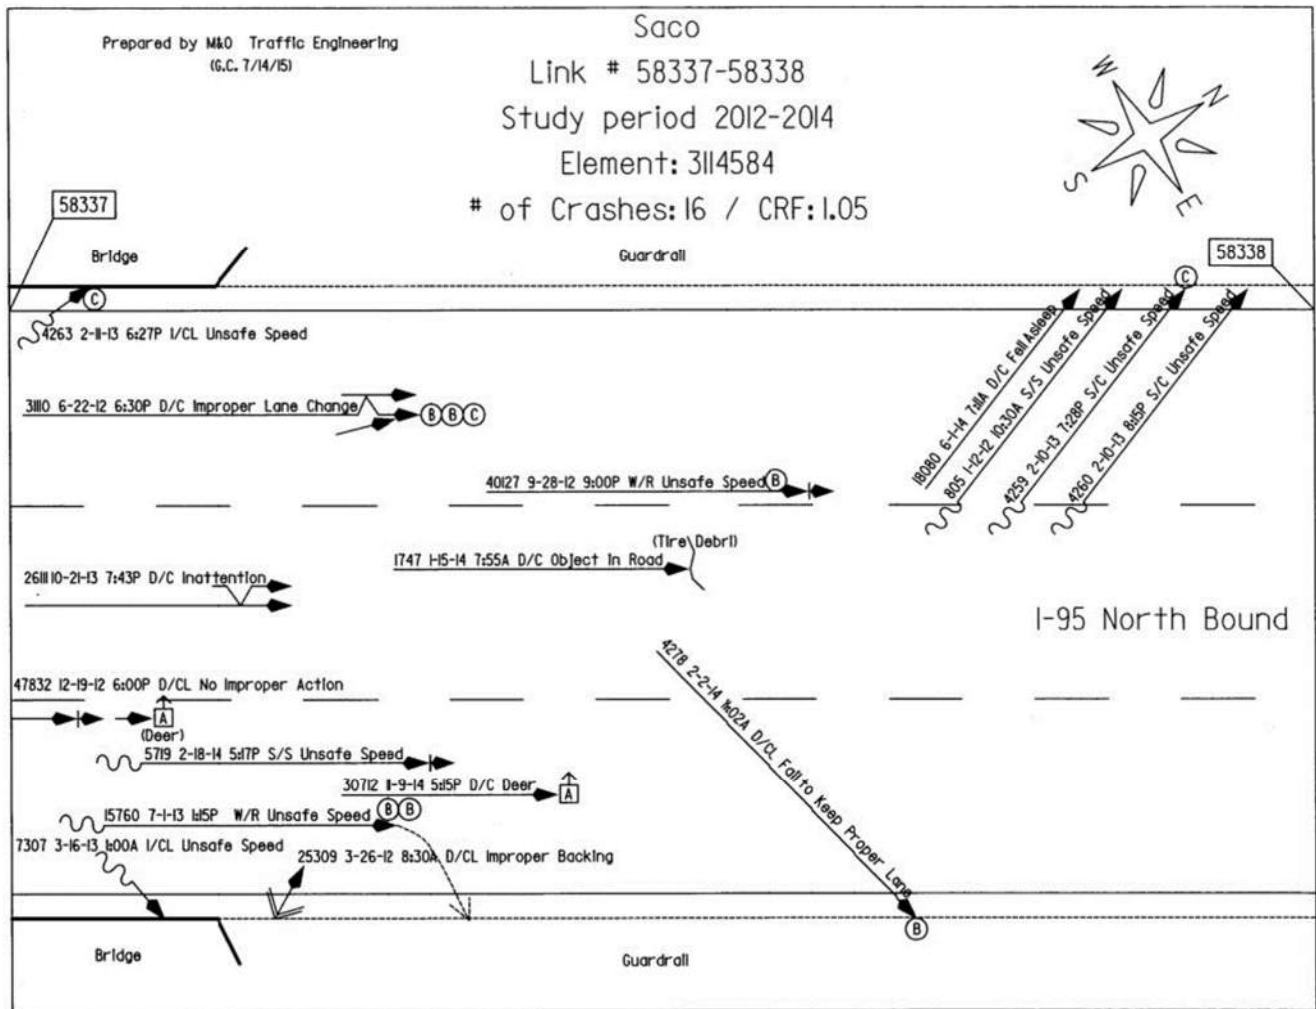
**Figure 2: 2012-2014 NB Segment Over Saco River Crash Diagram**

As shown in **Figure 2**, there were 16 crashes resulting in a 37.5% injury rate during this analysis period.

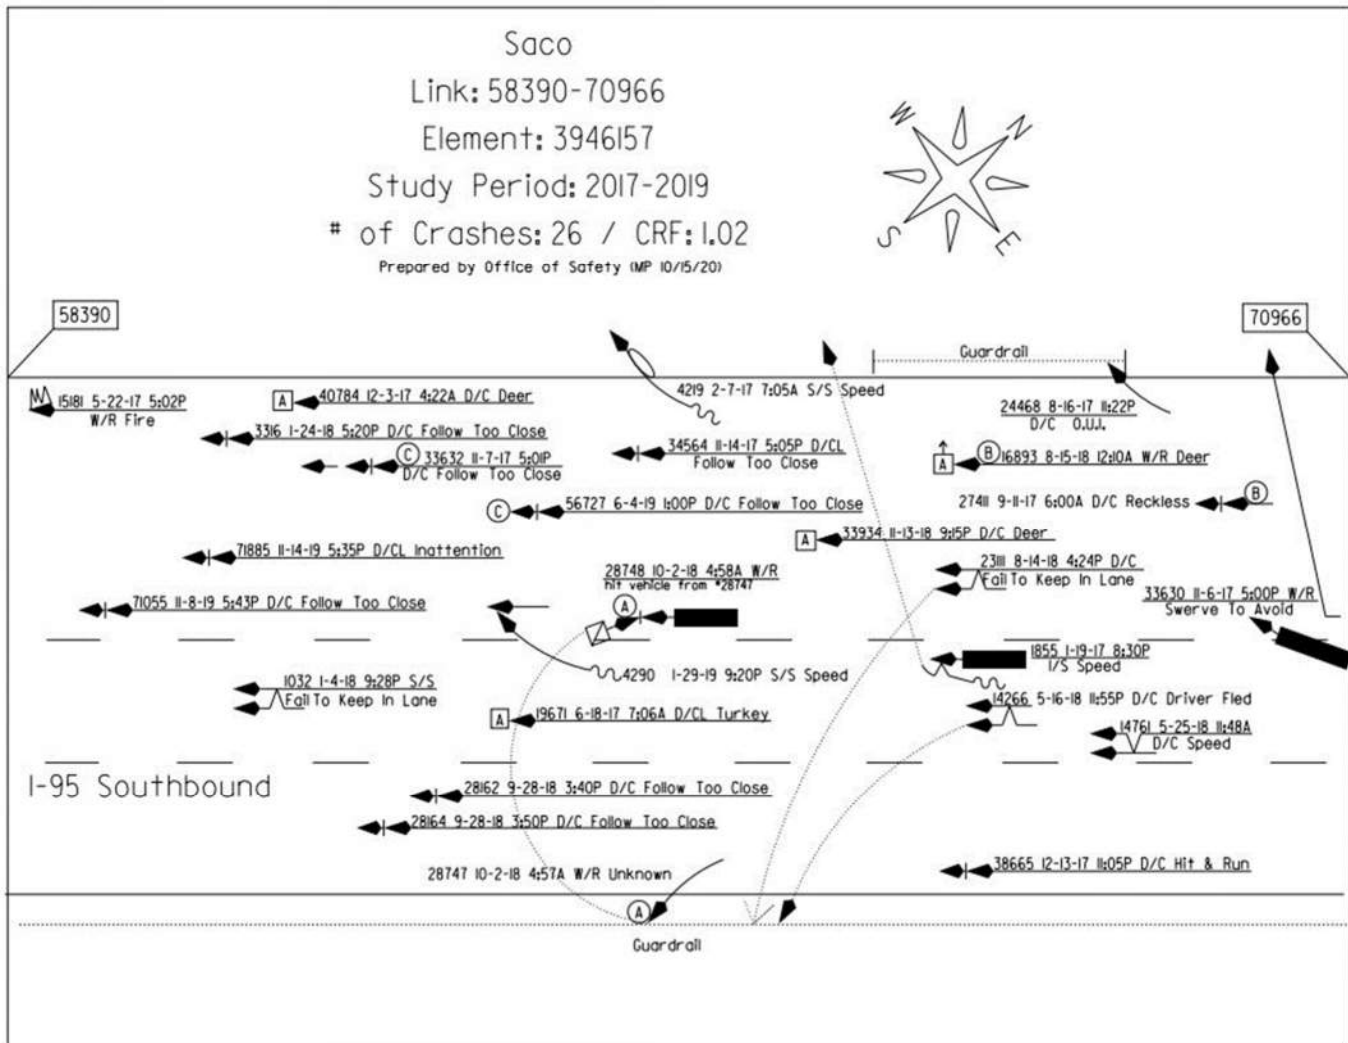
**Figure 2: 2017-2019 SB Mainline Between Exit 36 and 42 Crash Diagram**

As shown in **Figure 2**, there were 26 crashes resulting in a 23.1% injury rate during this analysis period.

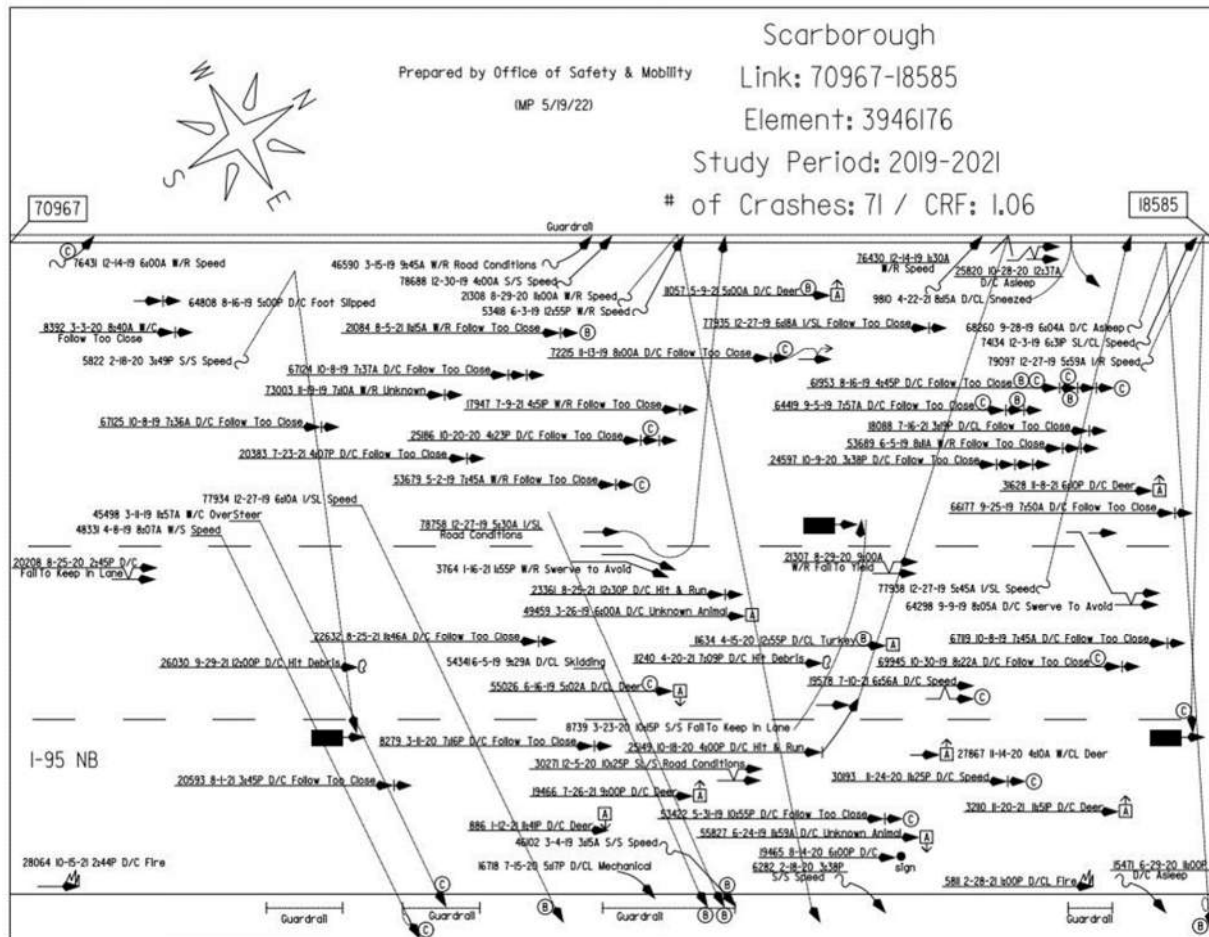
**Figure 3: 2019-2021 NB Mainline Between Exit 36 and 42 Crash Diagram**

As shown in **Figure 3**, there were 71 crashes resulting in a 31% injury rate during this analysis period.
