# 2022 Systemwide Safety and Capacity Study

June 30, 2023

Maine Turnpike Authority  
2360 Congress Street  
Portland, ME 04102

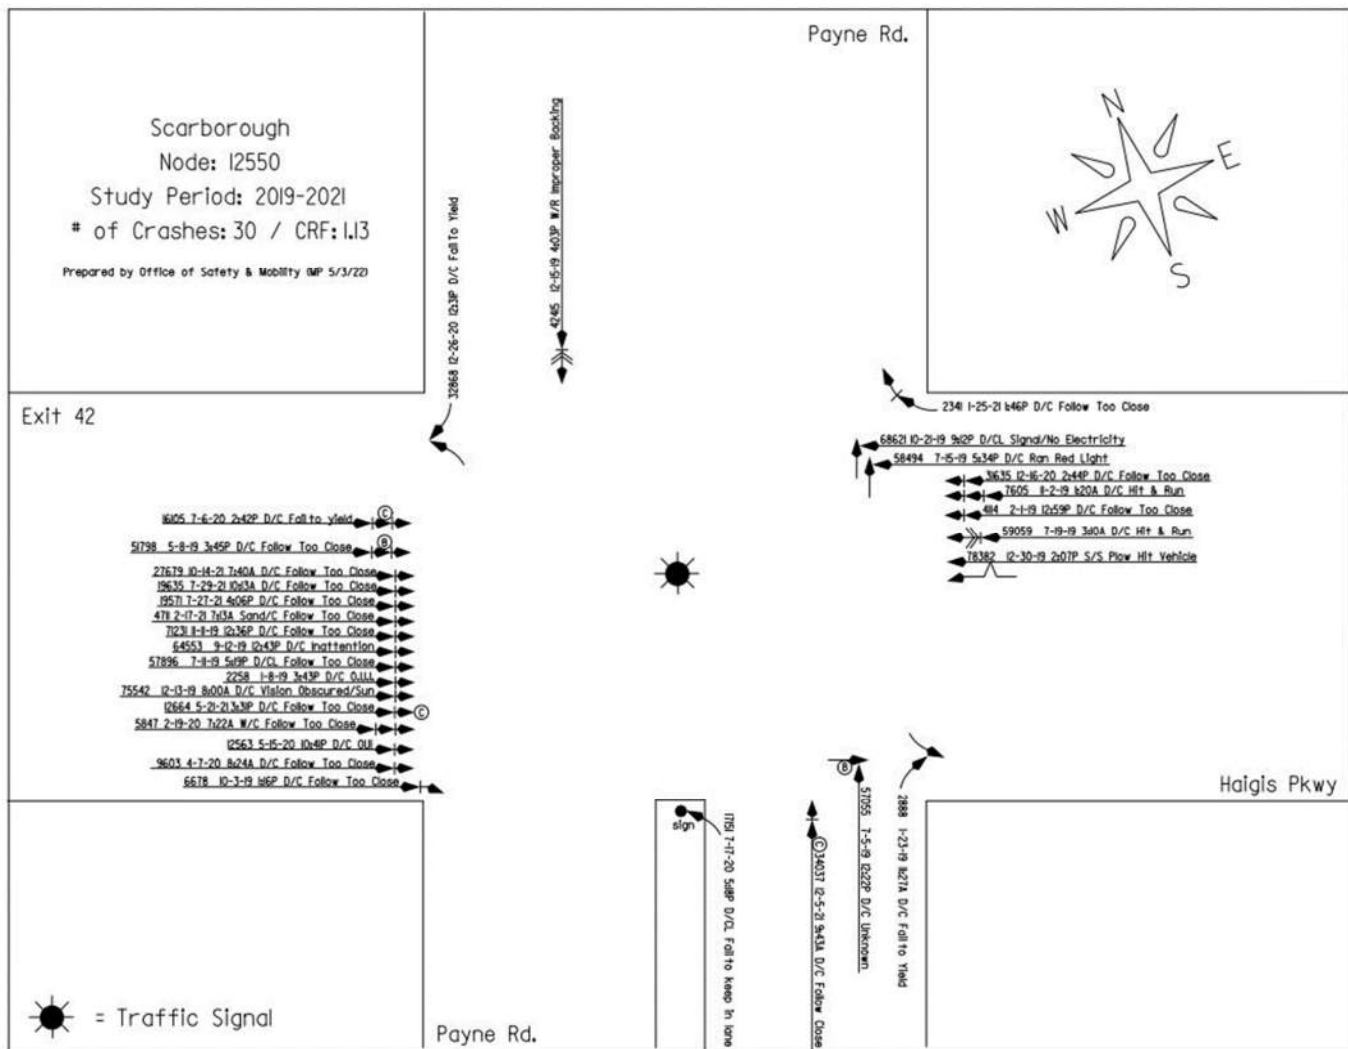
**Figure 2: (2019-2021) Exit 42 Intersection Crash Diagram**

As shown in **Figure 2**, there were 30 crashes resulting in a 16.7% injury rate during this analysis period.

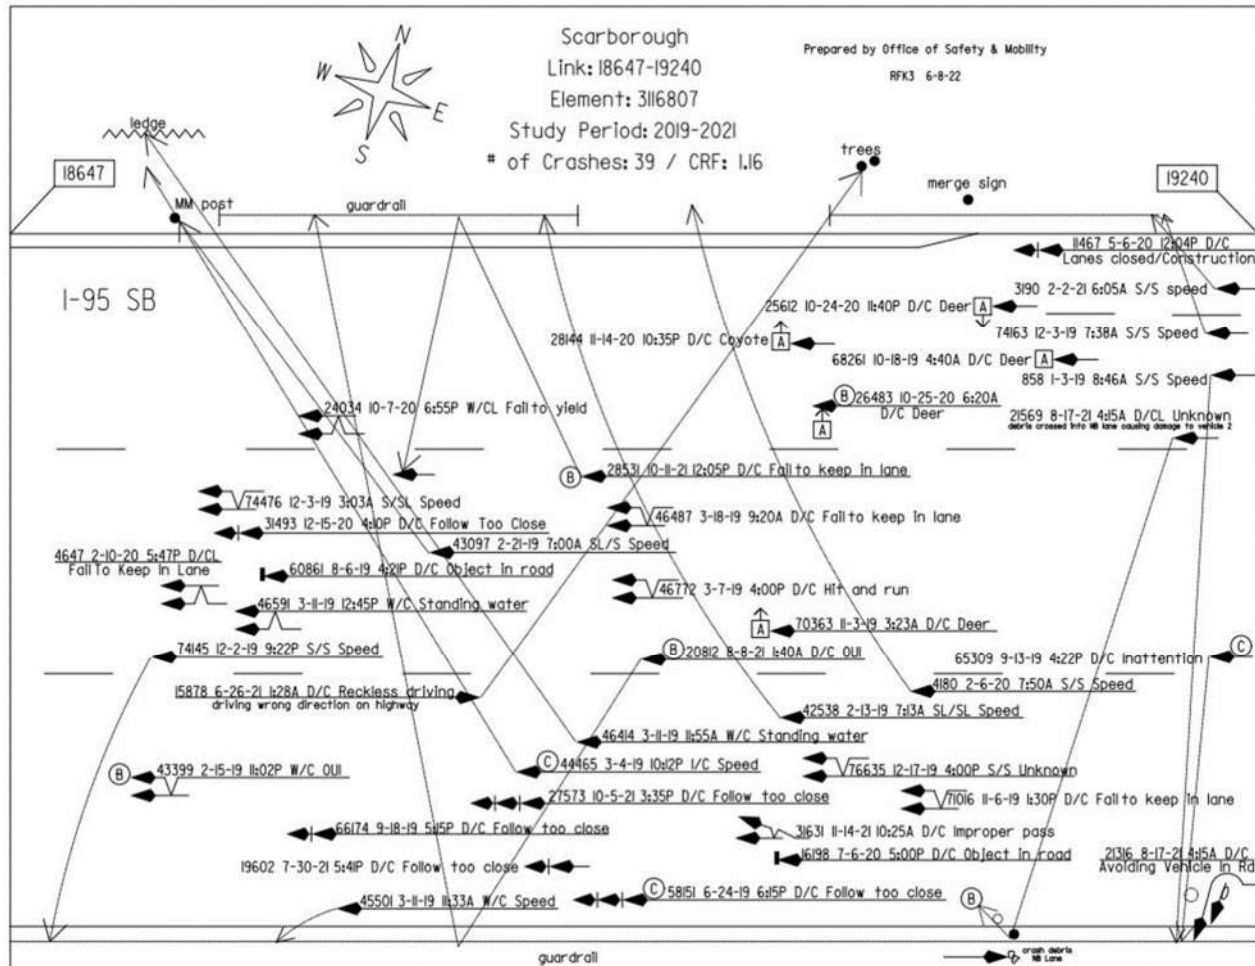
**Figure 2: 2019-2021 Exit 42 SB Off Ramp Approach Crash Diagram**

- The leading cause of crash in this location was speed, which was a contributing factor in 9 of these 39 crashes
- Following too close and collisions with large animals were the next most common cause with each acting as a contributing factor to 5 crashes
- 2 of the crashes at this location involved standing water
- 2 crashes at this location, each which resulted in a type B injury, were the result of an O.U.I.
- 16 of these 39 crashes (41%) resulted in vehicles departing the roadway and colliding with objects including guardrail, trees, ledge and signposts
- 16 of the recorded crashes at this location occurred between the months of June and October when this area experiences increased traffic volumes
- There is not a strong correlation between time of day and crash frequency at this location

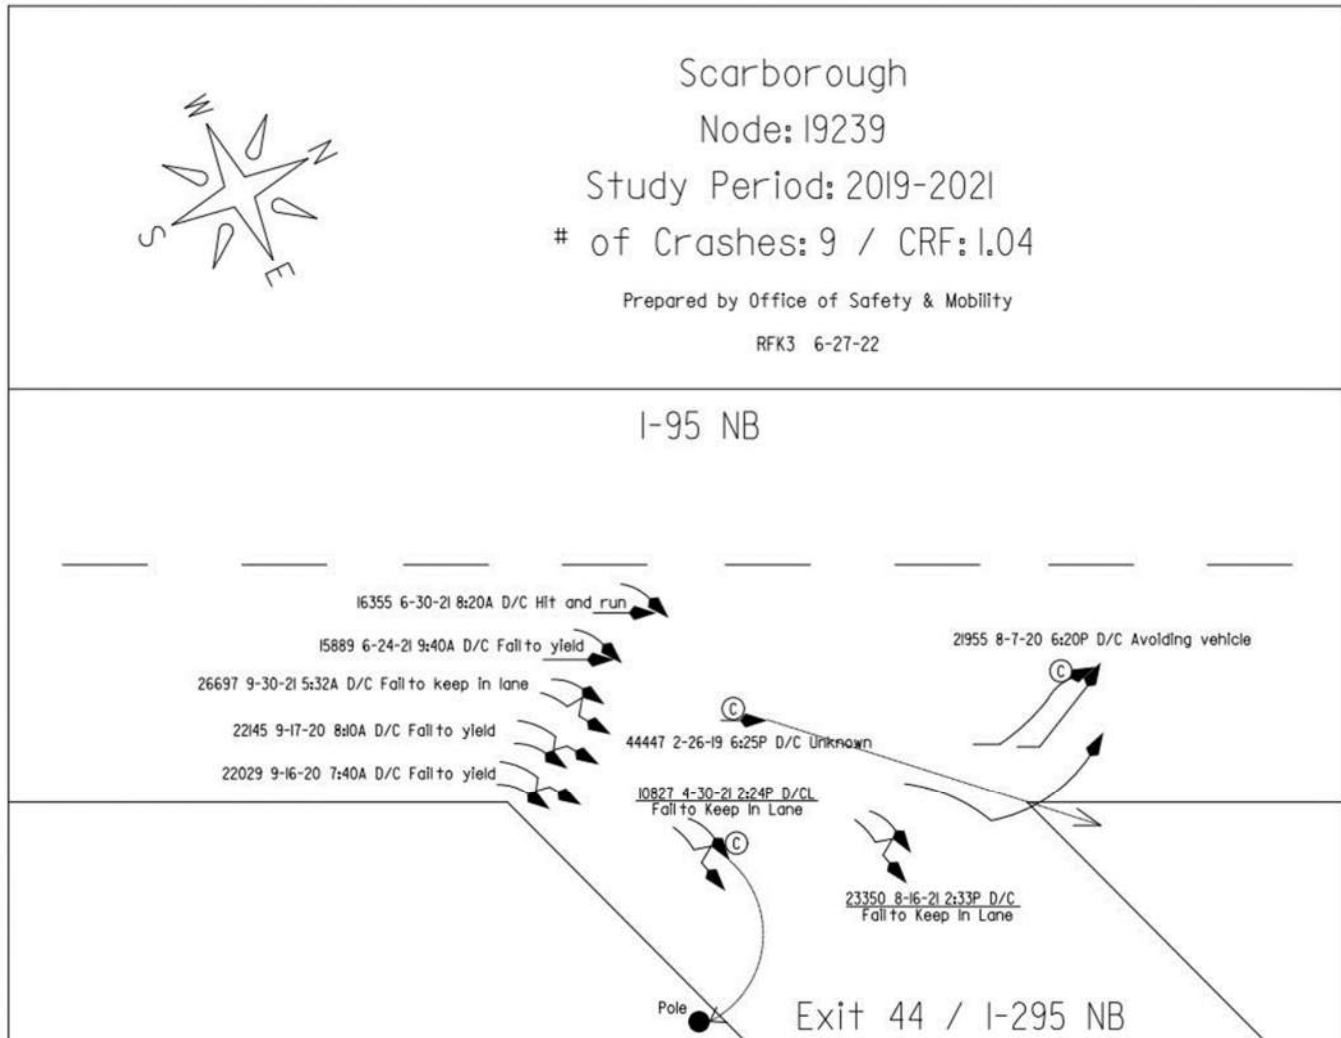
**Figure 4: 2019-2021 Exit 44 NB Diverge Crash Diagram**

As shown in **Figure 4**, there were 9 crashes resulting in a 33.3% injury rate during this analysis period.

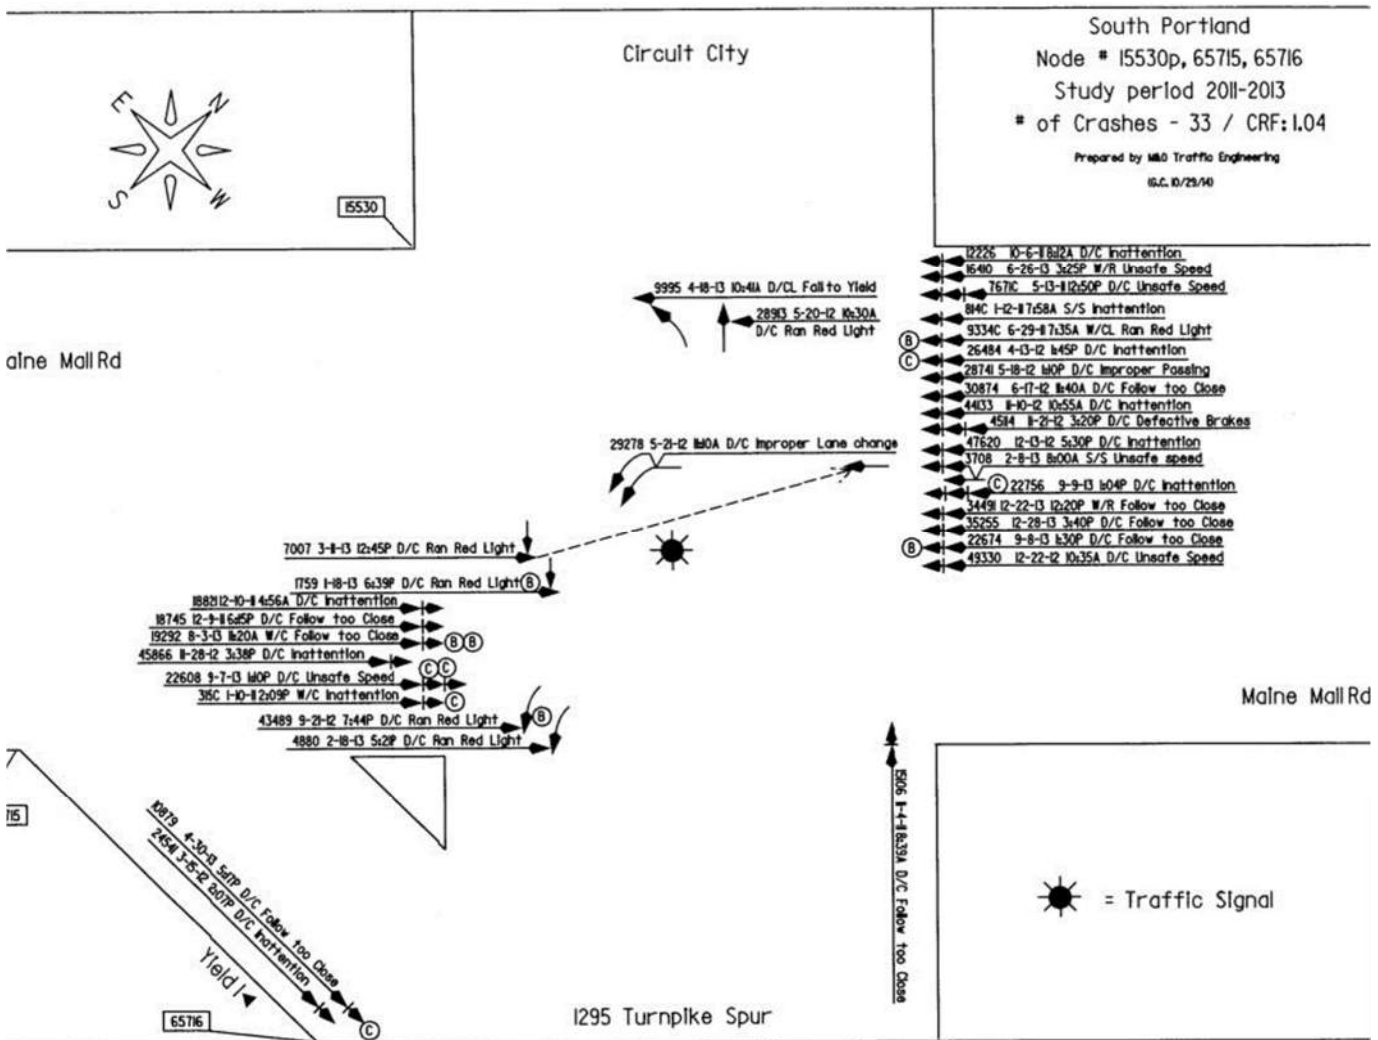
**Figure 2: 2011-2013 Exit 45 Off Ramp Intersection Crash Diagram**

As shown in **Figure 2**, there were 33 crashes resulting in a 30.3% injury rate during this analysis period.

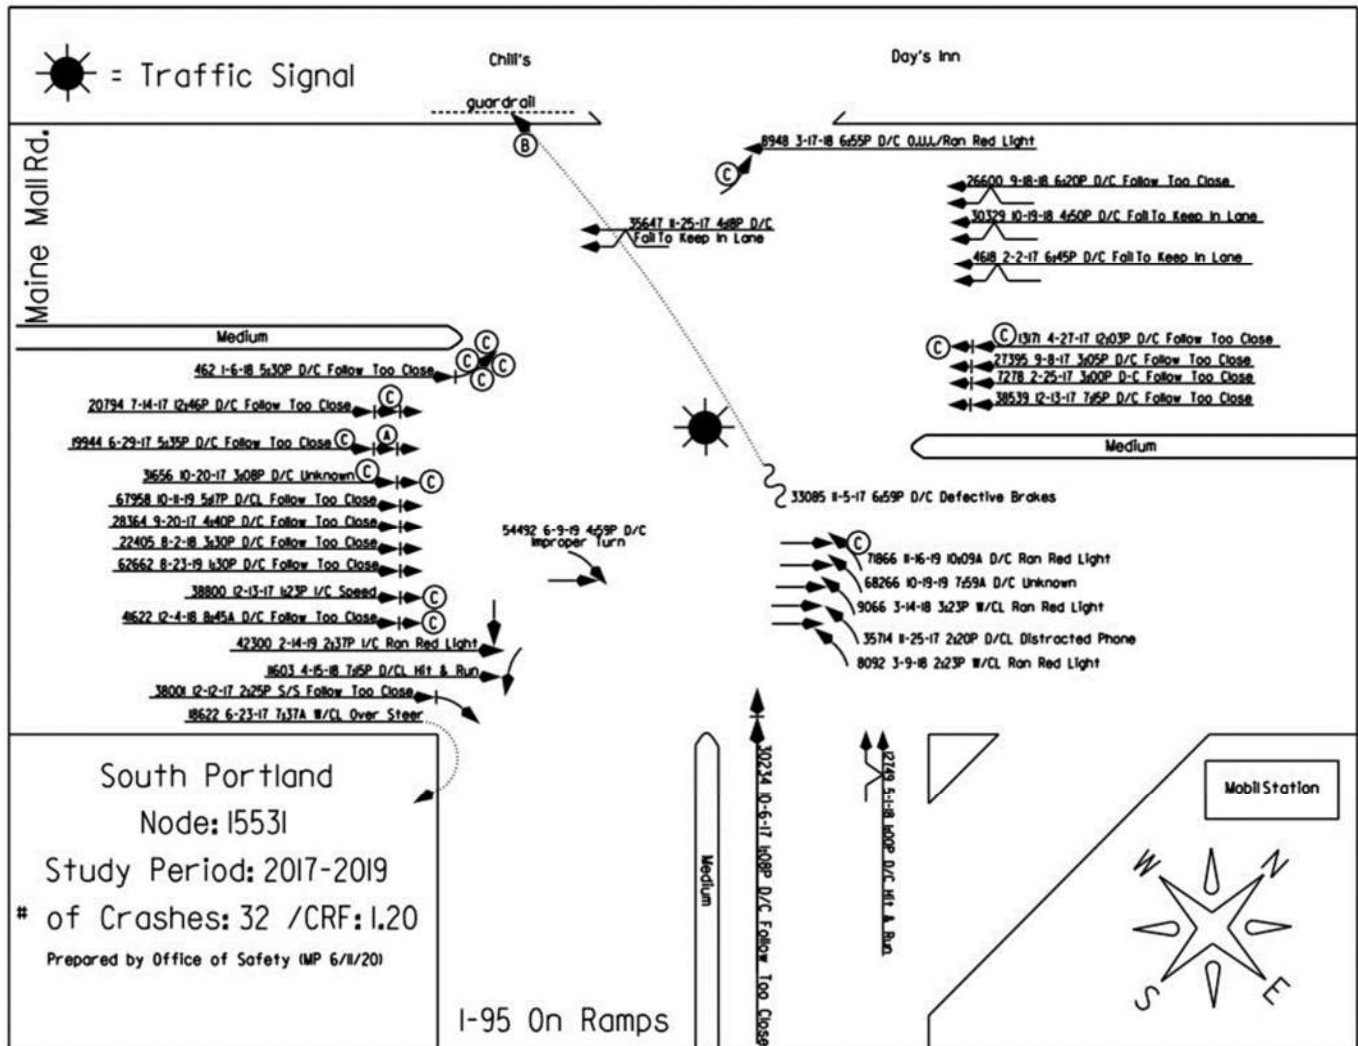
**Figure 3: 2017-2019 Exit 45 On Ramps Intersection Crash Diagram**

As shown in **Figure 3**, there were 32 crashes resulting in a 31.3% injury rate during this analysis period.

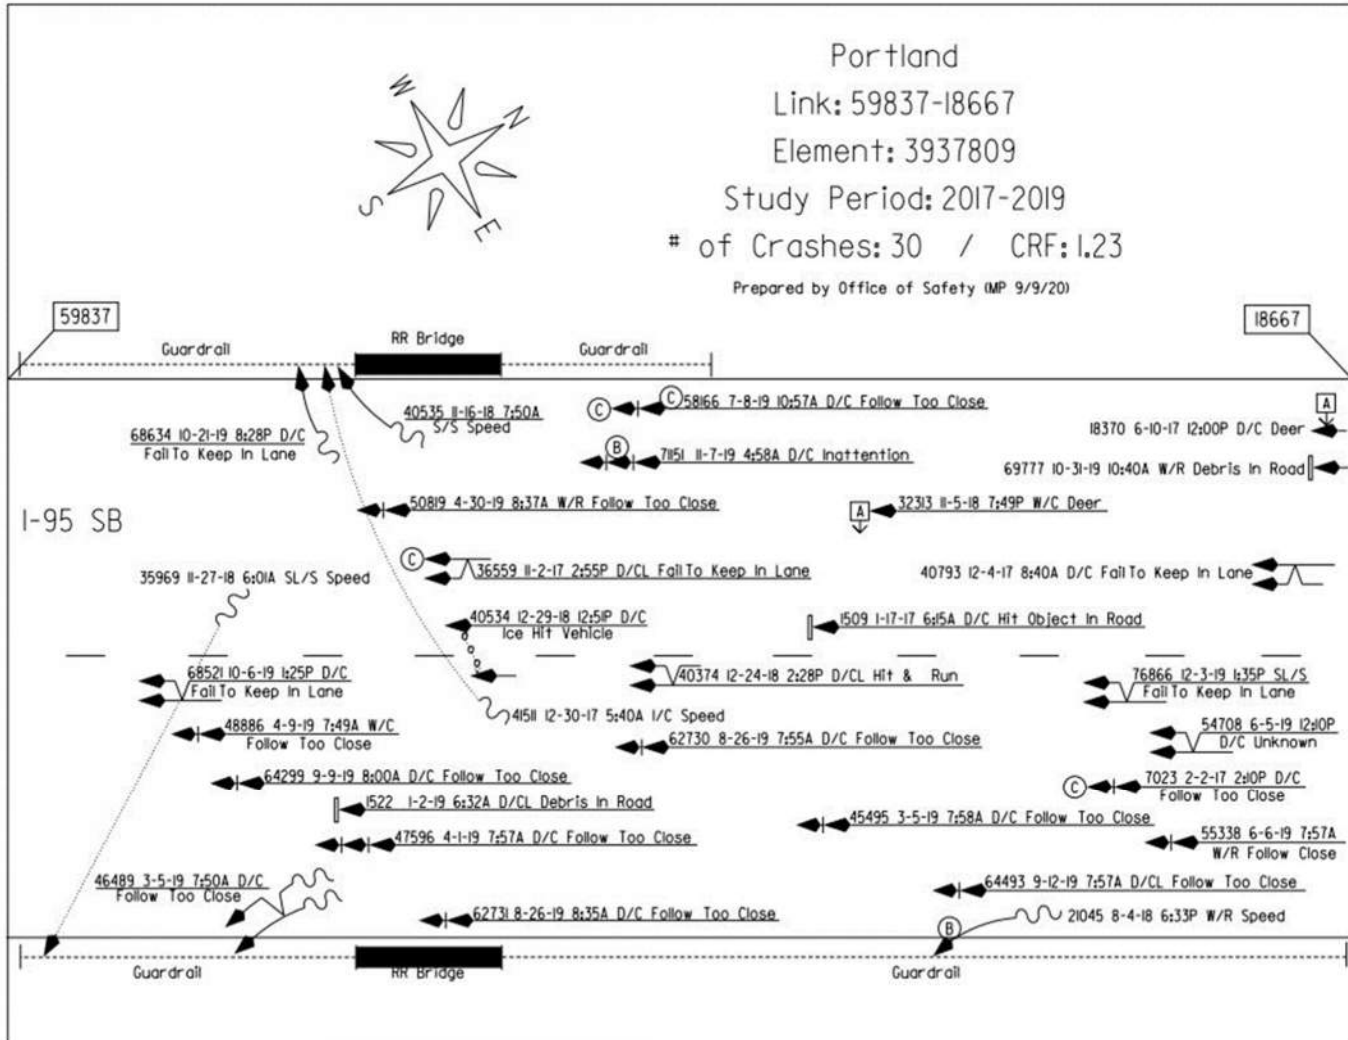
**Figure 2: 2017-2019 I-95 SB Mile Marker 47-48 Crash Diagram**

As shown in **Figure 2**, there were 30 crashes resulting in a 16.7% injury rate during this analysis period.

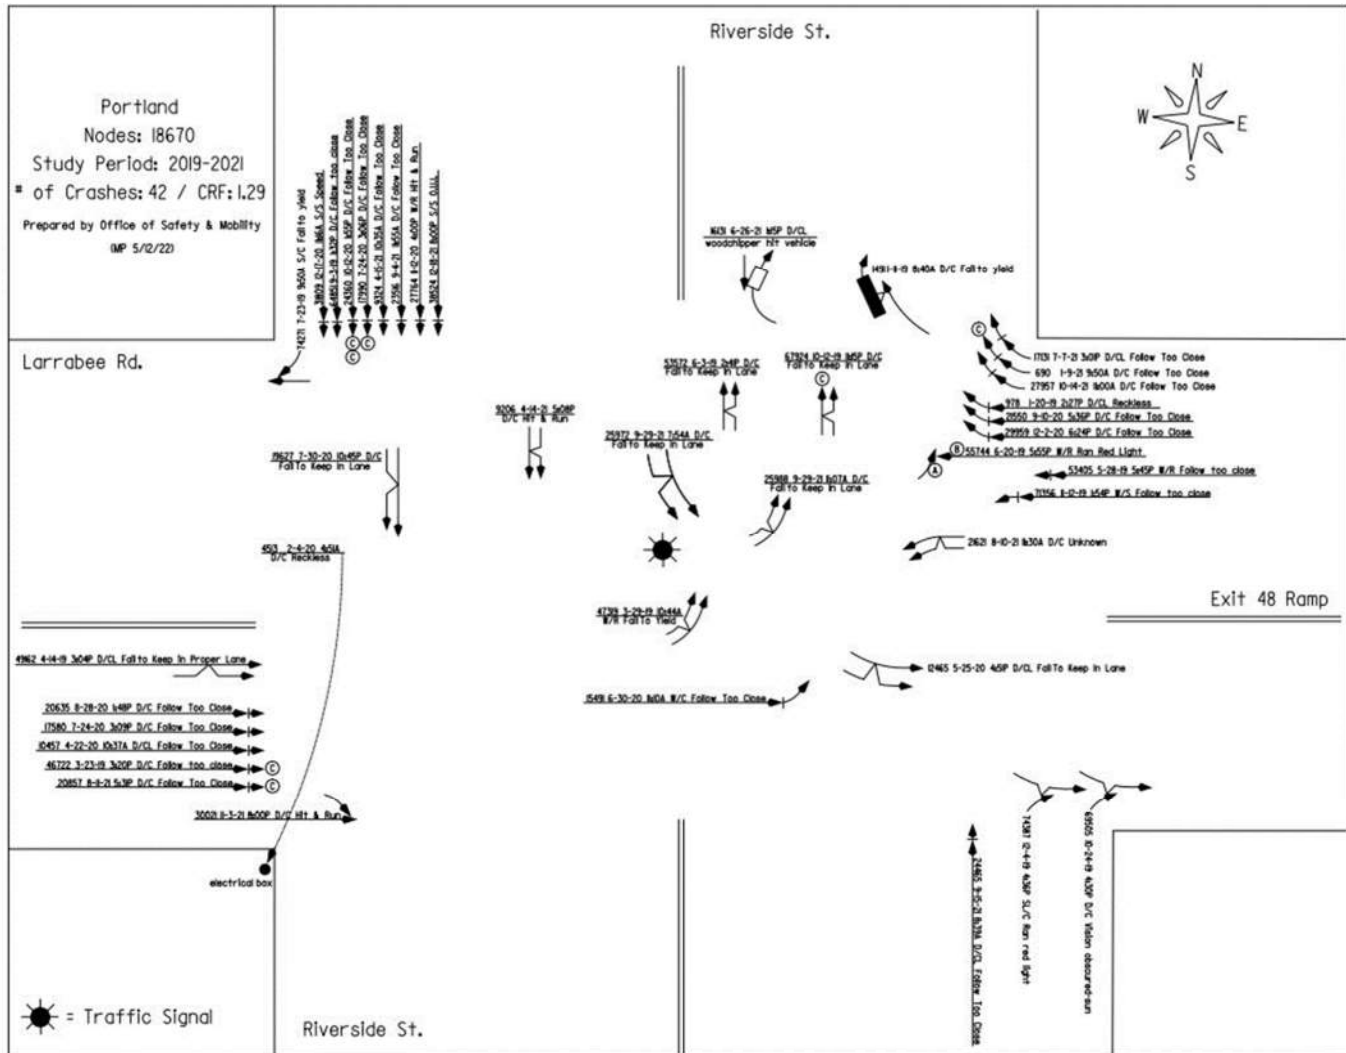
**Figure 2: 2019-2021 Exit 48 Intersection Crash Diagram**

As shown in **Figure 2**, there were 42 crashes resulting in a 16.7% injury rate during this analysis period.

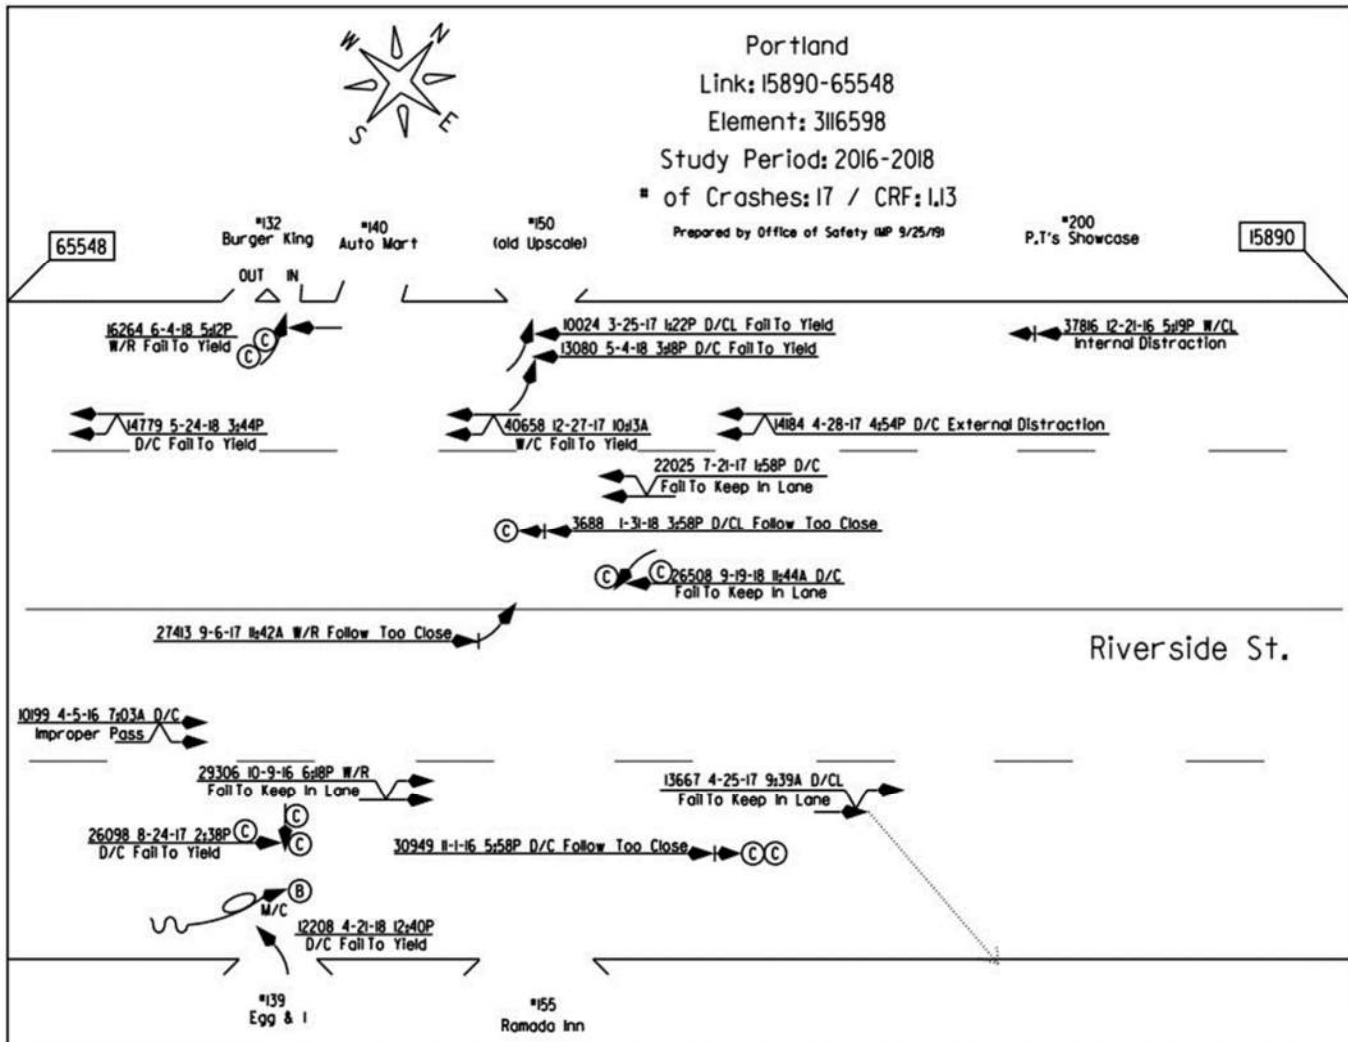
**Figure 3: 2016-2018 Riverside Street SB Approach Crash Diagram**

As shown in **Figure 3**, there were 17 crashes resulting in a 35.3% injury rate during this analysis period.

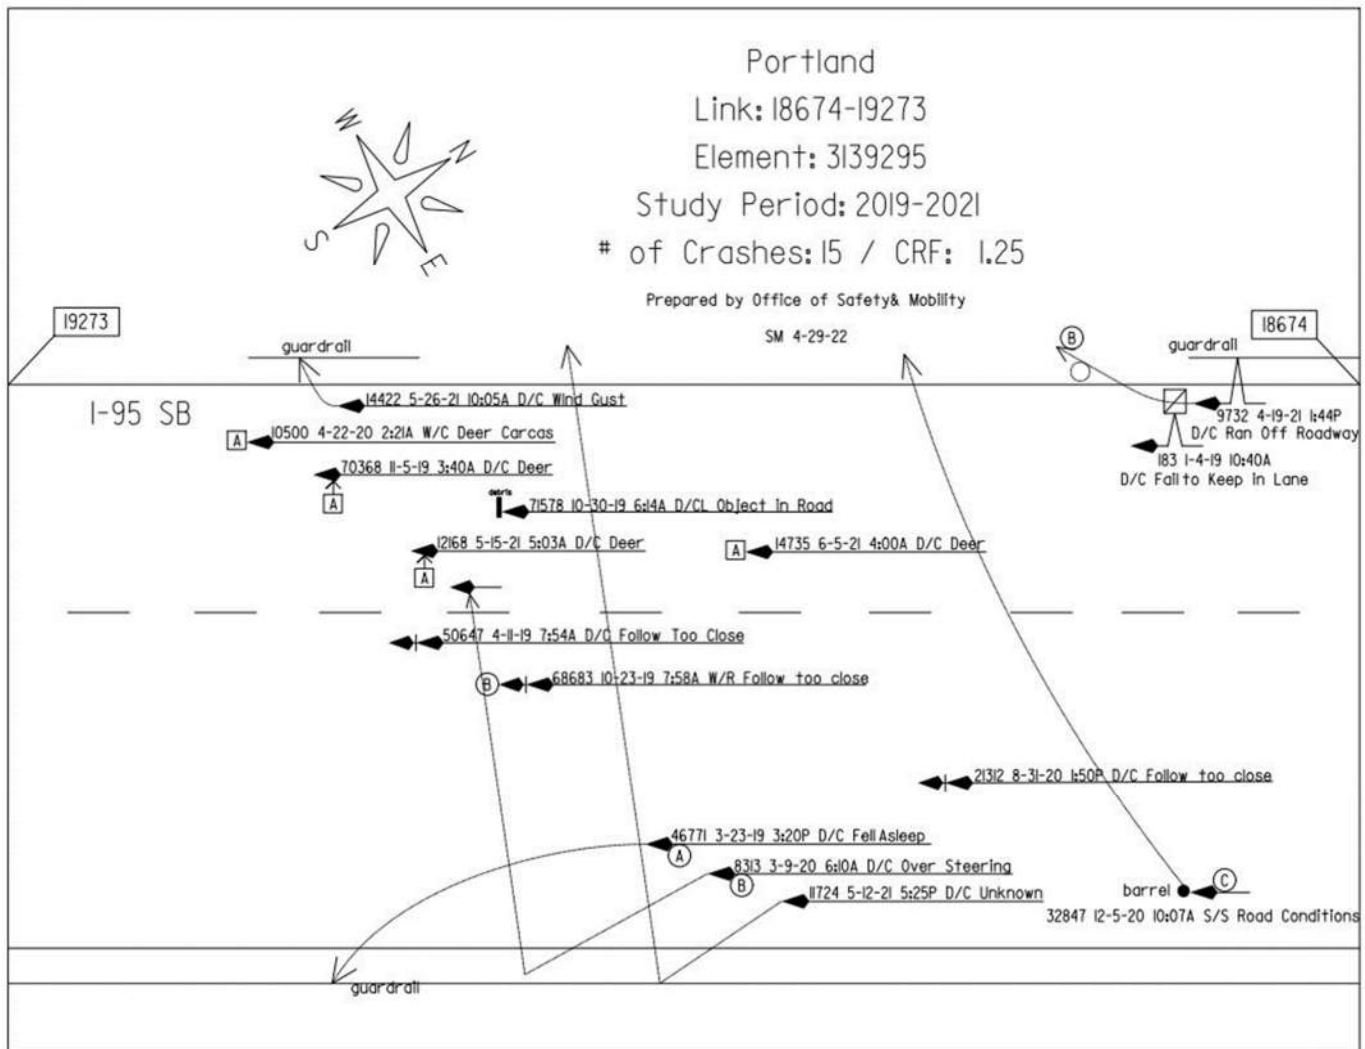
**Figure 2: 2019-2021 Exit 48 SB Ramp Approach Crash Diagram**

As shown in **Figure 2**, there were 15 crashes resulting in a 33.3% injury rate during this analysis period.

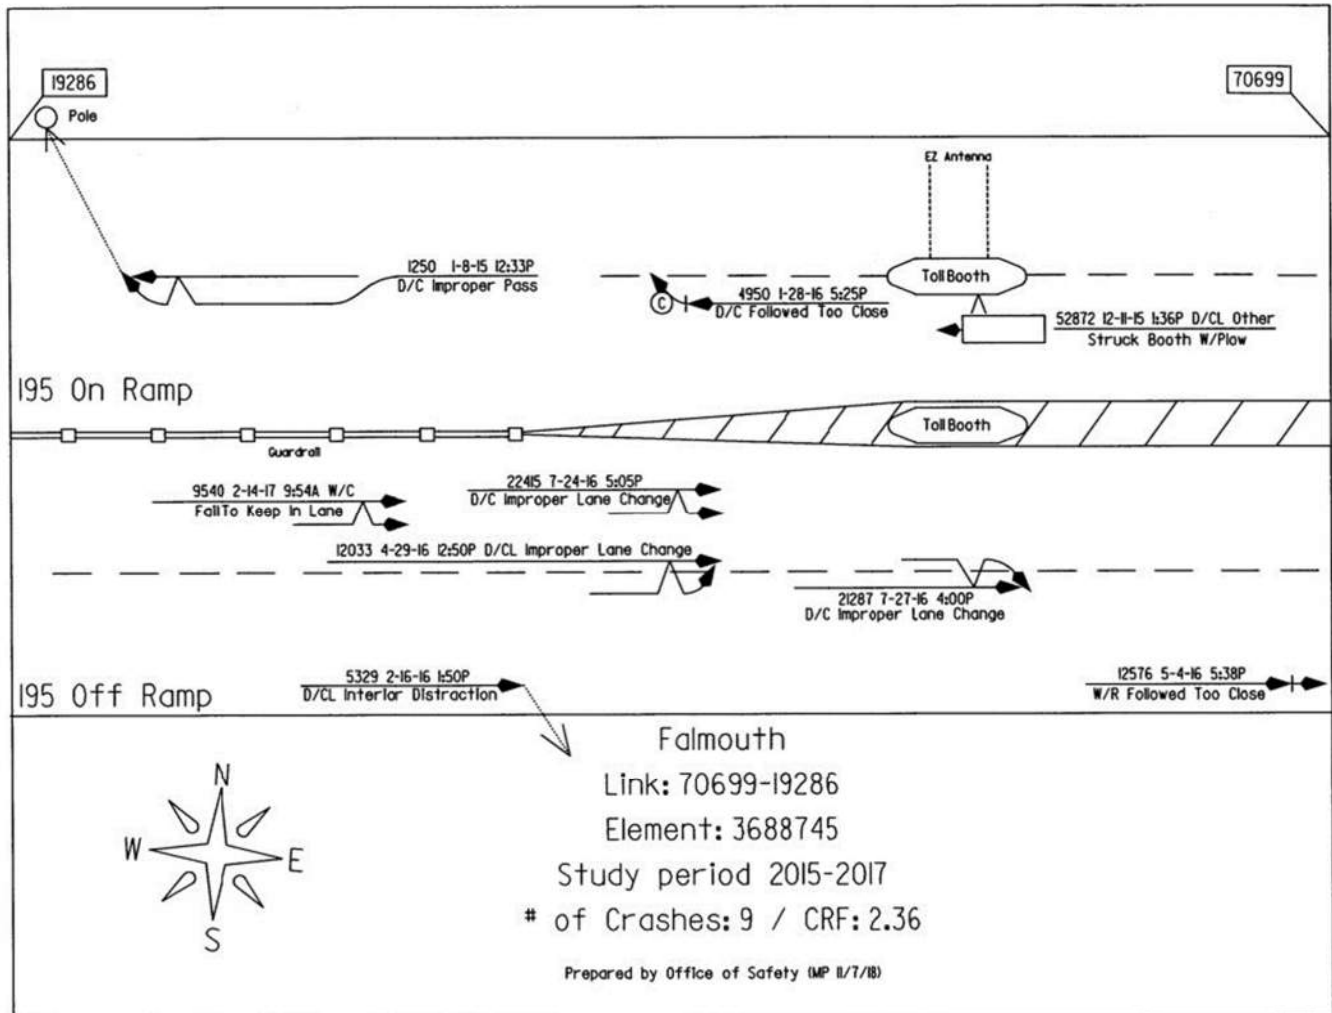
**Figure 2: 2015-2017 Exit 53 Toll Plaza Crash Diagram**

As shown in **Figure 2**, there were 9 crashes resulting in a 11.1% injury rate during this analysis period.

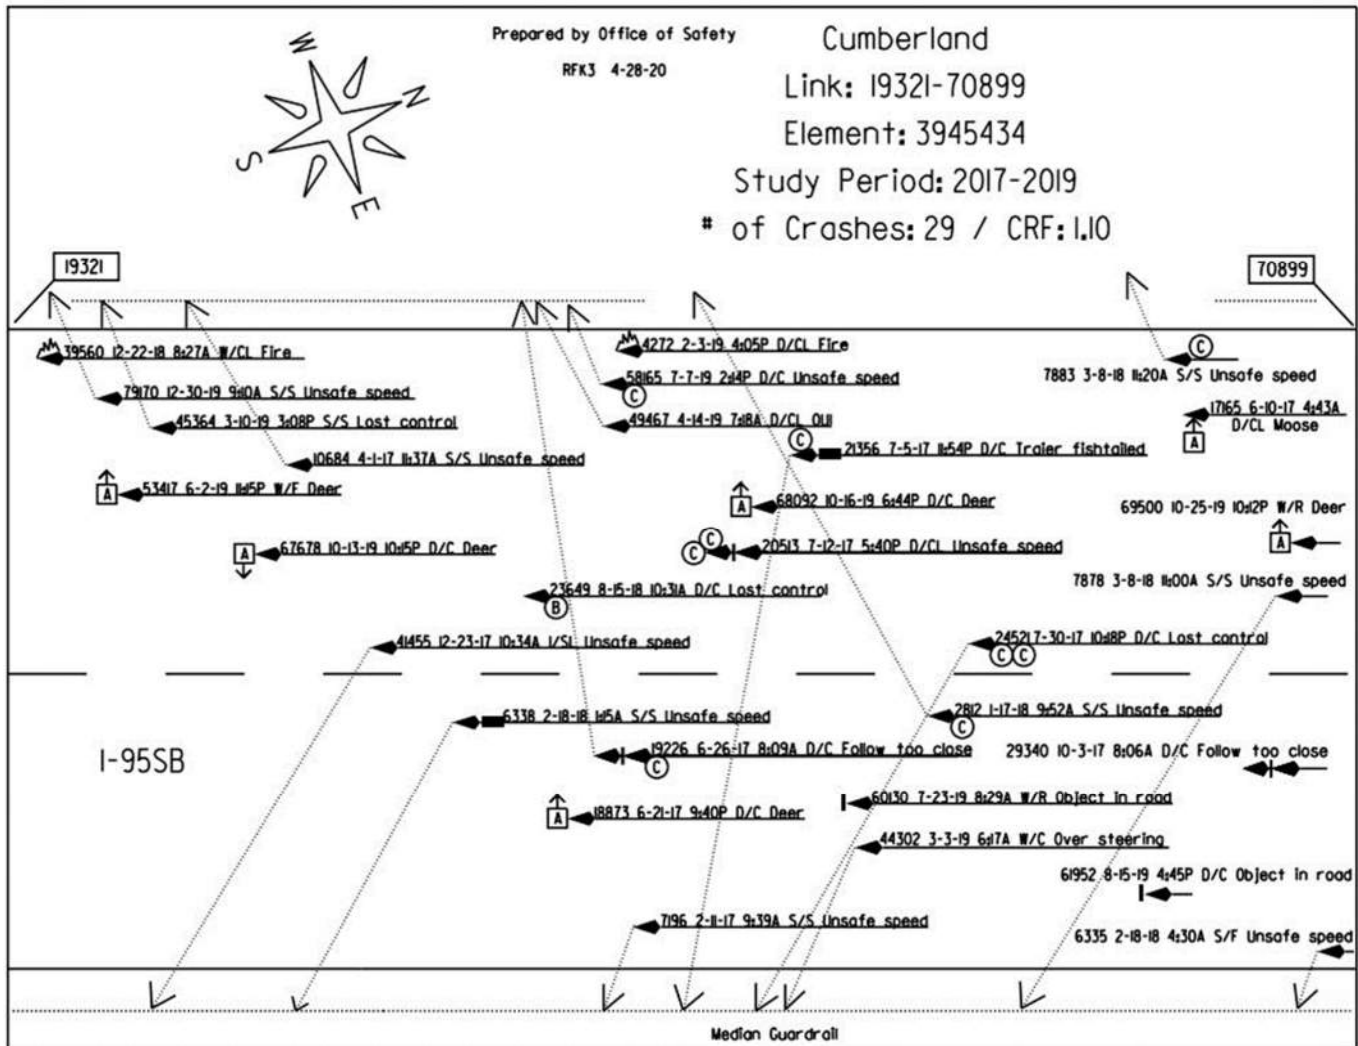
**Figure 2: 2017-2019 SB South of Upper Blackstrap Road Crash Diagram**

As shown in **Figure 2**, there were 29 crashes resulting in a 27.6% injury rate during this analysis period.

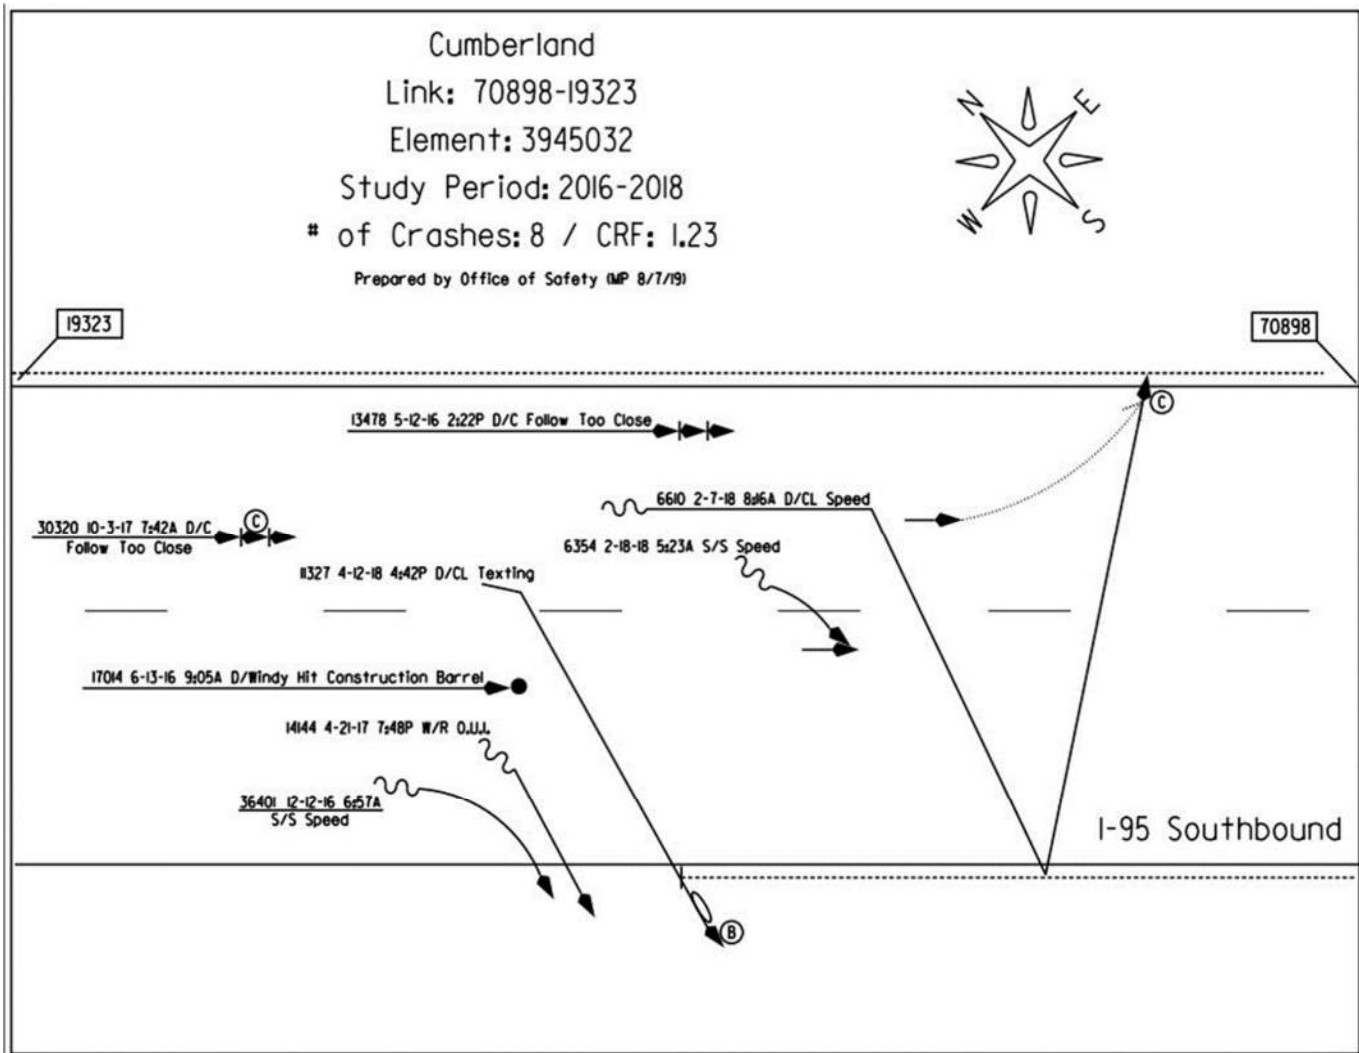
**Figure 2: 2016-2018 SB Plaza Approach Crash Diagram**

As shown in **Figure 2**, there were 8 crashes resulting in a 37.5% injury rate during this analysis period.

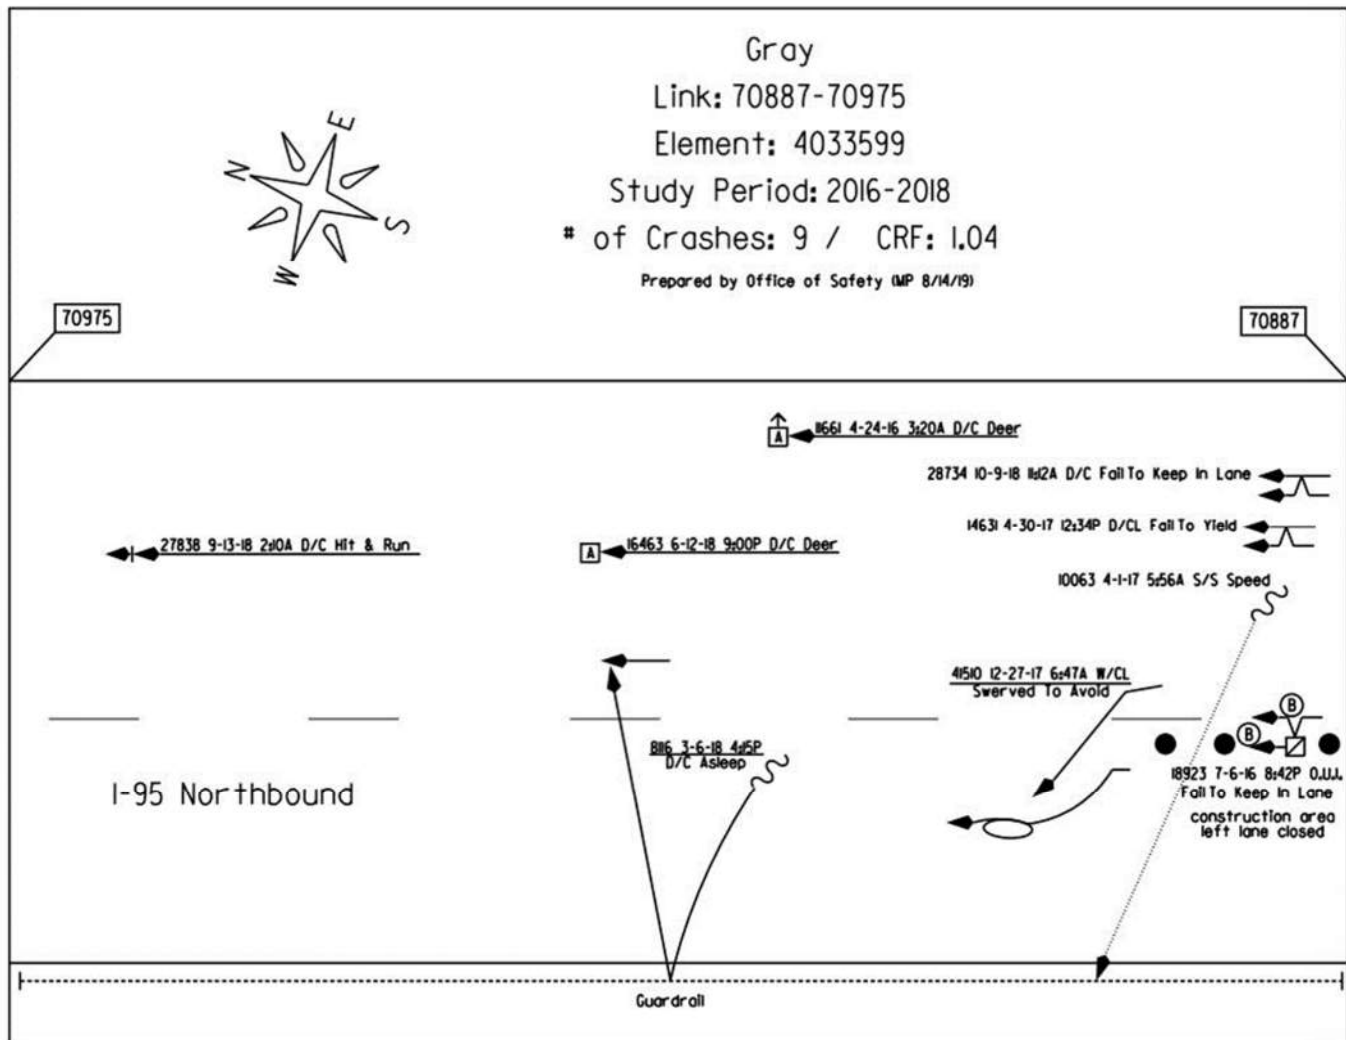
**Figure 3: 2016-2018 NB North of Gray Service Plaza Crash Diagram**

As shown in **Figure 3**, there were 9 crashes resulting in a 11.1% injury rate during this analysis period.

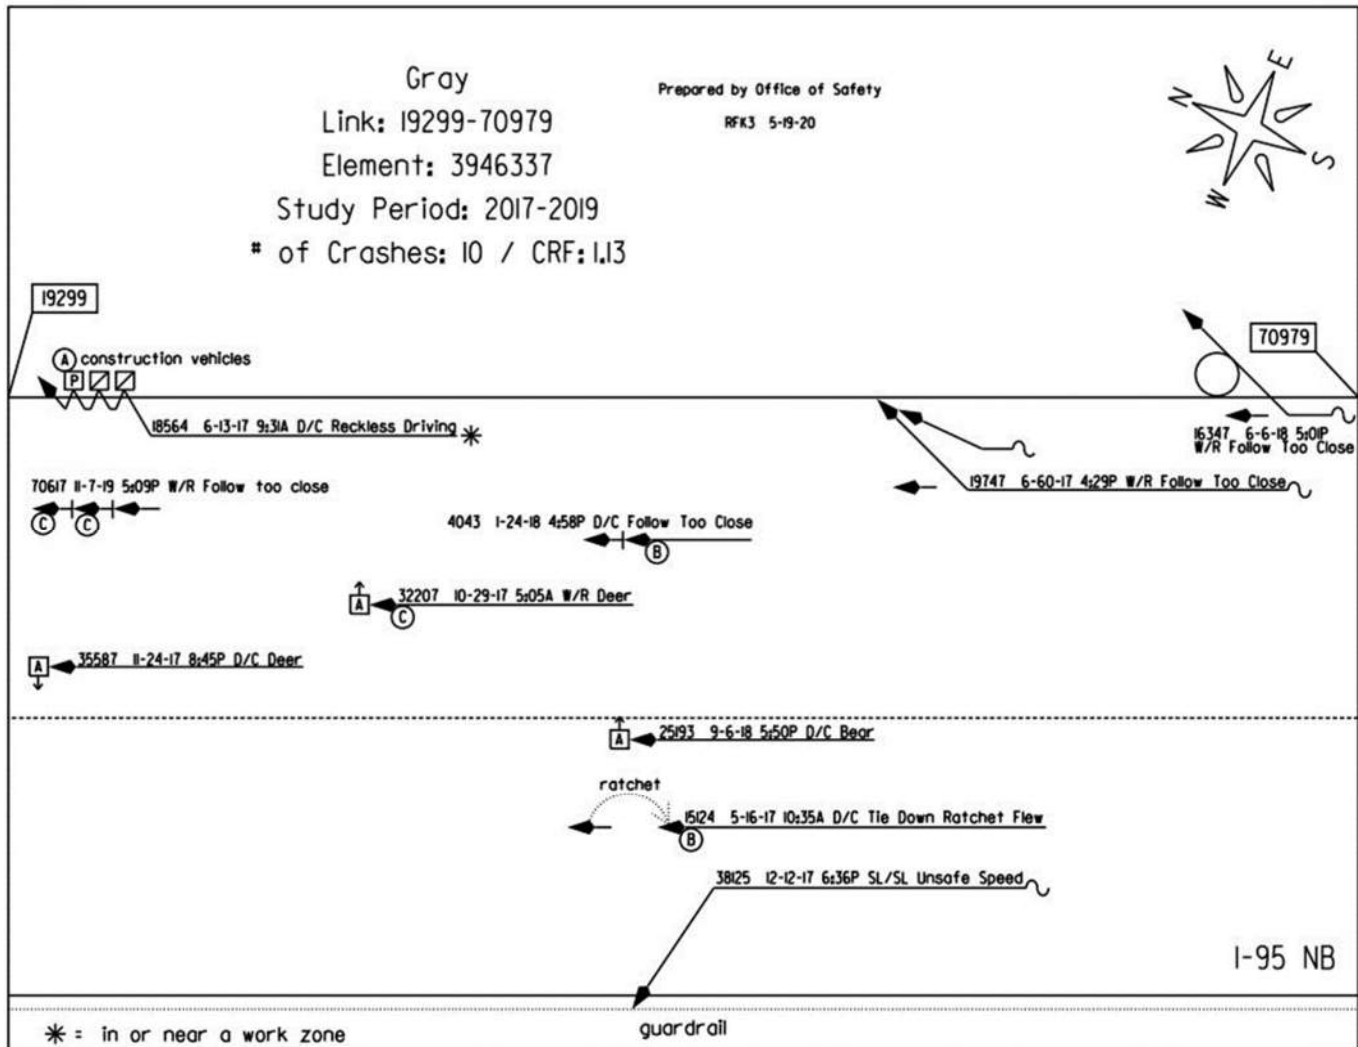
**Figure 2: 2017-2019 NB Exit 63 Off Ramp Approach Crash Diagram**

As shown in **Figure 2**, there were 10 crashes resulting in a 50% injury rate during this analysis period.

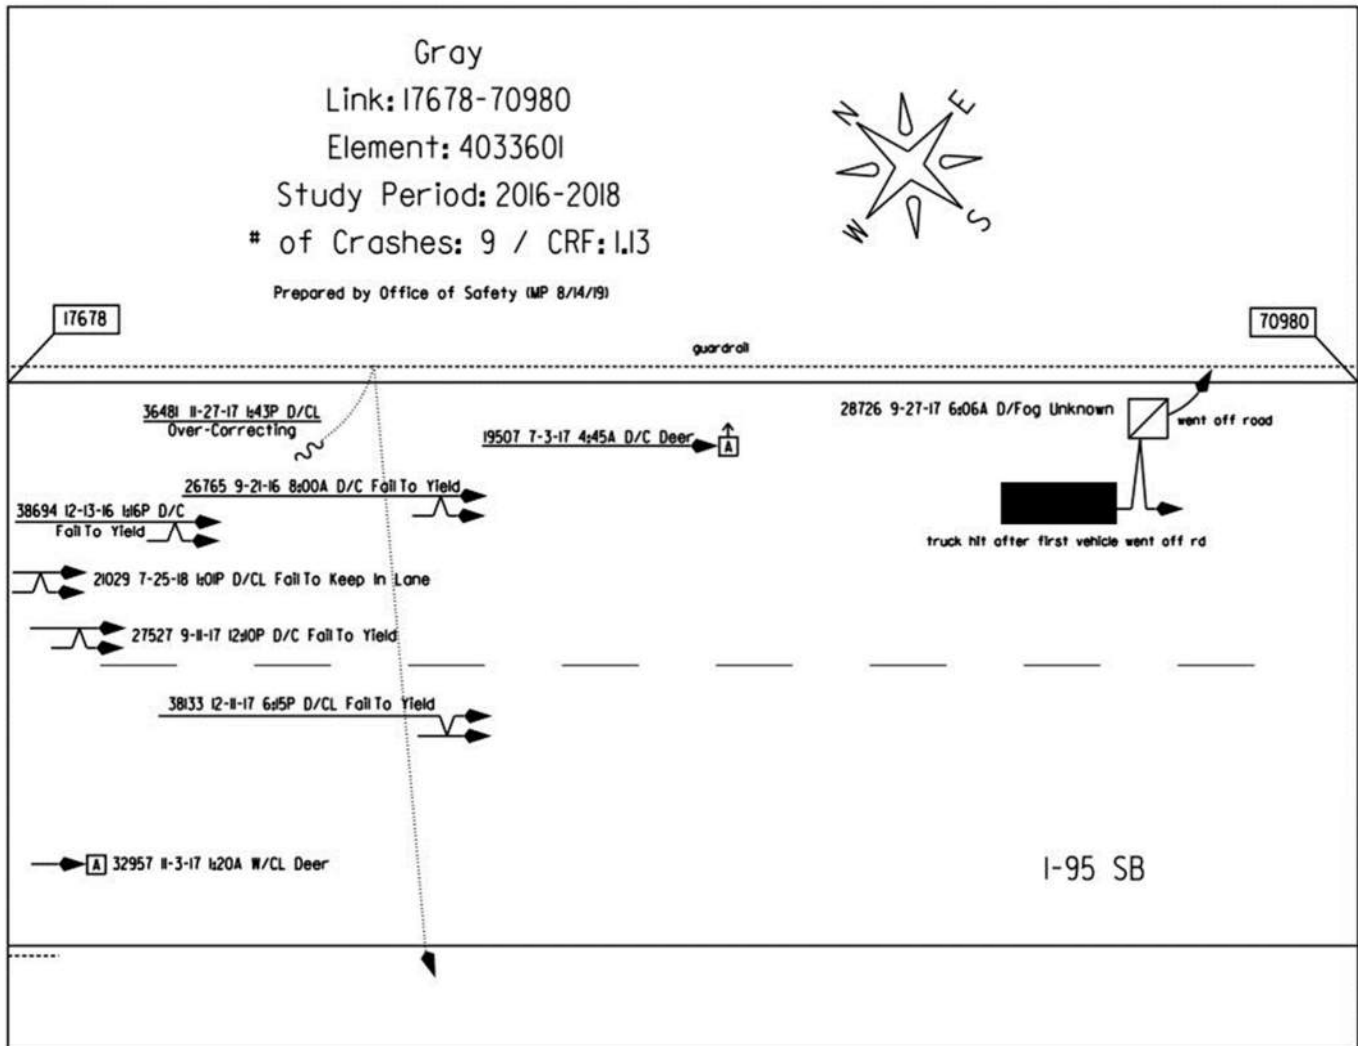
**Figure 3: 2016-2019 SB South of Exit 63 On Ramp Crash Diagram**

As shown in **Figure 3**, there were 9 crashes resulting in a 0% injury rate during this analysis period.

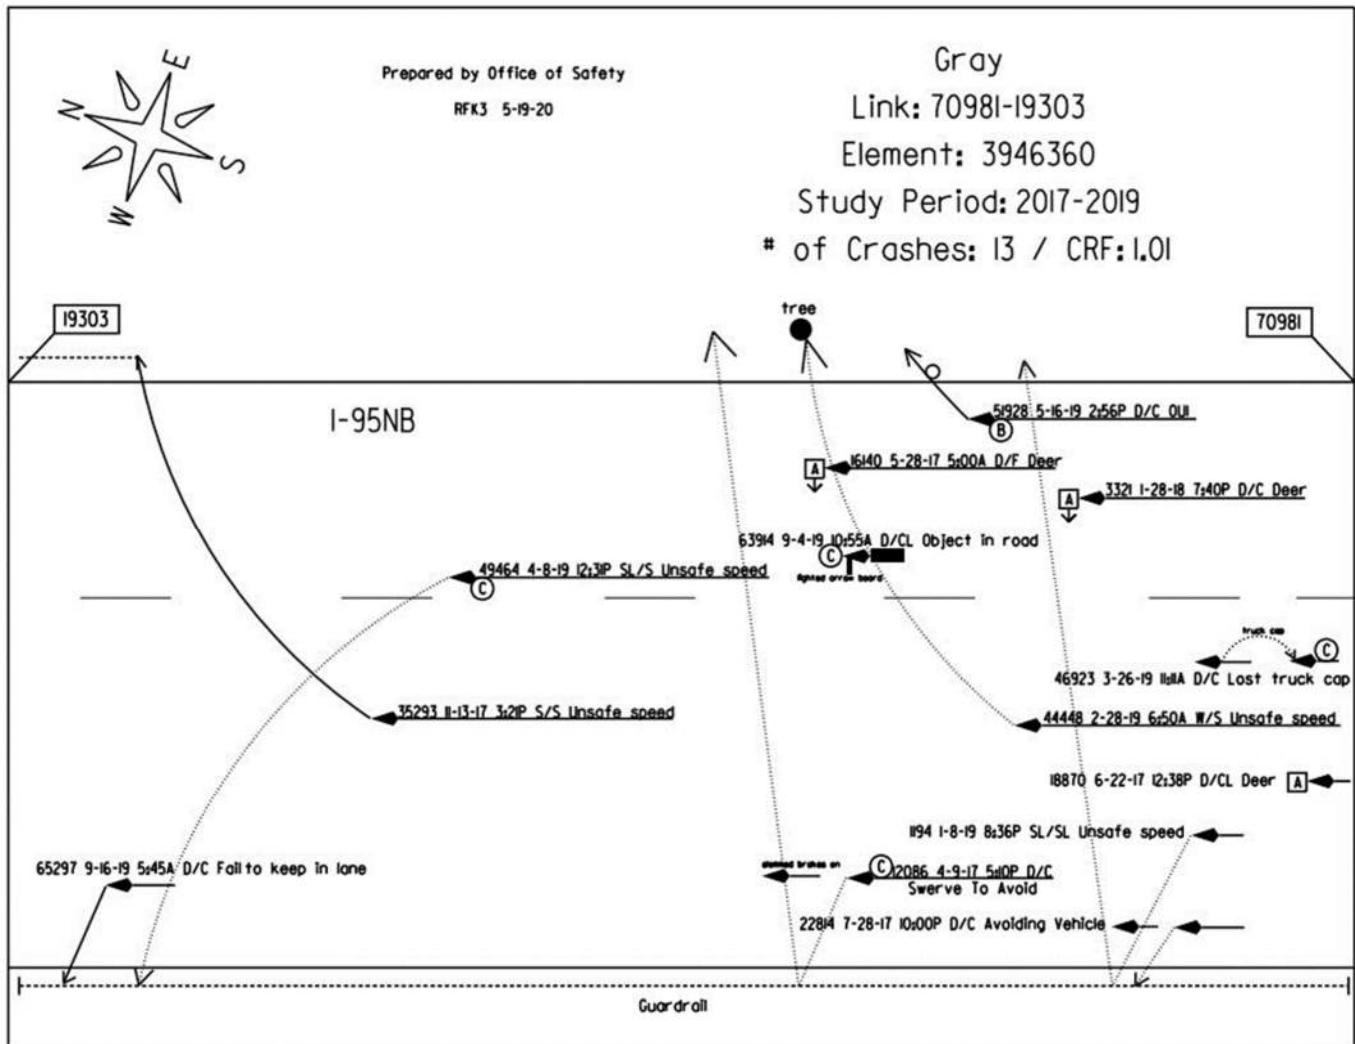
**Figure 3: 2017-2019 I-95 NB Near Shaker Road Crash Diagram**

As shown in **Figure 3**, there were 13 crashes resulting in a 38.5% injury rate during this analysis period.
