# 2022 Systemwide Safety and Capacity Study

June 30, 2023

Maine Turnpike Authority  
2360 Congress Street  
Portland, ME 04102

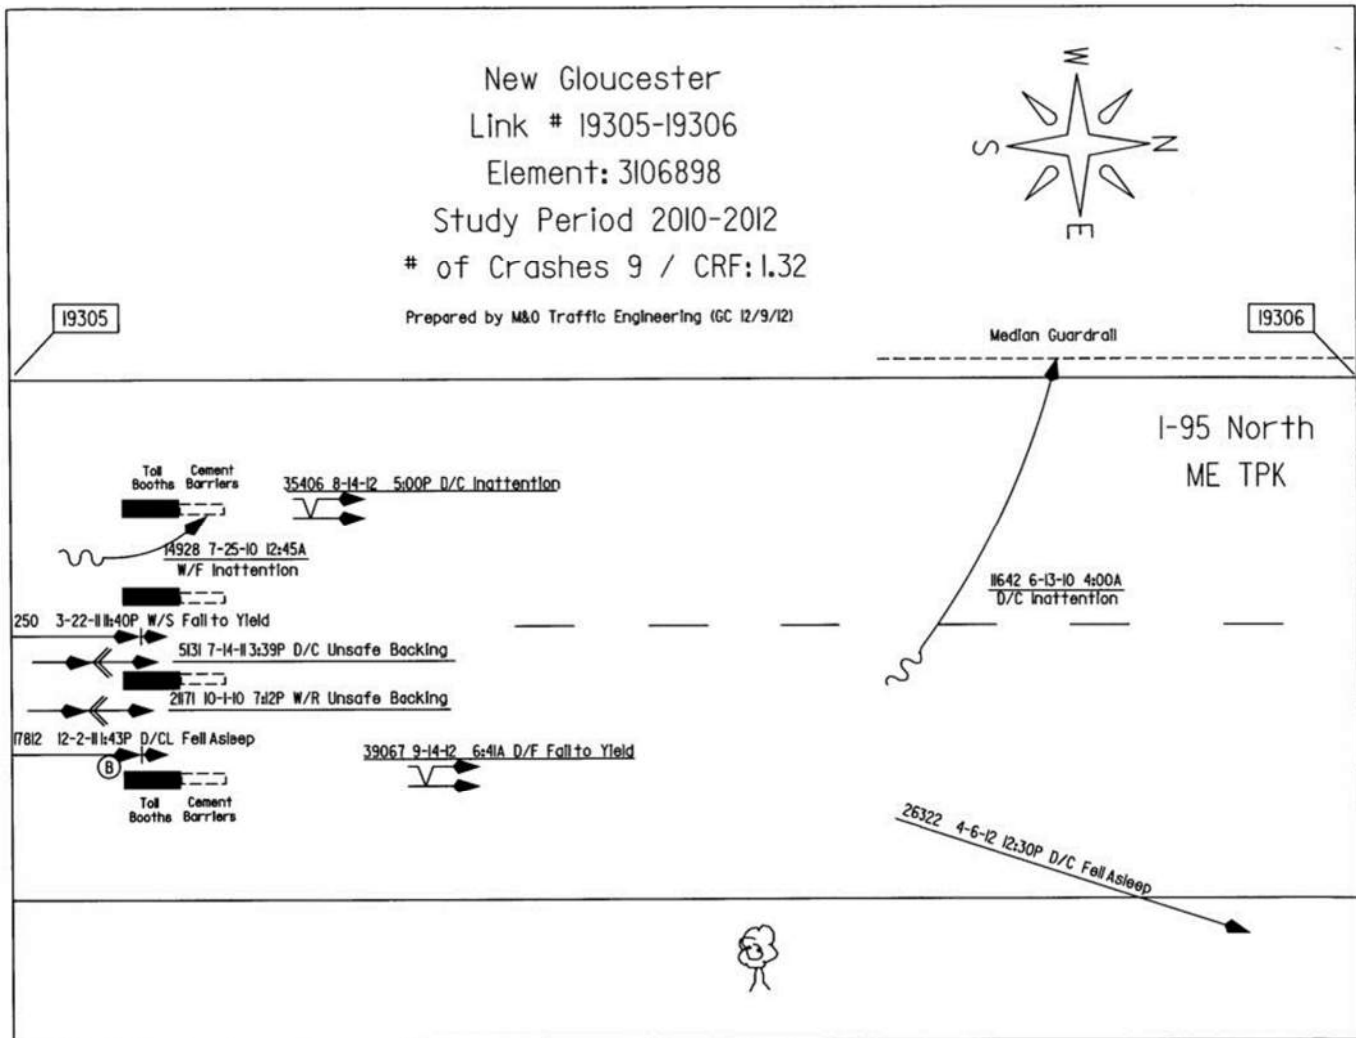
**Figure 2: 2010-2012 NB Toll Plaza Crash Diagram**

As shown in **Figure 2**, there were 9 crashes resulting in a 11.1% injury rate during this analysis period.

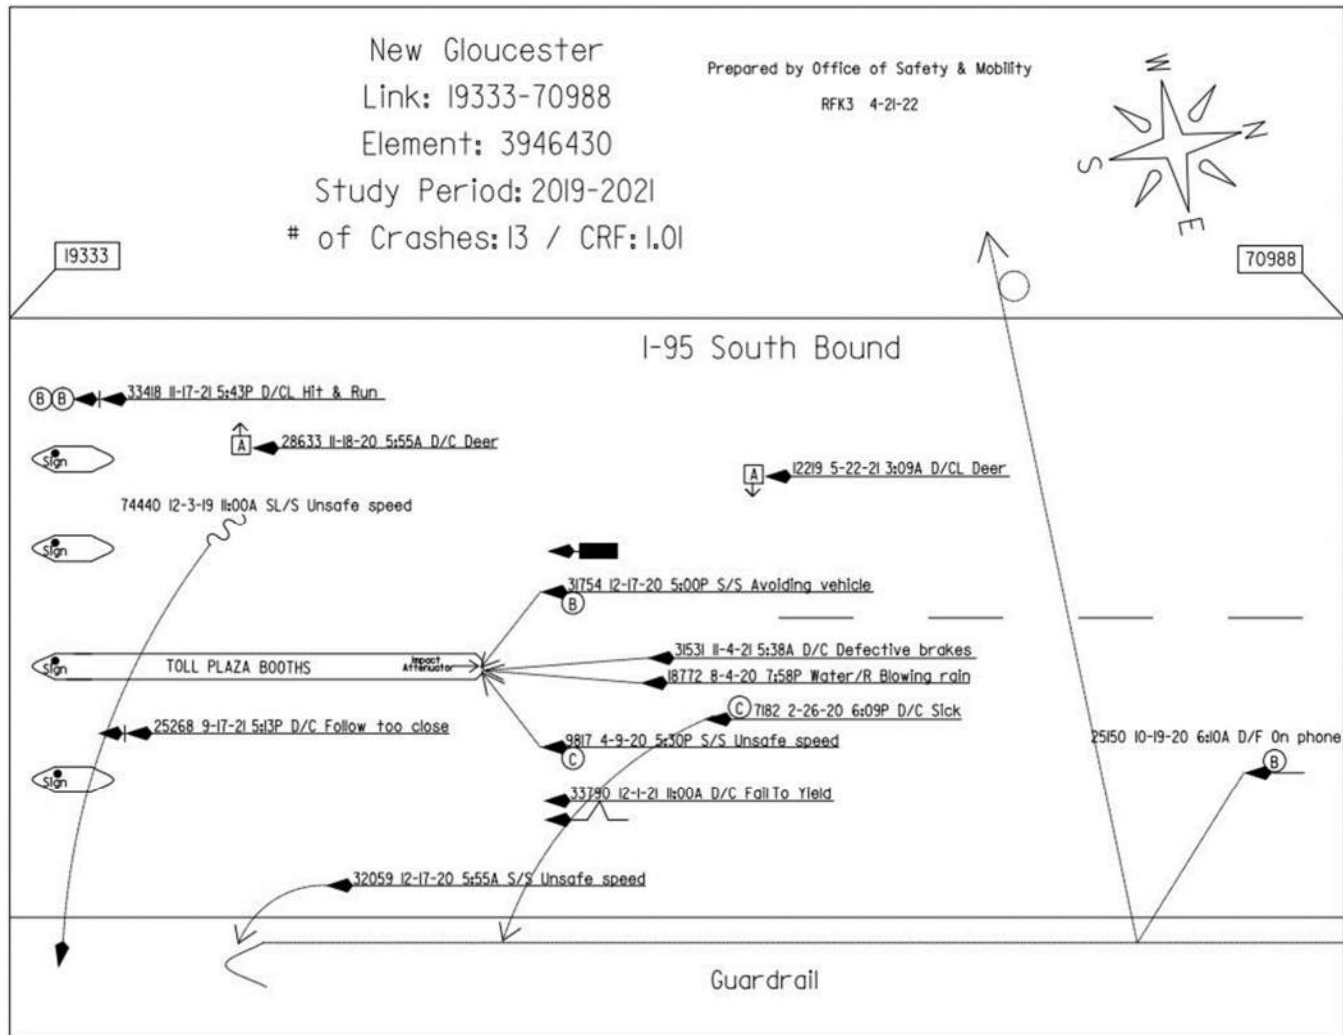
**Figure 3: 2019-2021 New Gloucester Toll Plaza SB Crash Diagram**

As shown in **Figure 3**, there were 13 crashes resulting in a 38.5% injury rate during this analysis period.

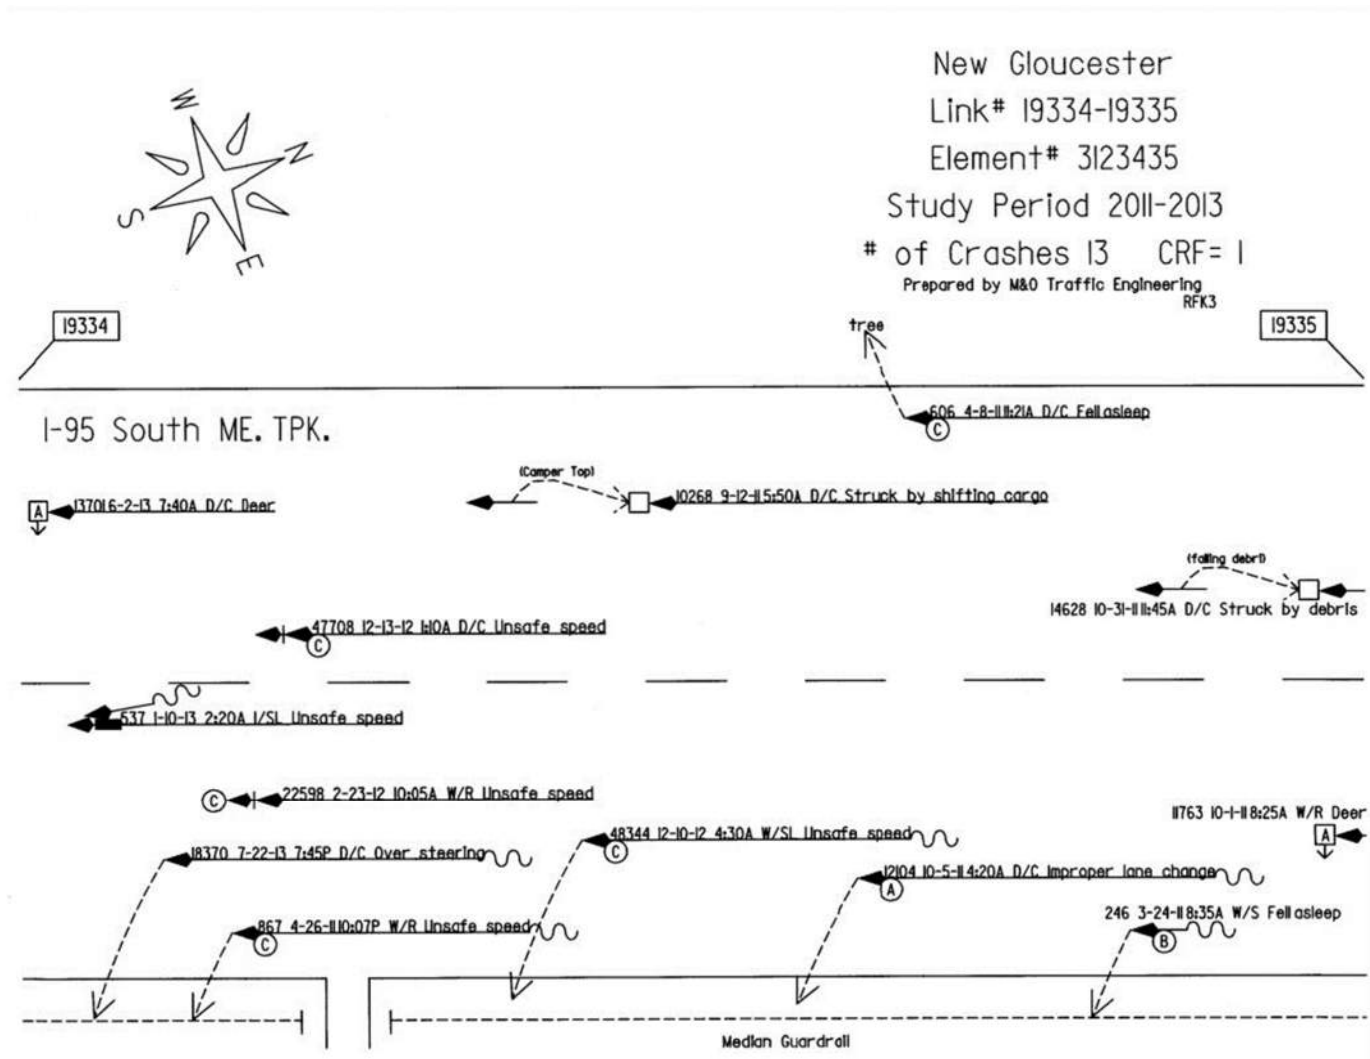
**Figure 4: 2011-2013 SB North of Toll Plaza Crash Diagram**

As shown in **Figure 4**, there were 13 crashes resulting in a 53.8% injury rate during this analysis period.

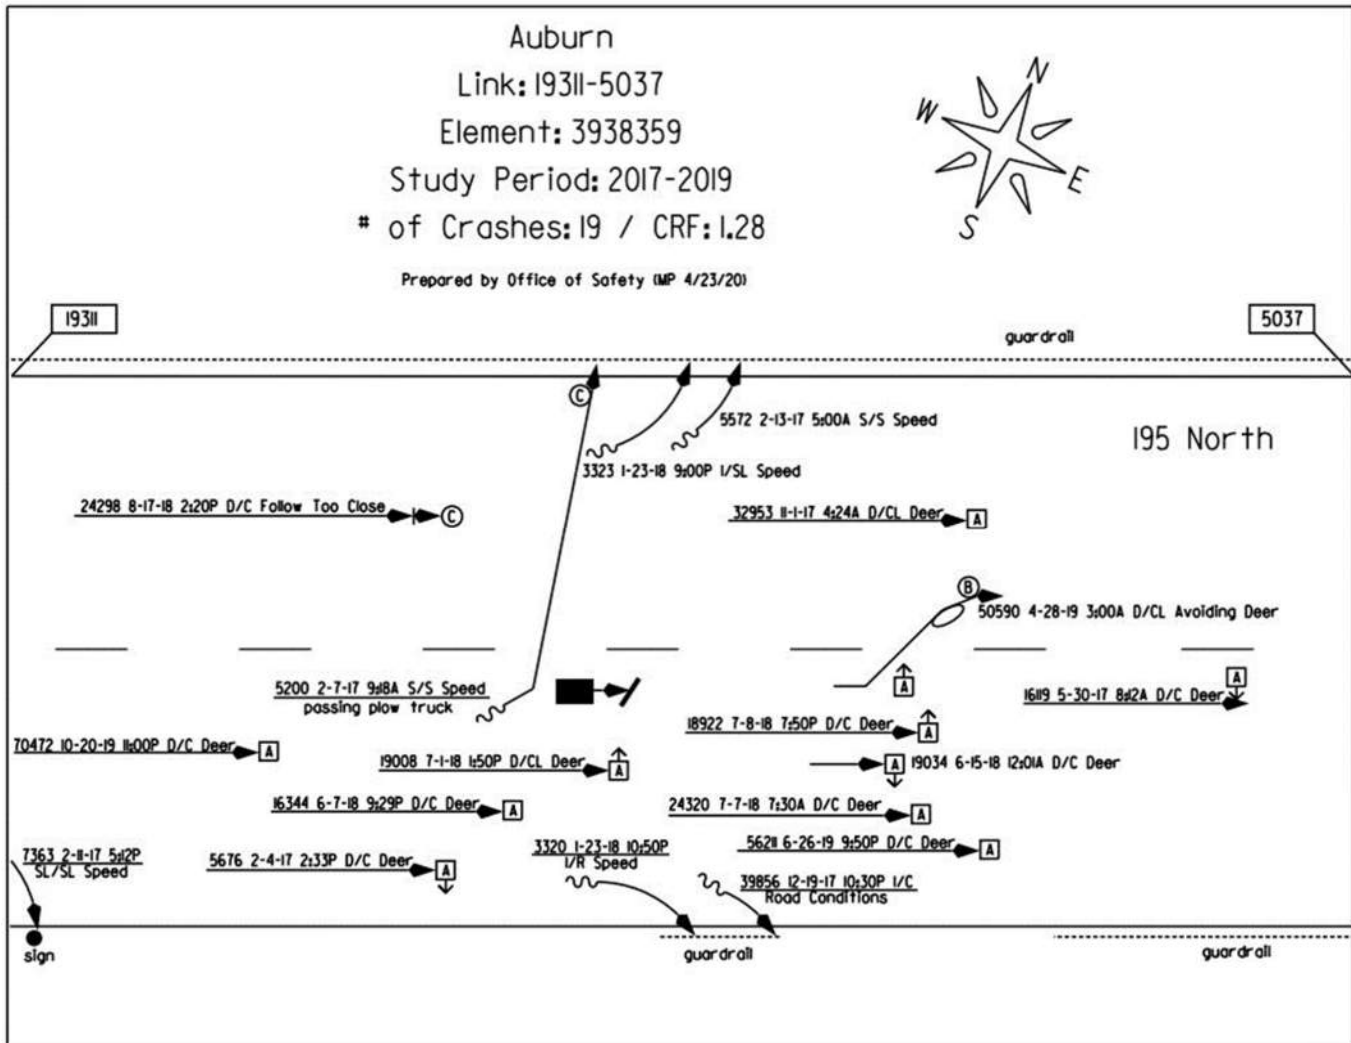
**Figure 2: 2017-2019 NB Segment over Poland Springs Bridge Crash Diagram**

As shown in **Figure 2**, there were 19 crashes resulting in a 15.8% injury rate during this analysis period.

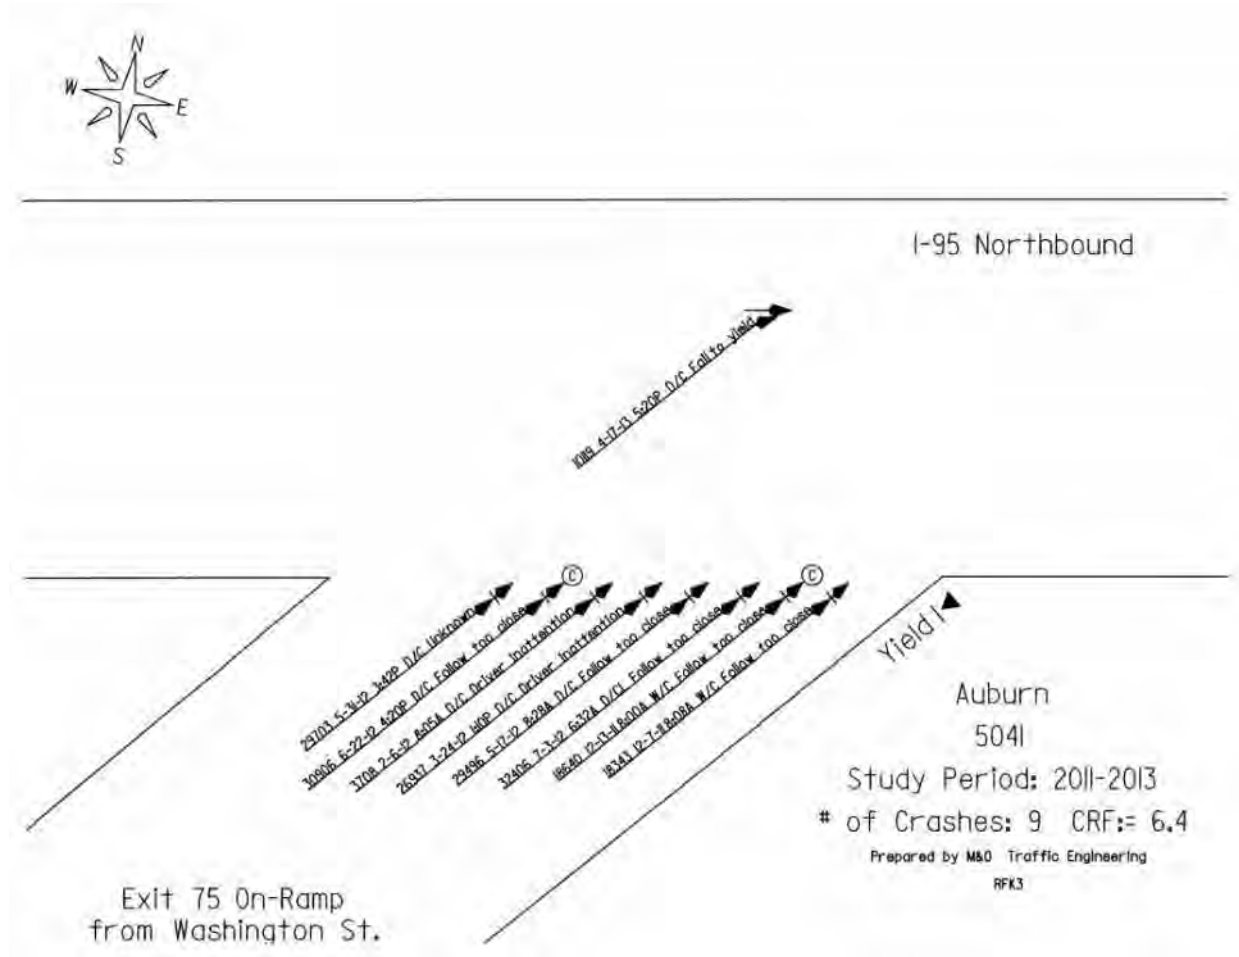
**Figure 2: 2011-2013 Exit 75 NB On Ramp Merge Crash Diagram**

As shown in **Figure 2**, there were 9 crashes resulting in a 22.2% injury rate during this analysis period.

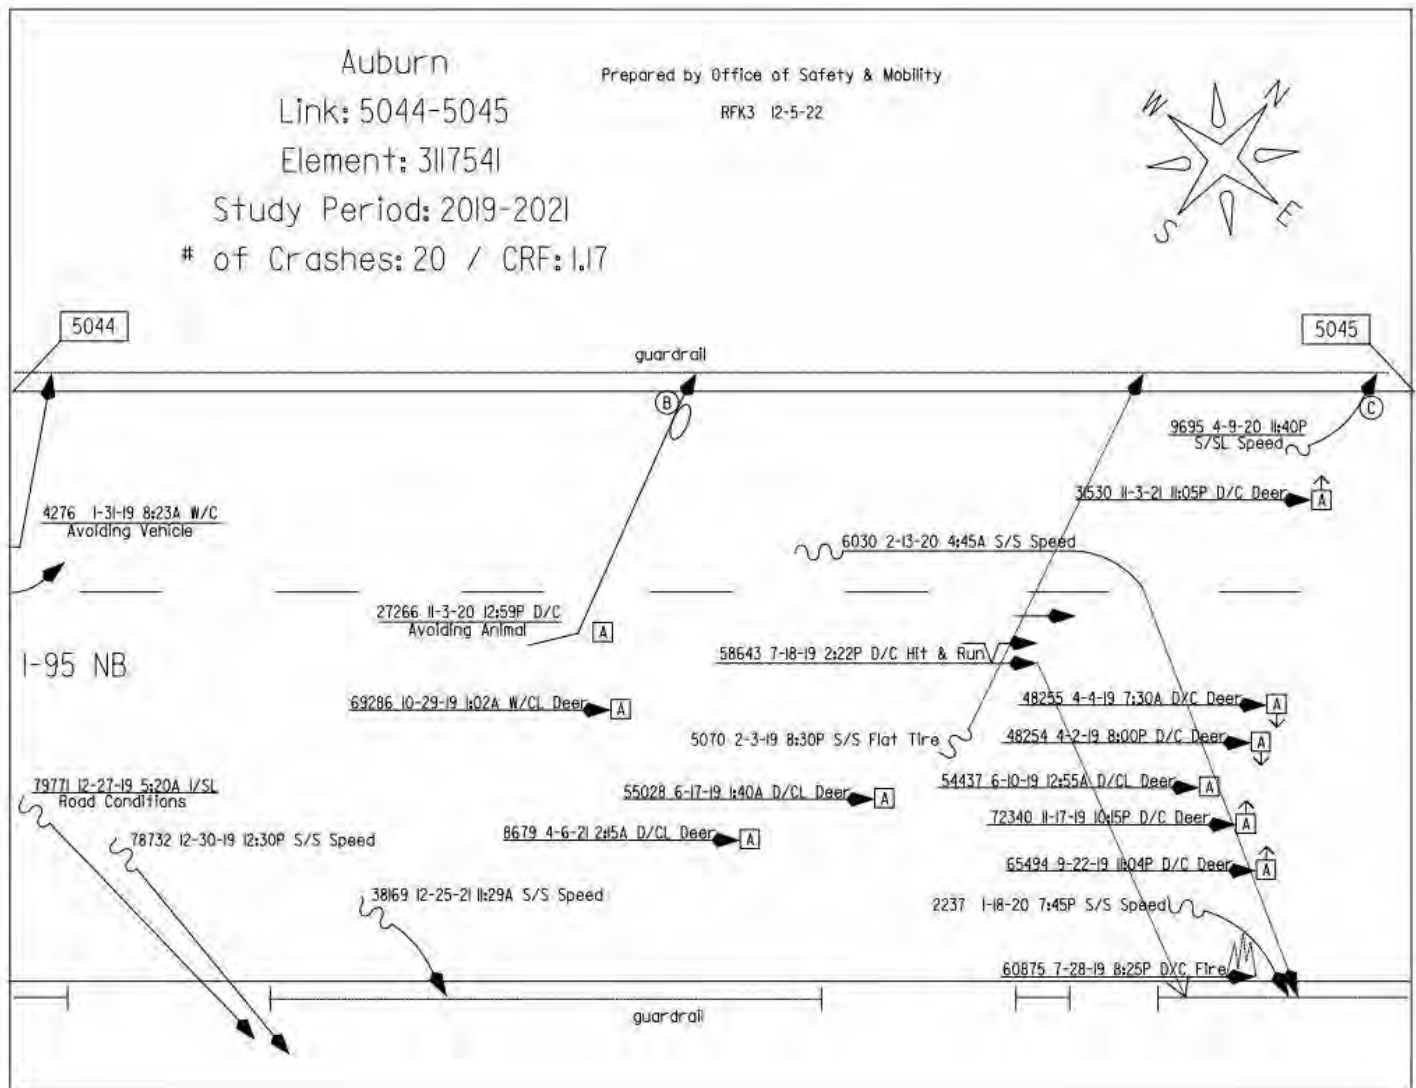
**Figure 2: 2019-2021 I-95 NB Crash Diagram**

As shown in **Figure 2**, there were 20 crashes resulting in a 10% injury rate during this analysis period.
