# 2022 Systemwide Safety and Capacity Study

June 30, 2023

Maine Turnpike Authority  
2360 Congress Street  
Portland, ME 04102

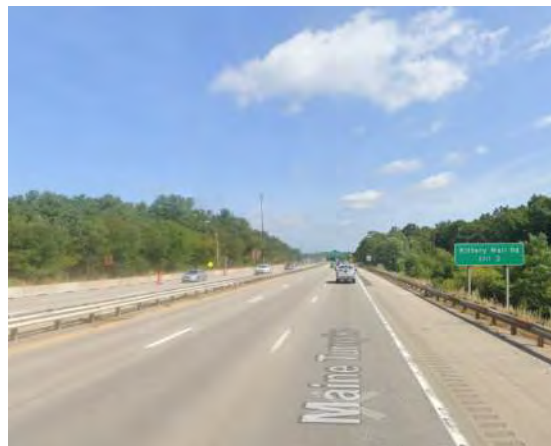
**Photo 1: I-95 NB MM 0-1 (2019)**

**Photo 1: 1-95 NB MM 0-1 (2019)** captured by Google Maps September 2019 depicts the condition of this location at the time that it was most recently noted as an HCL.

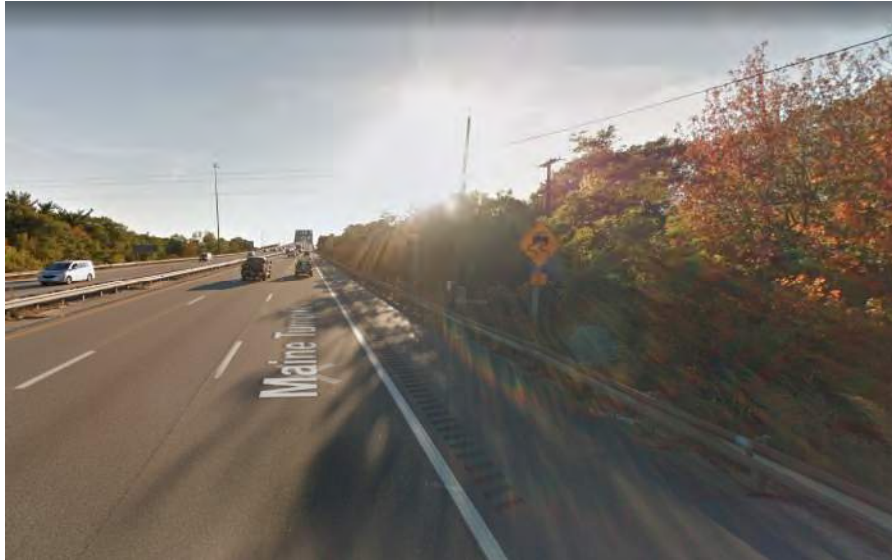
**Photo 2: I-95 SB MM 0-1 (2015)**

**Photo 2: 1-95 SB MM 0-1 (2015)** captured by Google Maps October 2015 depicts the condition of this location at the time that it was most recently noted as an HCL.

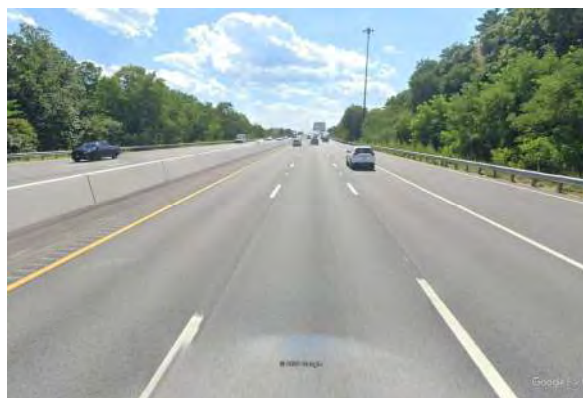
**Photo 3: PTSU<sup>3</sup>**

PTSU will provide some additional capacity and should be monitored when implemented to understand safety concerns and the potential life of this improvement. Because there are no pull off areas, MTA service patrol will need to be present during PTSU activities to ensure mobility is maximized. This will not replace the need for future widening at this location.

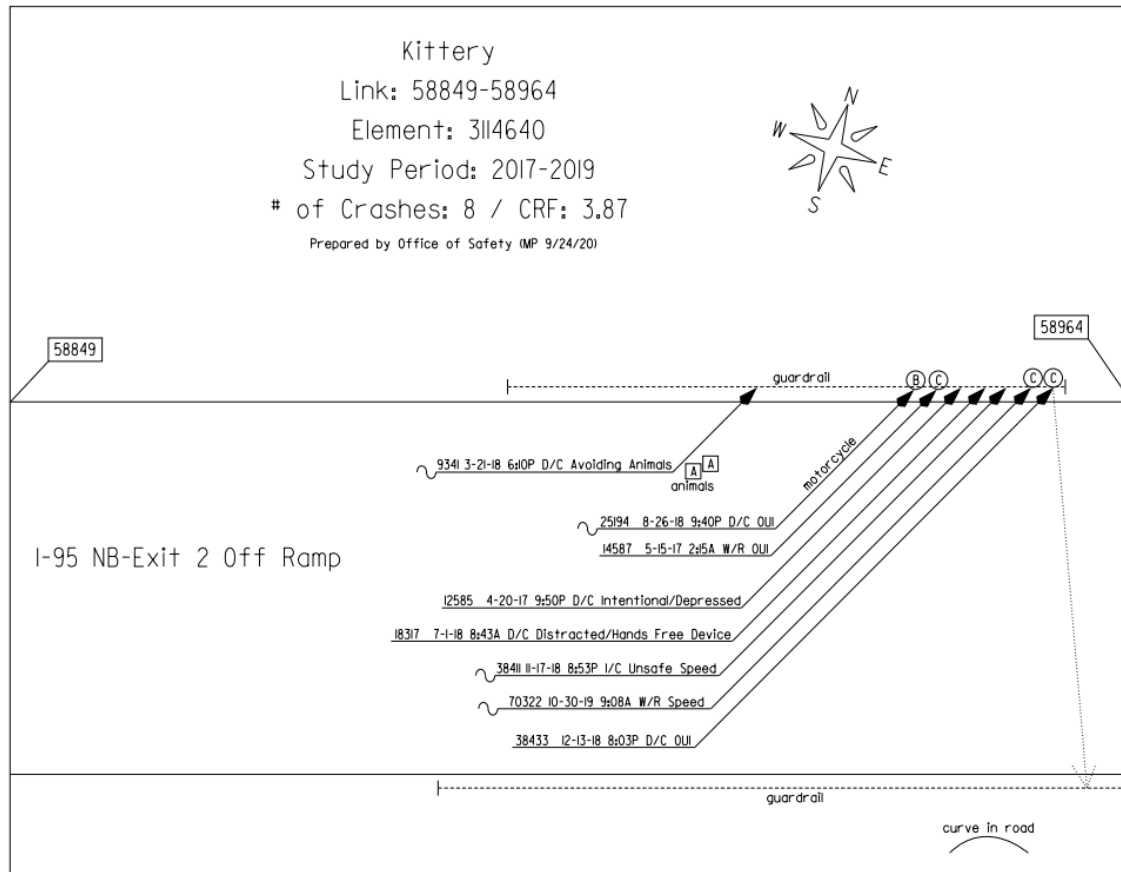
**Figure 2: 2017 – 2019 NB Crash Diagram**

**Figure 2: 2017 – 2019 I-95 Exit 2 NB Off Ramp Crash Diagram** depicts the ramp high crash location. It should be noted this crash pattern, the only time this location was an HCL in the most recent 10-year period occurred overlapped with the rehabilitation efforts of the Piscataqua River Bridge.

As shown in **Figure 2**, there were 8 crashes resulting in a 50% injury rate.

- Most crashes occurred on the curve of the ramp hitting guardrail on the outside of the curve
- Crashes were mostly human contributions – 3 OUIs, 1 distracted driving, and 1 intentional crash; 2 crashes were related to unsafe speeds
- Of those crashes, drivers are most likely to have an injury when OUIs were the cause.
- Most crashes occurred at night

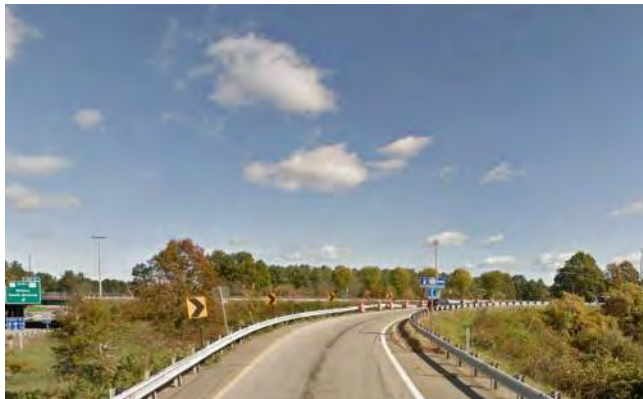
**Photo 1: I-95 Exit 2 NB Off**

**Photos 1 and 2** captured by Google Maps September 2019 depicts the condition during the most recent high crash location designation.

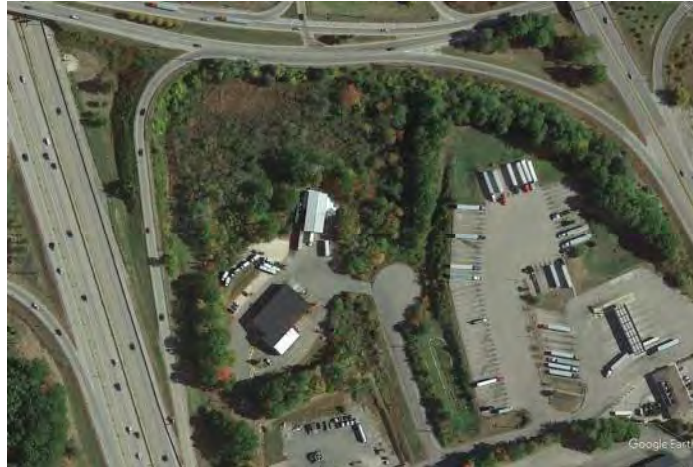
**Photo 3: I-95 NB Exit 2 Area Aerial**

**Photo 3** captured by Google Maps October 2020 provides an overall aerial showing the interaction of movements.

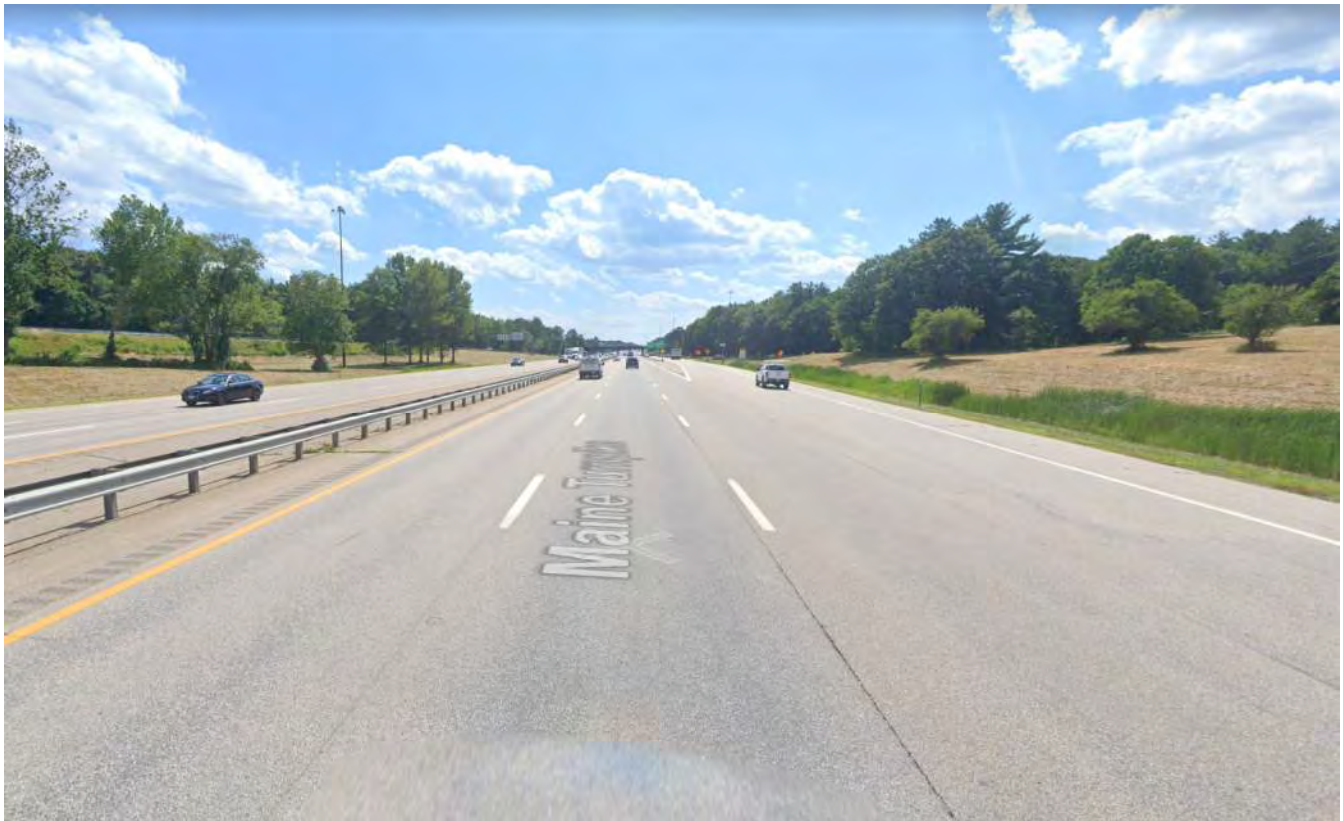
- 8 of the crashes included in the diagram (36%) were a result of vehicles following too close, which is a typical crash cause in locations of high congestion
- 6 crashes (27%) were a result of drivers hitting animals or debris in the roadway
- There was 1 fatality included in this HCL diagram, which was caused by a driver under the influence driving the wrong way on the Turnpike
- The majority of these crashes occurred during the summer months which is when there is the highest percentage of unfamiliar drivers traveling for recreational purposes

**Photo 2: I-95 SB Just North of C-D Split (July 2022)** captured by Google Maps<sup>3</sup> in July of 2022 depicts the condition of this location at the time that it was most recently noted as an HCL.

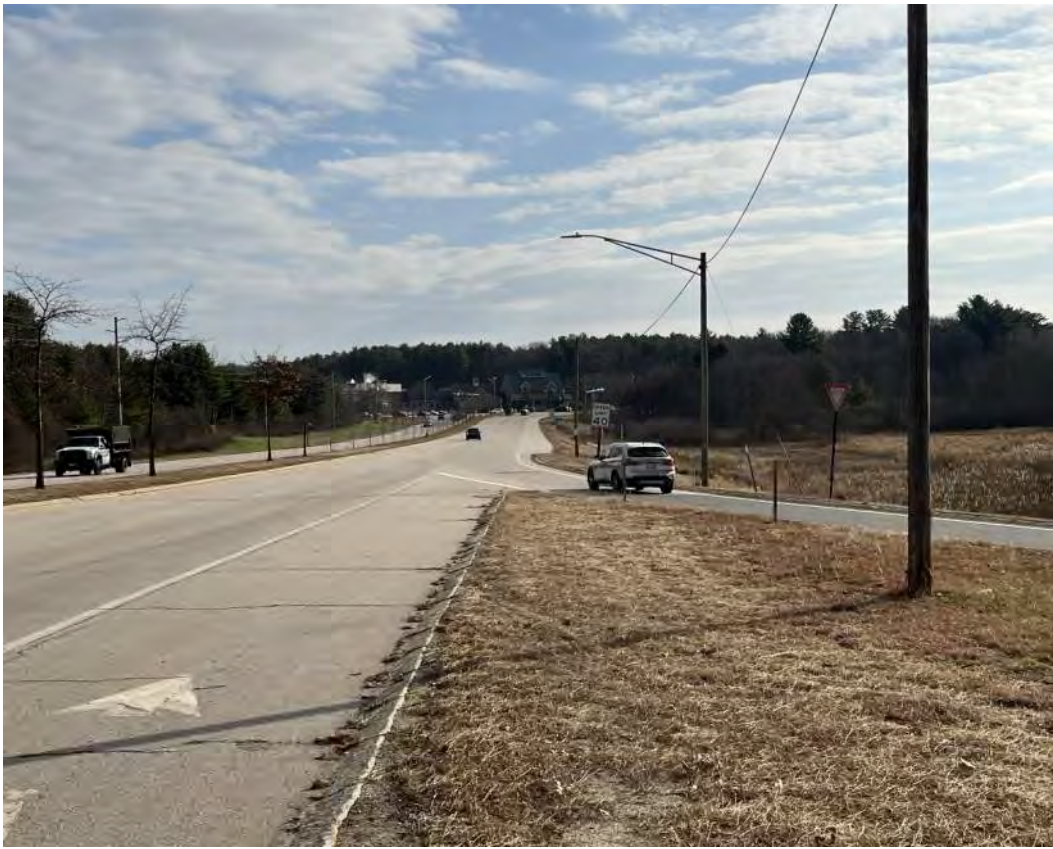
- The crashes represented in this diagram were exclusively a result of vehicles following too close, which is common in areas of high congestion, especially in locations under yield conditions
- 6 of these crashes (75%) occurred between the months of June and August

**Photo 3: Slip Ramp Intersection from Spur Road (November 2022)** captured by HNTB in November of 2022 depicts the condition of this location at the time that it was most recently noted as an HCL.

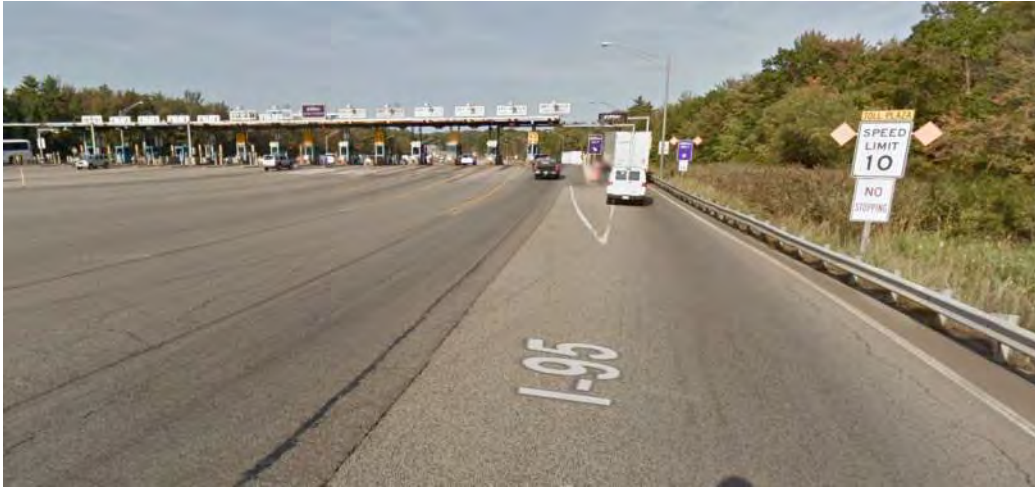
- The most common cause of crash at this location was failure to yield (5 crashes, 50% of the recorded crashes)
- The second most common cause was following too close
- 6 of the 10 crashes at this location occurred between the months of June and August which is the time that this area experiences an increased volume due to tourism
- There does not appear to be a strong correlation between time of day and crashes

**Photo 1: Toll Plaza NB (2011)** captured by Google Maps<sup>2</sup> in September of 2011 depicts the condition of this location at the time that it was most recently noted as an HCL. **Photo 2: Toll Plaza NB (2022)** displays the most recent

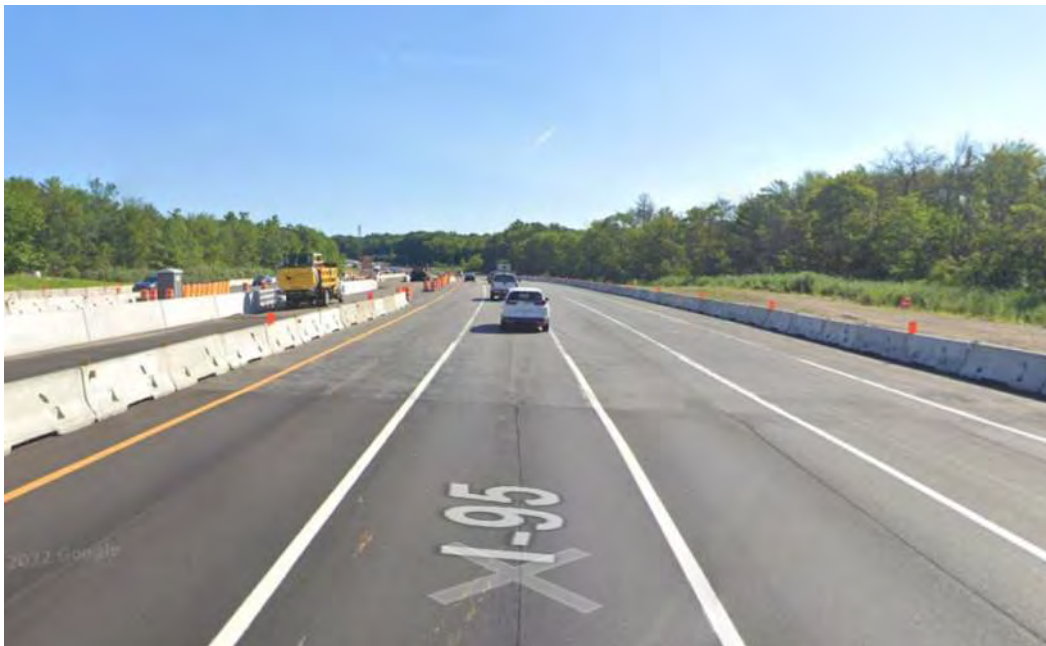
**Photo 2: Toll Plaza NB (2022)**

available Google Street View imagery at the same location. In this photo, the toll plaza construction is active and the old plaza has been removed.

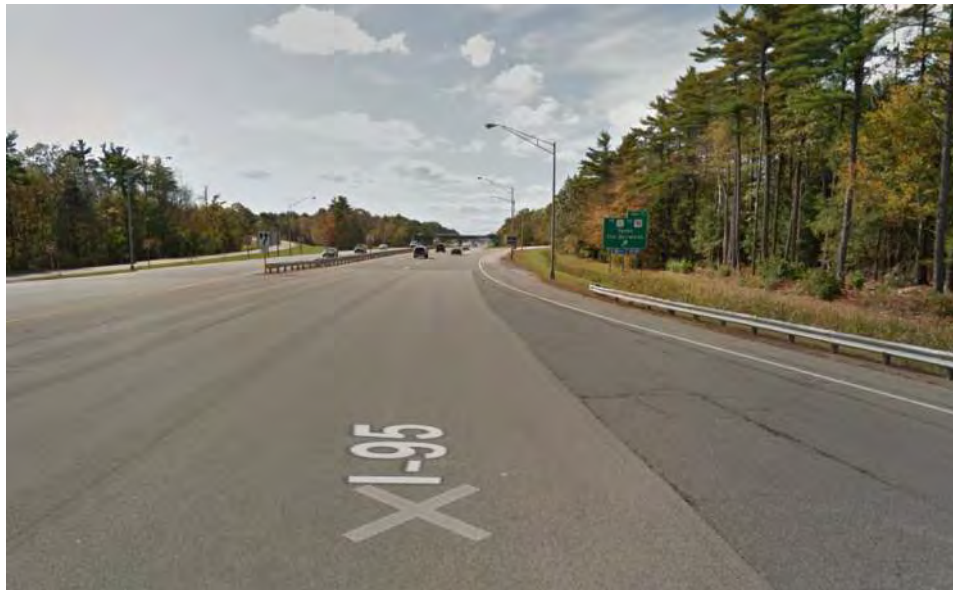
- The primary cause of crash in this location during the most recent HCL period was failure to yield as a result of an attempted lane change (3 crashes)
- Inattention was the next leading cause for crashes in this location, causing 2 of the recorded crashes
- A heavy vehicle was involved in one of the recorded crashes
- While there is not a strong correlation between time of day or year and crash frequency at this location, all but 1 of the crashes that had weather and pavement conditions at time of crash listed occurred on dry pavement when the weather was clear
- None of these crashes resulted in injury

**Photo 3: South of SB Toll Plaza (2011)** captured by Google Maps<sup>3</sup> in October of 2011 depicts the condition of this location at the time that it was most recently noted as an HCL.

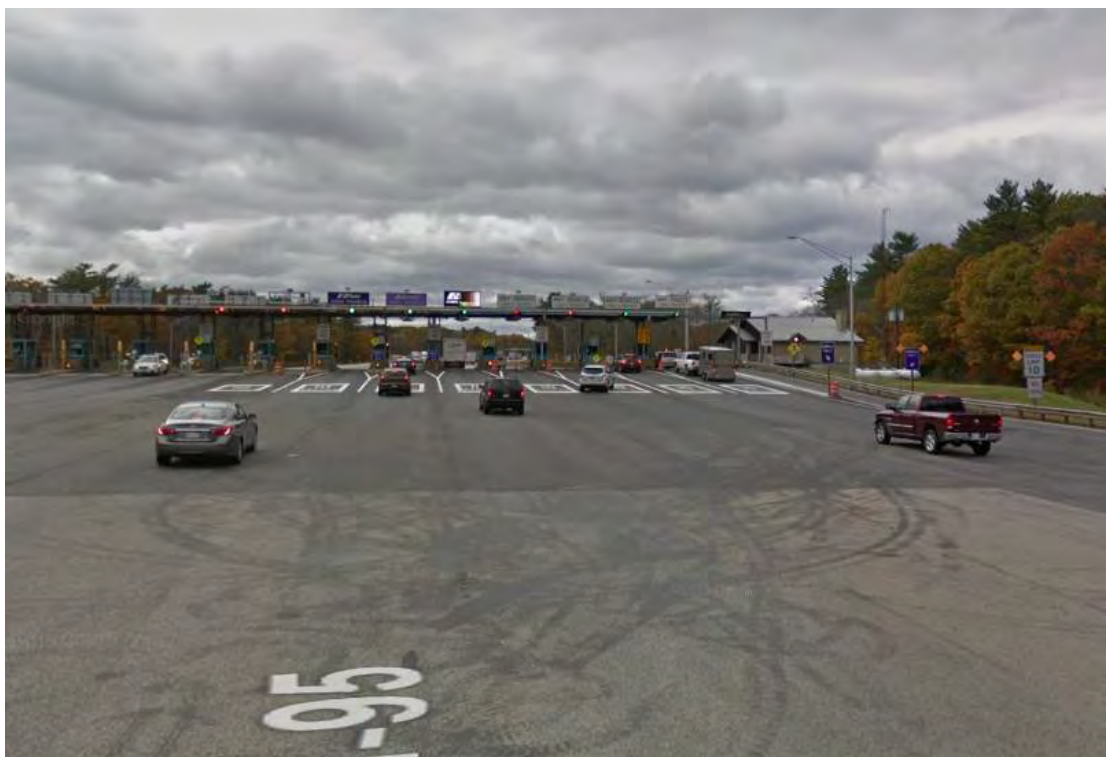
- 4 of these 11 crashes involved heavy vehicles
- Following too close was the most common cause for crashes in this location, causing 3 crashes, closely followed by speed which contributed to 2 crashes at this location
- 5 of these crashes occurred between July and September, which are some of the months in which this area experiences an increased volume and higher number of drivers unfamiliar with the area

**Photo 4: SB Toll Plaza (2018)** captured by Google Maps<sup>4</sup> in October of 2018 depicts the condition of this location at the time that it was most recently noted as an HCL.

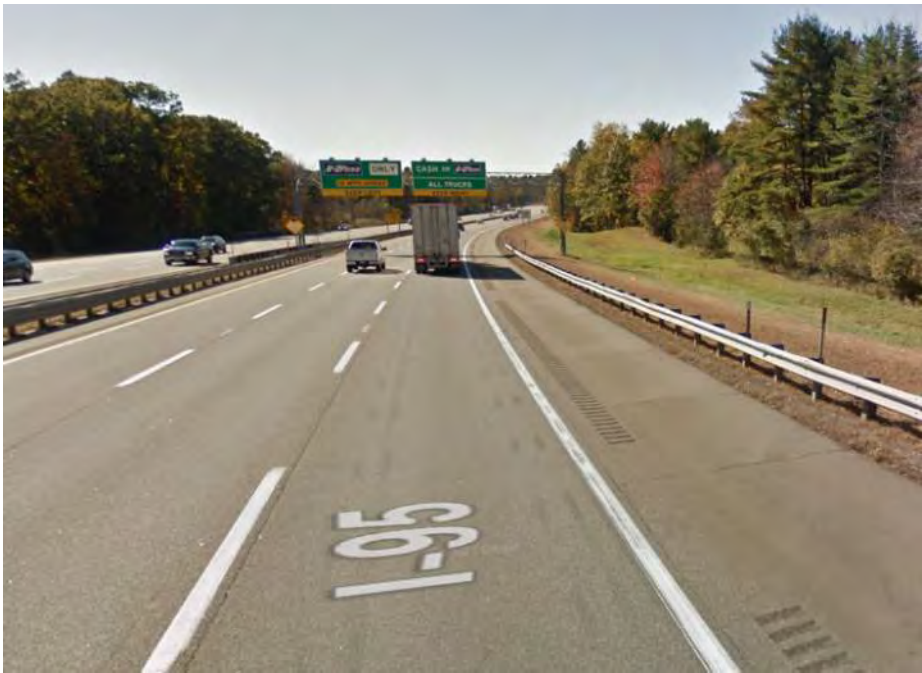
- This is an extremely significant location in regards to safety concerns based on the volume of crashes
- One of these crashes involved a heavy vehicle
- Failure to yield, failure to keep in lane, following too close and speed appear to be the prominent causes of crashes at this location, some of which are common at congested areas especially those such as toll plazas when lane changes are frequently being made
- Recklessness and collisions with animals are the next most observable causes at this location
- The majority of the crashes at this location occurred during the summer months in which there is increased volume and higher numbers of drivers who are unfamiliar with the area

**Photo 5: North of SB Toll Plaza** captured by Google Maps<sup>5</sup> in October of 2018 depicts the condition of this location at the time that it was most recently noted as an HCL.

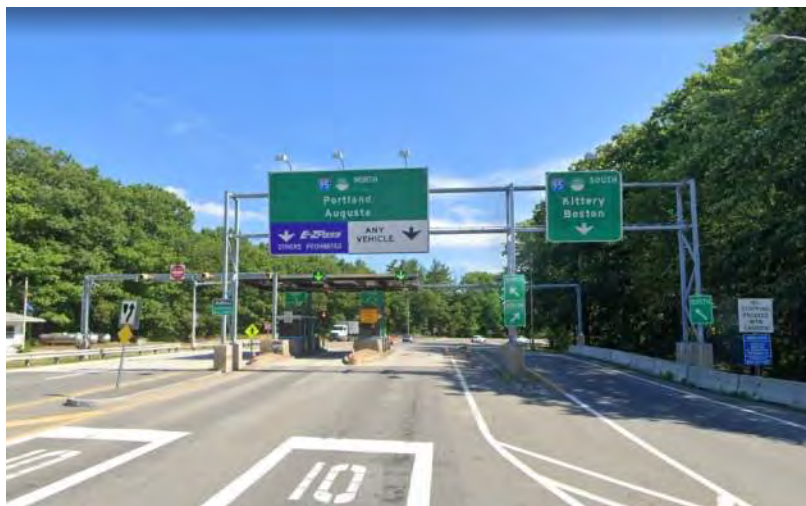
- There are not many strong trends in causes of crash at this location
  - The most common type of crash at this location was improper backing, which contributed to 2 of the 8 recorded crashes at this location
  - Two of the recorded crashes at this location had contributing factors outside of the control of the vehicle operator (1 due to road conditions, 1 due to defective brakes)
- 5 of the 8 recorded crashes at this location happened during the hour of 3:00pm (3 of these 5 occurred during the weekend days of Friday – Sunday)
- All but 1 of the recorded crashes at this location occurred when the pavement was dry and the weather was clear

**Photo 1: HCL 66 – Exit 19 Plaza Segment** captured by Google Maps<sup>3</sup> on August 2022, depicts the condition of this location at the time that it was most recently noted as an HCL. This picture shows the approach to the intersection after the plaza.

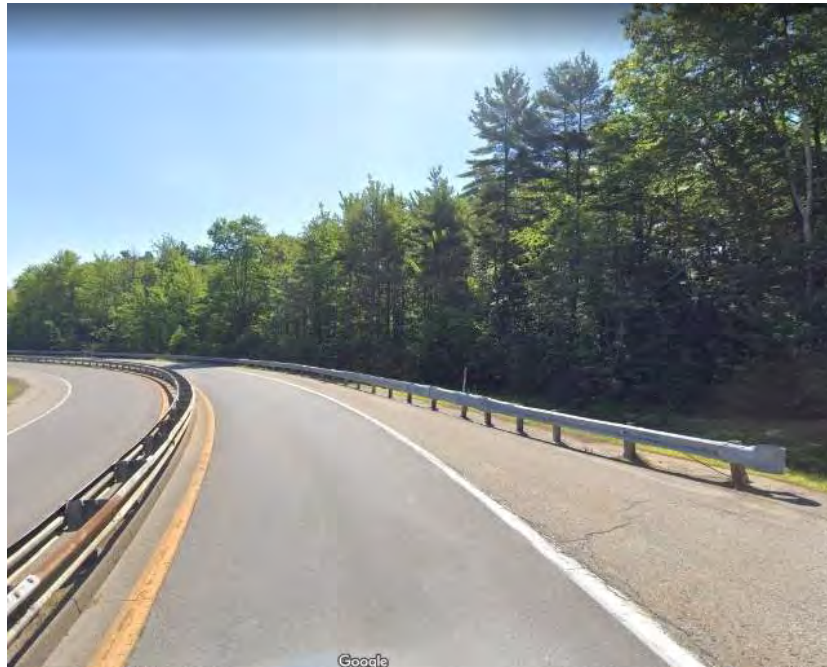
- All recorded crashes at this location involved colliding with the guardrail on the outside of the ramp's curve
- 4 of the crashes (50%) were a result of unsafe speed around the curve
- 2 of the crashes (25%) were due to road conditions
- 6 of the recorded crashes at this location occurred between the months of December – February, including both crashes that were a result of road conditions

**Photo 2: HCL 78 – Northbound On-Ramp** captured by Google Maps<sup>4</sup> on August 2022 depicts the condition of this location at the time that it was most recently noted as an HCL. The picture shows the northbound on approach approaching the guardrail where most of the crashes occurred.

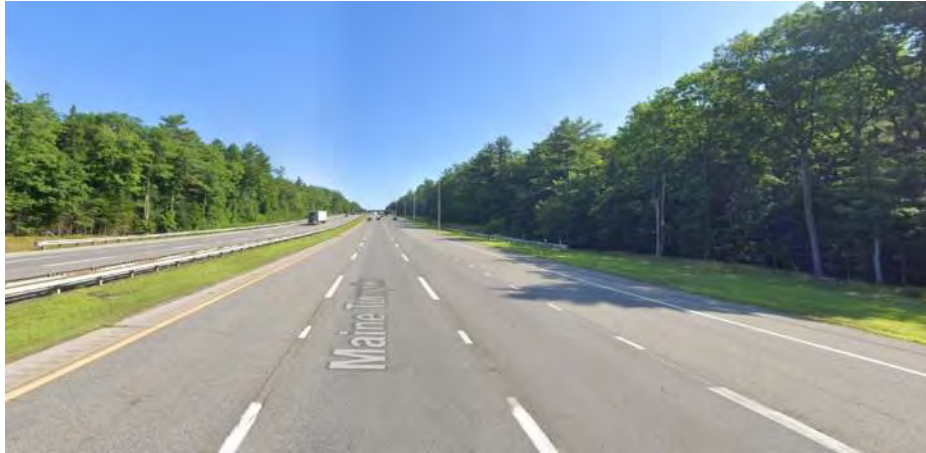
**Photo 1: Exit 19 Northbound Mainline and NB On Merge**

**Photo 1: HCL 8 – Northbound Mainline and NB On Merge** captured by Google Streetview on July 2022 depicts the condition of this location at the time that it was most recently noted as an HCL.

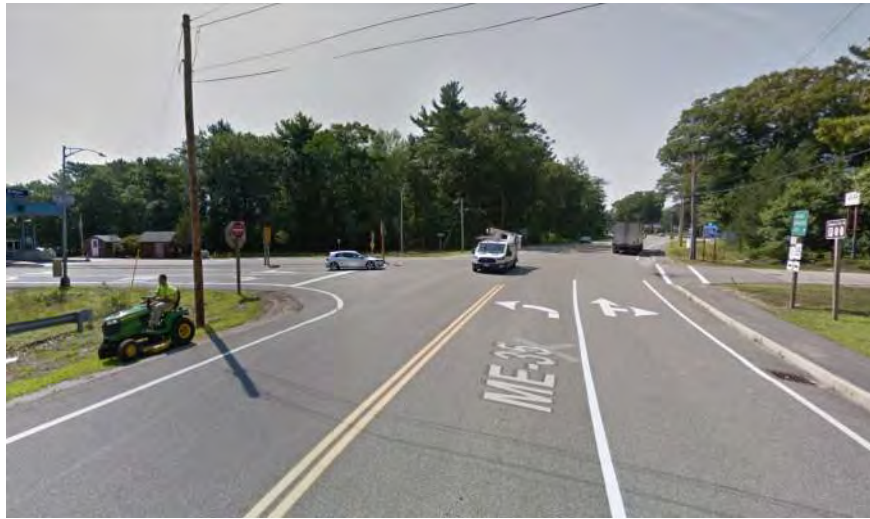
**Photo 1: Exit 25 SB Ramps Intersection – Unsignalized from Alewife Road SB**

**Photo 1** captured by Google Maps<sup>3</sup> in August of 2018 depicts the intersection as it existed at the time that it was most recently noted as an HCL, while **Photo 2**, captured by HNTB on November 23, 2022, depicts the intersection as it currently exists in its signalized condition.

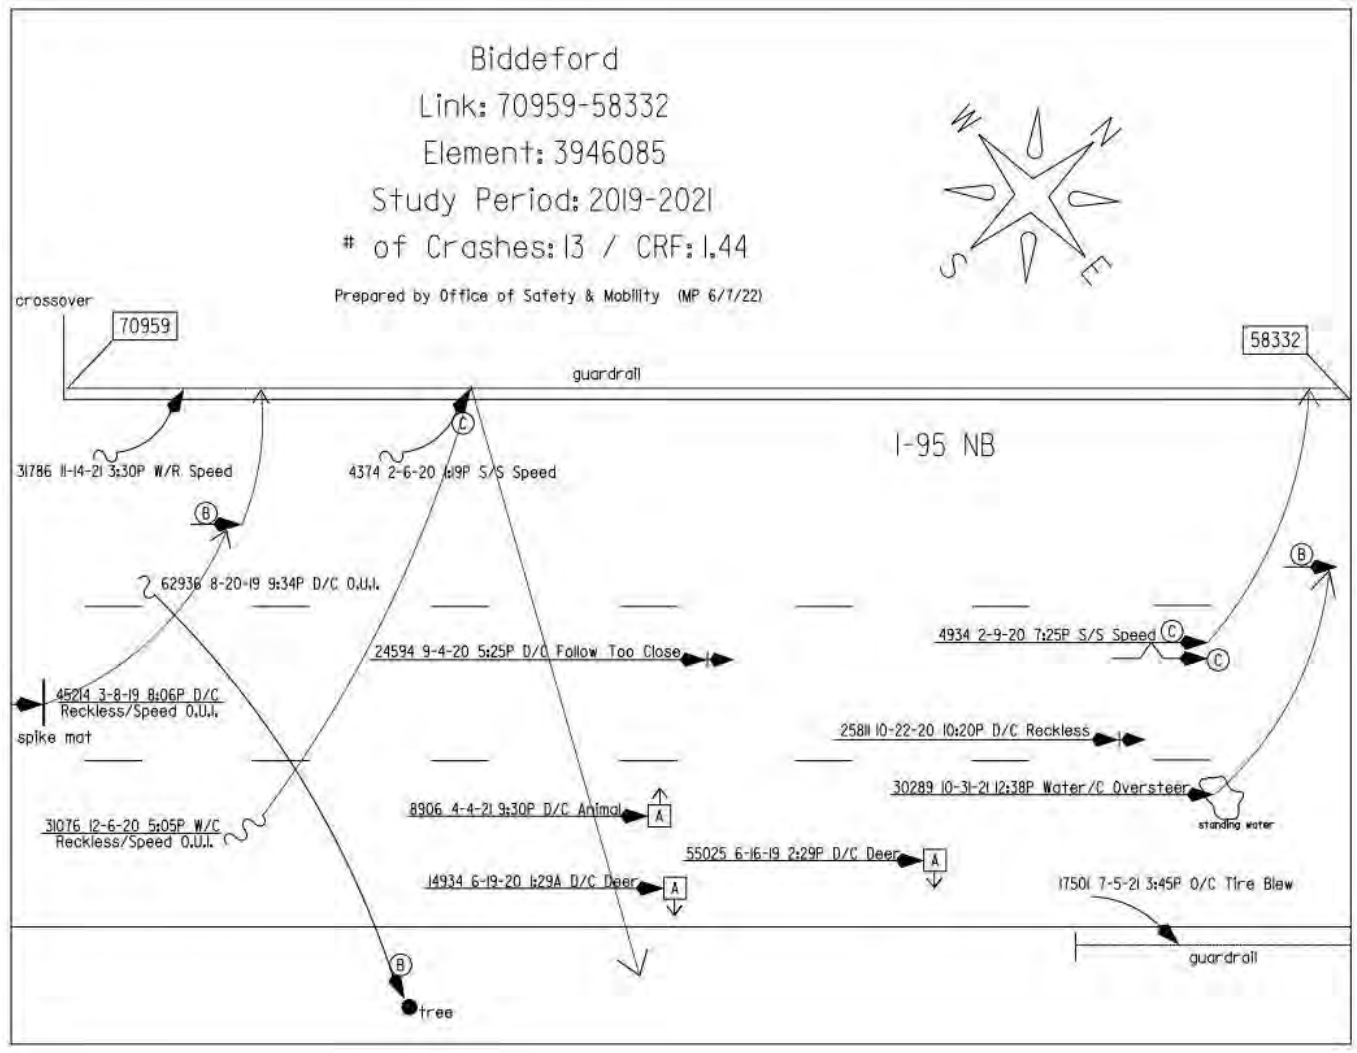
**Figure 1: (2019-2021) Exit 32 NB Off Ramp Approach Crash Diagram** depicts the crash diagram for the location during the time period in which it was most recently identified as an HCL. This location was also classified as an HCL during the 2018-2020 time period.

- 5 of these 13 crashes (38%) had speed as a contributing factor
  - 2 of these 5 speed-related crashes also involved an O.U.I.
  - There was 1 additional O.U.I. crash in this location which did not have speed listed as a contributing factor
- The next most common contributor to crashes at this location was large animal collisions
- 5 of these crashes resulted in vehicles leaving the travel way and colliding with either guardrail or other objects
- One of these crashes involved standing water in the travel way
- 7 of these crashes occurred during the evening hours of 3:00pm – 10:30pm

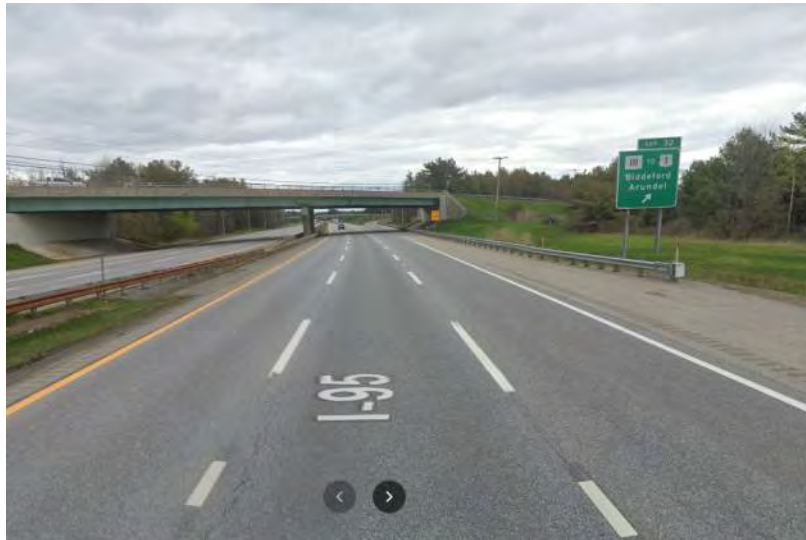
**Photo 1: Exit 32 NB Off Ramp Approach (2019)**

**Photo 1: HCL 9 – Exit 32 NB Off Ramp Approach** captured by Google Maps<sup>1</sup> on June 2019 depicts the condition of this location at the time that it was most recently noted as an HCL.

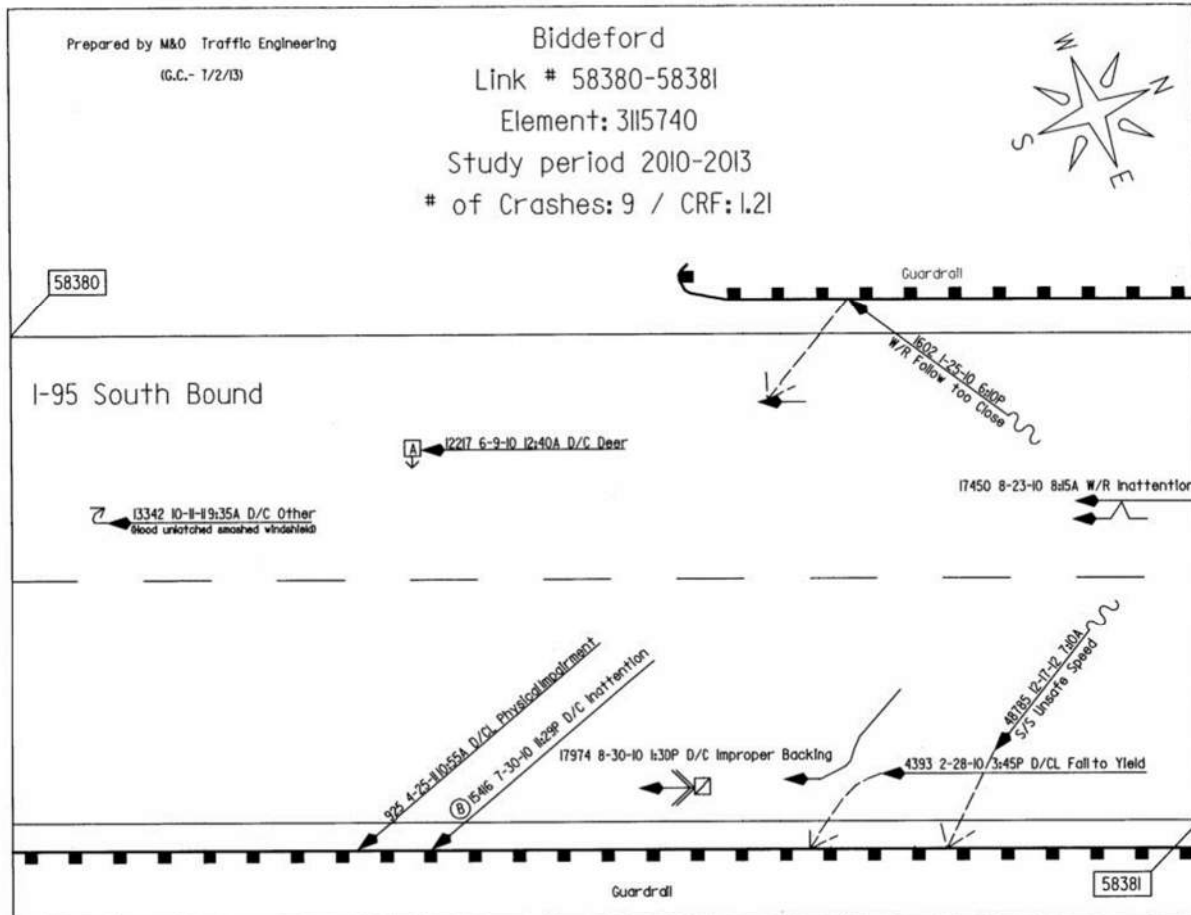
**Figure 3: 2010-2013 Segment after Exit 32 SB On Ramp Crash Diagram** depicts the HCL along the mainline just south of the Exit 32 southbound off ramp. This is the only time period over the last 10 years in which this location was identified as an HCL.

As shown in **Figure 3**, there were 9 crashes resulting in a 11.1% injury rate during this analysis period.

- The only cause that contributed to more than one crash at this location was inattention (contributed to 2 crashes)
- Other than inattention, all crashes recorded at this location had different causes including unsafe speed, following too close, improper backing, deer and physical impairment
- There does not appear to be significant correlation between time of day, time of year nor cause of crash and crash frequency at this location

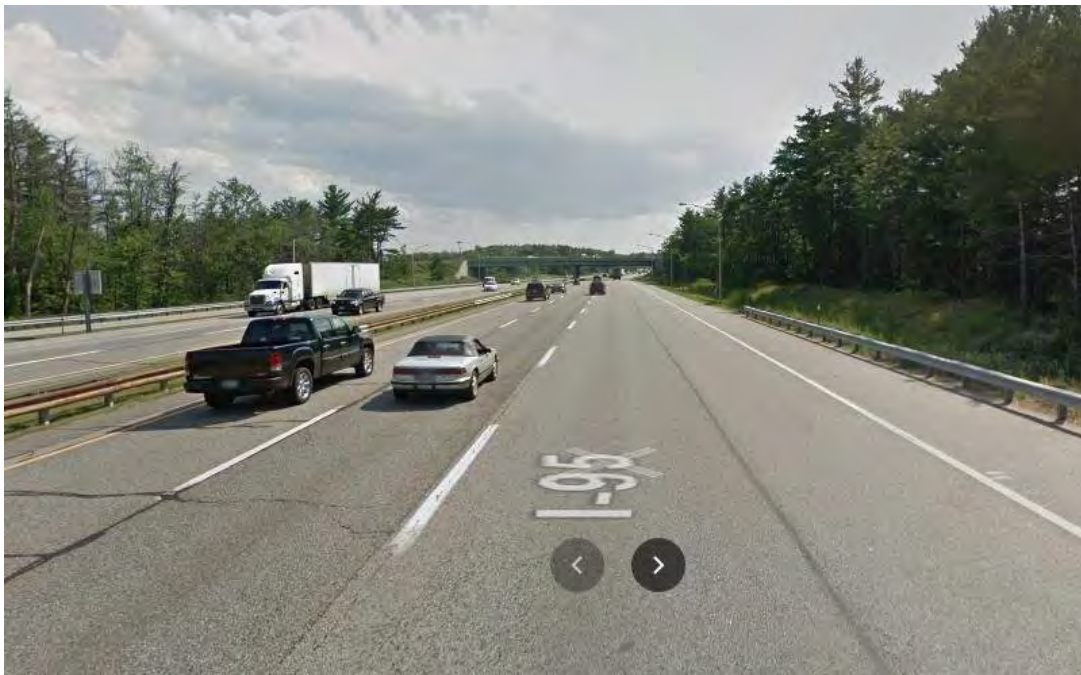
**Photo 2: Segment after Exit 32 SB On Ramp (2011)**

**Photo 2: Segment after Exit 32 SB On Ramp** captured by Google Maps<sup>2</sup> on July 2011 depicts the condition of this location at the time that it was most recently noted as an HCL.

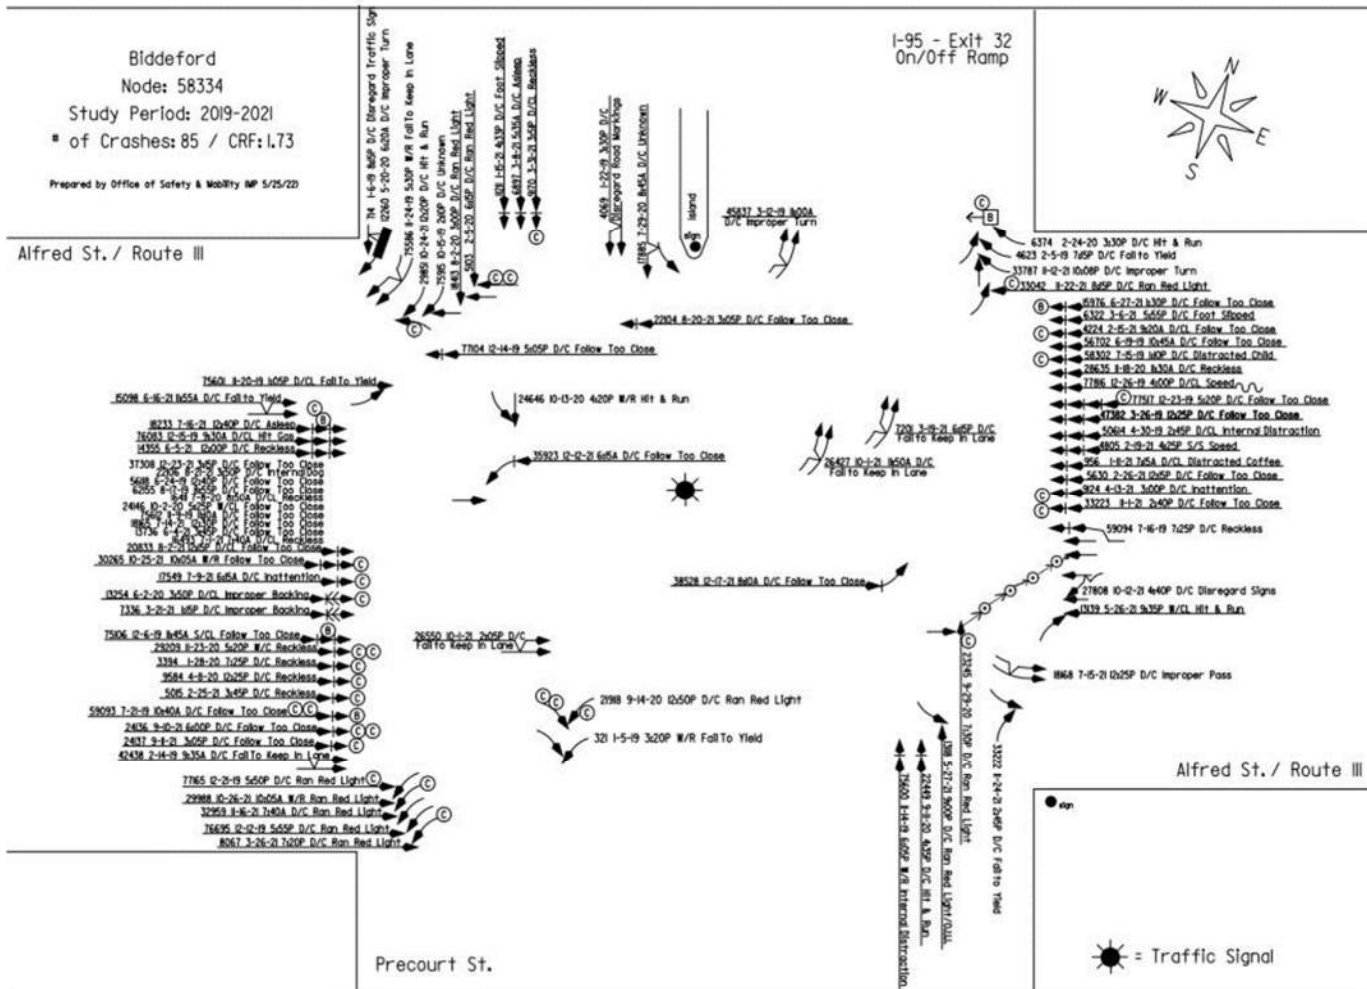
**Figure 2: 2019-2021 Exit 32 Intersection Crash Diagram** depicts the HCL location at the node of the Exit 32 Ramps intersection with Alfred Street. This location was identified as an HCL during 8 other time periods over the past 10 years.

As shown in **Figure 2**, there were 85 crashes resulting in a 32.9% injury rate during this analysis period.

- While there were many intersection movement crashes at this location, the majority occurred at the intersection approaches
  - Of the crashes that occurred at the intersection approaches, the vast majority were a result of vehicles following too close, followed by recklessness
- Many of the intersection movement crashes were a result of running red lights
- The vast majority of the crashes at this intersection occurred at or along the Alfred Street approaches
- June to August and December to February were the most common time spans for which crashes occurred
- One of these crashes involved a heavy vehicle

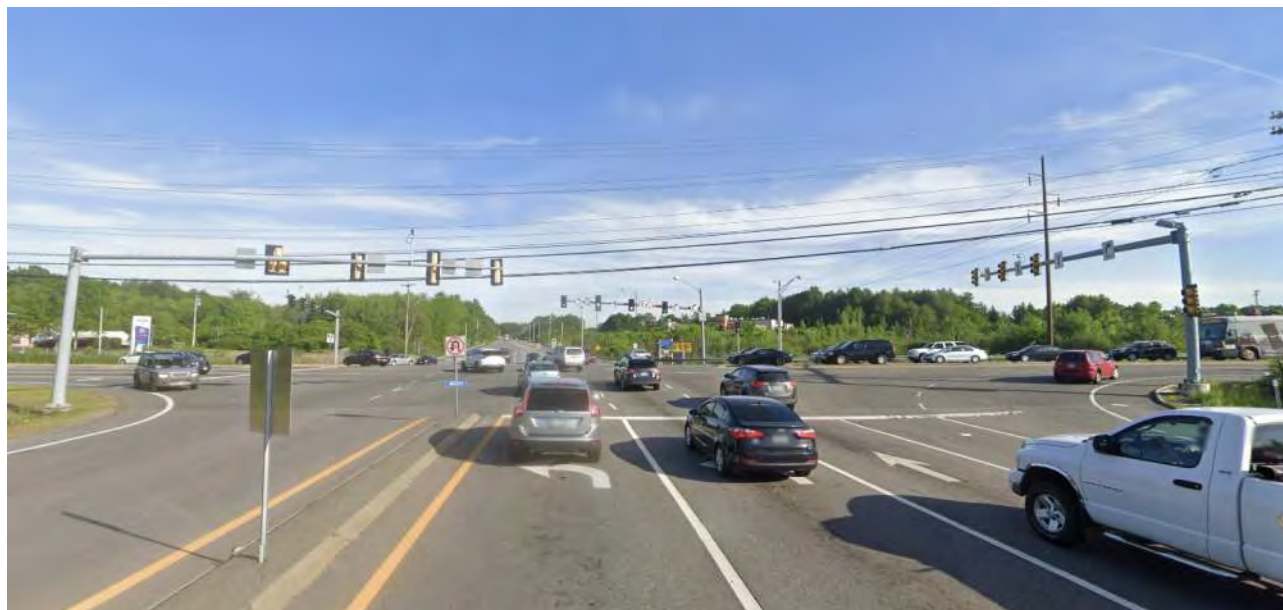
**Photo 1: Exit 32 Intersection** captured by Google Maps<sup>3</sup> in June of 2019 depicts the condition of this location at the time that it was most recently noted as an HCL. The photo represents the intersection from the view of the Exit 32 Ramps approach.

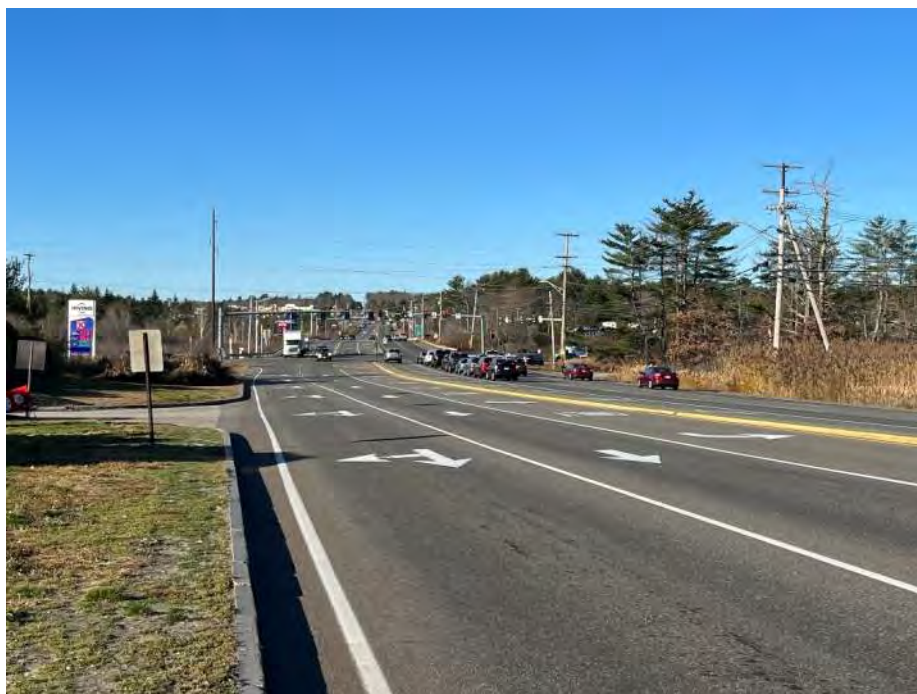
**Photo 4: Alfred Street WB Approach<sup>5</sup>**

It can be observed from this table that there were 5 crashes at this location with a 0% injury rate during this time period.

**Photo 4: Alfred Street WB Approach** captured by HNTB on November 8<sup>th</sup>, 2022, depicts the condition of this location at the time that it was most recently noted as an HCL.

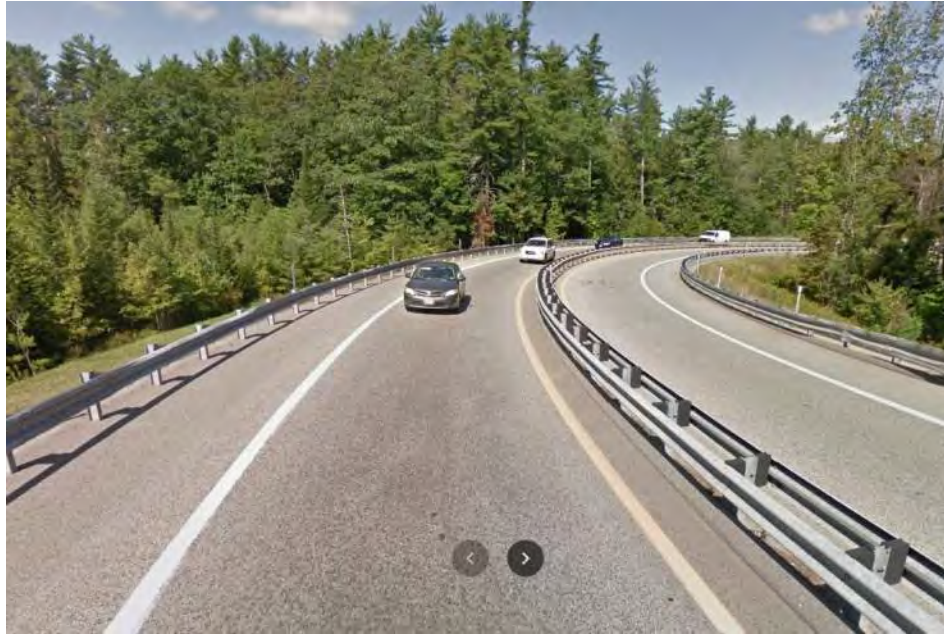
- 6 of the 8 crashes in this location resulted in vehicles departing from the roadway and colliding with guardrail spans
  - 4 of these 6 crashes were a result of unsafe speeds
  - All but one of these crashes occurred when the road was not dry
  - While it is not depicted in the crash diagram, this location is along the curve of the ramp
- The two crashes that did not result in vehicles departing from the roadway were a result of following too close
- 7 of the 8 crashes occurred between the months of October and February, the months in which winter conditions are most common
- There is not a strong correlation between time of day and crash frequency

**Photo 5: Exit 32 SB Off Ramp** captured by Google Maps<sup>6</sup> in September of 2017 depicts the condition of this location at the time that it was most recently noted as an HCL.

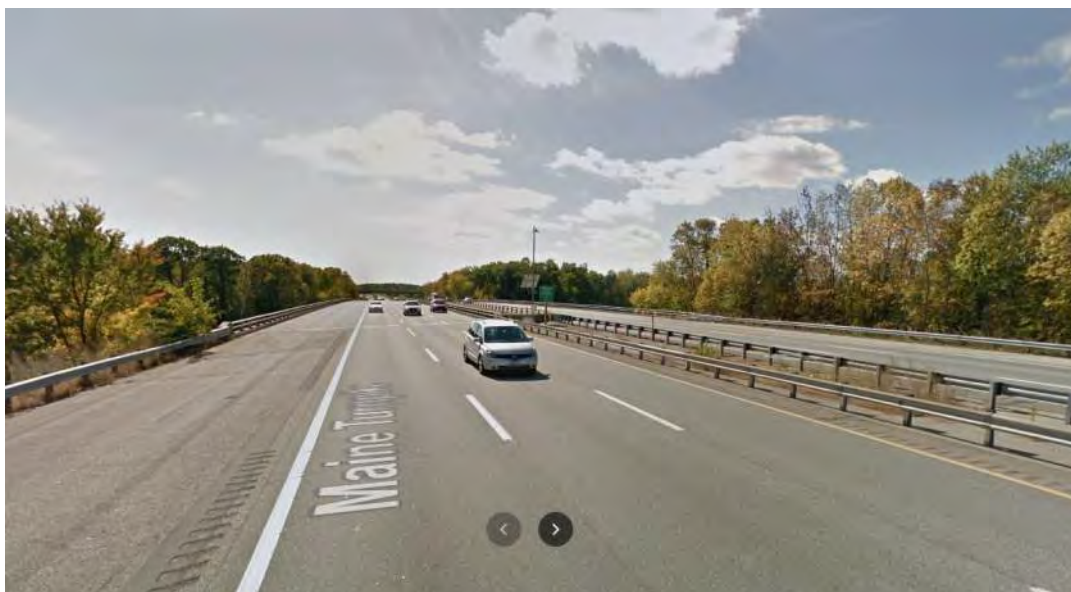
- 8 of the 16 crashes included in this crash diagram (50%) were a result of unsafe speed
  - None of these 8 crashes occurred on a dry roadway
  - 7 of these 8 crashes resulted in vehicles departing from the travel way and colliding with either bridge rail or guardrail
- 2 crashes at this location were due to collisions with large animals
- 3 of the 16 crashes included in this diagram occurred during the time period of increased summer traffic volumes
- 9 of the 16 crashes occurred during the evening hours between 5:00pm and 10:00pm

**Photo 1: Mainline over Saco River** captured from Google Maps<sup>2</sup> in October of 2015 depicts the condition of this location at the time that it was most recently noted as an HCL.

Many of the crashes in this location were a result of unsafe speeds, especially in cases that the roadway was wet or icy. Additionally, large animal collisions were present in this area. While this can be used to identify safety concerns during the analysis period, the most recent time span in which this location was identified as an HCL was 2012-2014. For this

reason, the recommendations for this HCL will focus around monitoring the area for any current safety concerns, particularly the post-construction conditions after the surrounding interchange updates are implemented.

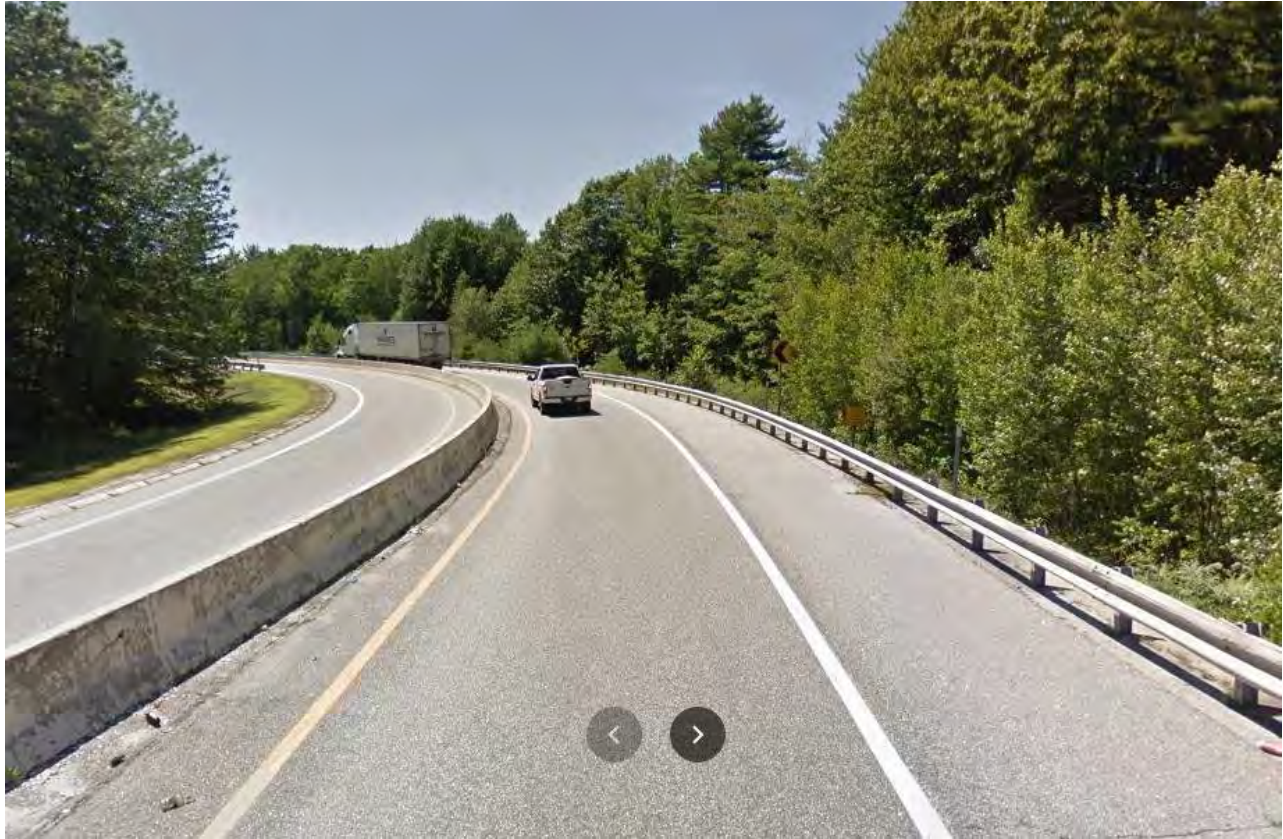
- The two most common causes of crashes at this location were unsafe speeds and inattention, each contributing to 3 crashes
- Following too closely contributed to 2 crashes at this location
- 6 of the crashes along the ramp resulted in vehicles departing from the travel way and colliding with guardrail
- 6 of the 9 crashes occurred between the months of October and February, the months in which winter conditions are most common in this area
- Crashes in this area are most common in the evening, with 6 of the 9 occurring between 5:30pm and midnight

**Photo 1: Exit 36 SB Off Ramp** captured by Google Maps<sup>3</sup> in July of 2018 depicts the condition of this location at the time that it was most recently noted as an HCL.

Since this location will soon be under construction to implement major reconfiguration and changes to both the ramp as well as surrounding areas, the recommendations for this HCL will center around monitoring post-construction conditions. This will be especially important as travel patterns change and vehicles distribute themselves between the Exit 35 and 36s interchanges, as well as begin to maneuver the collector distributor that will be present along the southbound corridor.
