# 2022 Systemwide Safety and Capacity Study

June 30, 2023

Maine Turnpike Authority  
2360 Congress Street  
Portland, ME 04102

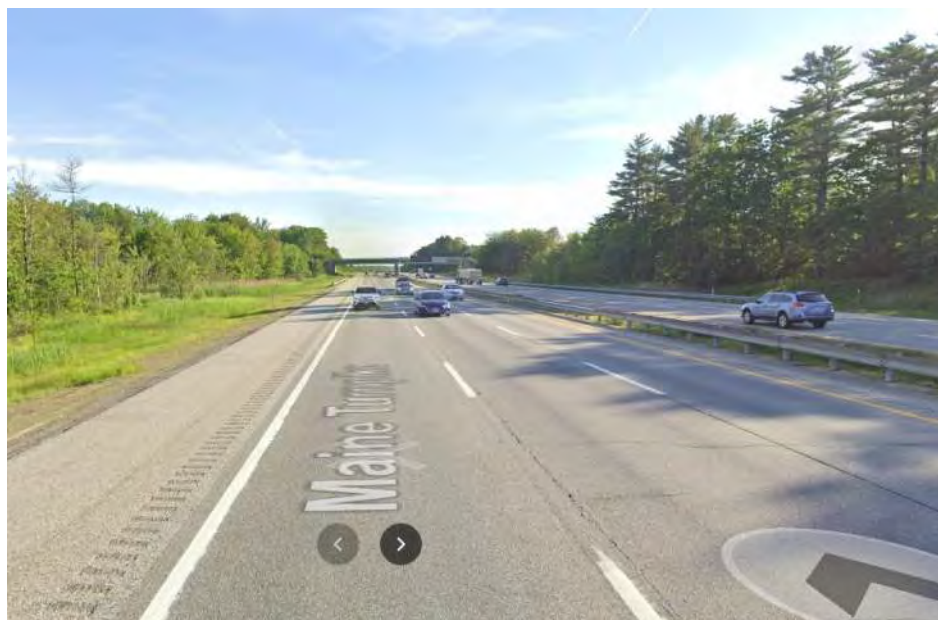
- The most common crash cause at this location during the analysis period was following too close, which contributed to 22 crashes
  - This is a common crash cause at locations such as these that have high traffic volumes, causing congestion
- Speed was the next most common contributing factor, causing 15 crashes at this location
  - Many of these occurred during times in which the pavement was not dry
- There were 10 crashes involving collisions with animals at this location
- 20 of these crashes resulted in vehicles departing from the roadway, some of which resulted in these vehicles colliding with guardrail
- 3 of these crashes involved heavy vehicles
- 38 of these 71 crashes (approximately 54%) occurred between the months of May and October when traffic volumes in this location are increased

**Photo 2: Just Prior to Exit 42 NB Off Ramp** captured by Google Maps<sup>3</sup> in June of 2019 depicts the condition of this location at the time that it was most recently noted as an HCL.

Vehicles following too close was the main crash cause at both of the HCLs examined as a part of this audit. This is a common crash type on congested roadways with high volumes such as this mainline segment. For this reason, future widening at this location should be evaluated, especially as volumes continue to grow in the future.

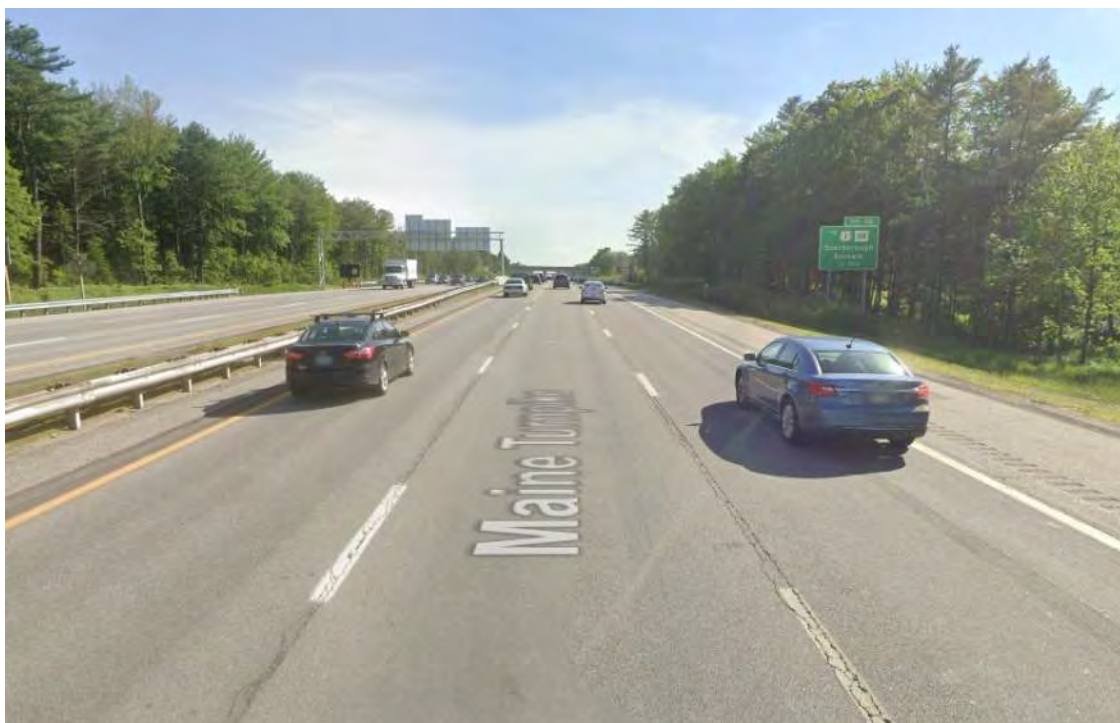
**Photo 1: Exit 42 SB Off Ramp Approach**

**Photo 1: Exit 42 SB Off Ramp Approach**, captured by Google Maps<sup>3</sup> in June of 2019, depicts the condition of this location at the time that it was most recently noted as an HCL.

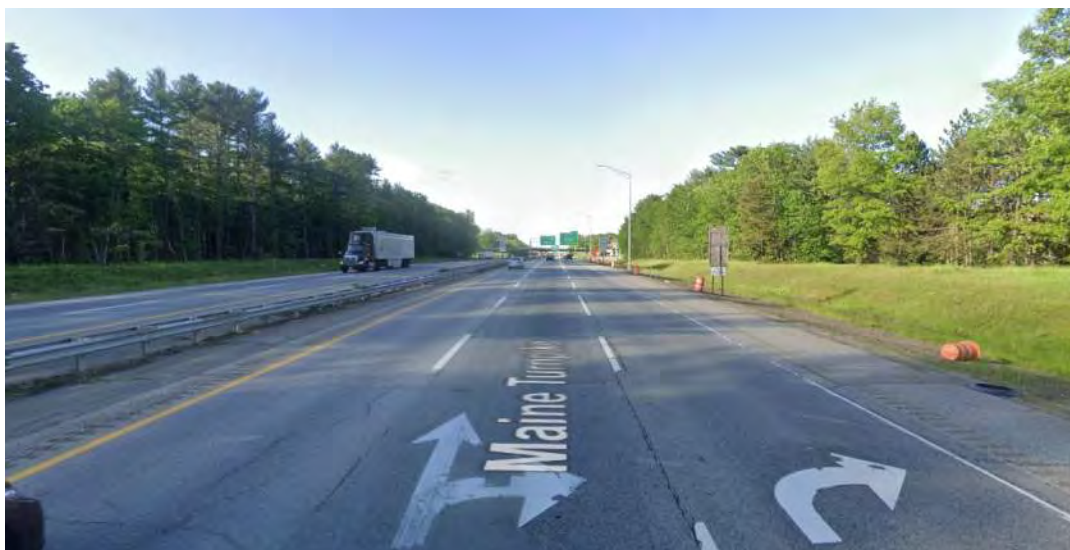
**Photo 2: Just South of the Exit 44 NB Off Ramp** captured by Google Maps<sup>4</sup> in June of 2019 depicts the condition of this location at the time that it was most recently noted as an HCL.

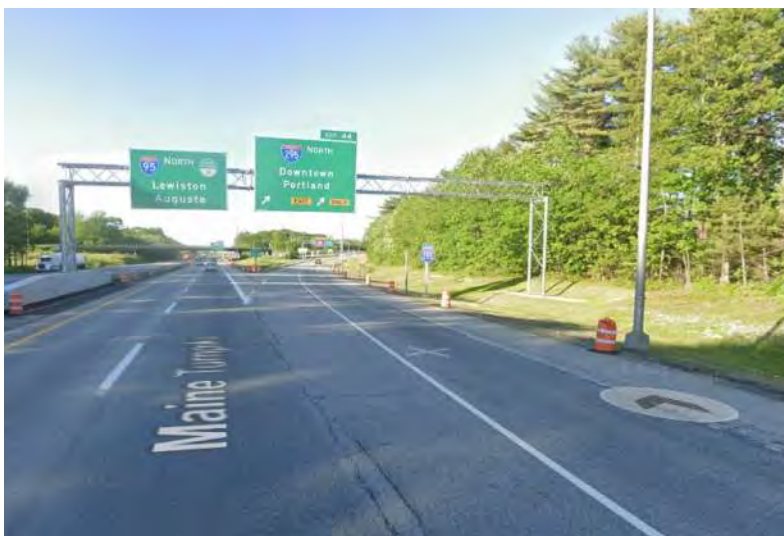
**Photo 3: Exit 44 NB Diverge**

**Photo 3: Exit 44 NB Diverge**, captured by Google Maps<sup>5</sup> in June of 2019, depicts the condition of this location at the time that it was most recently noted as an HCL.

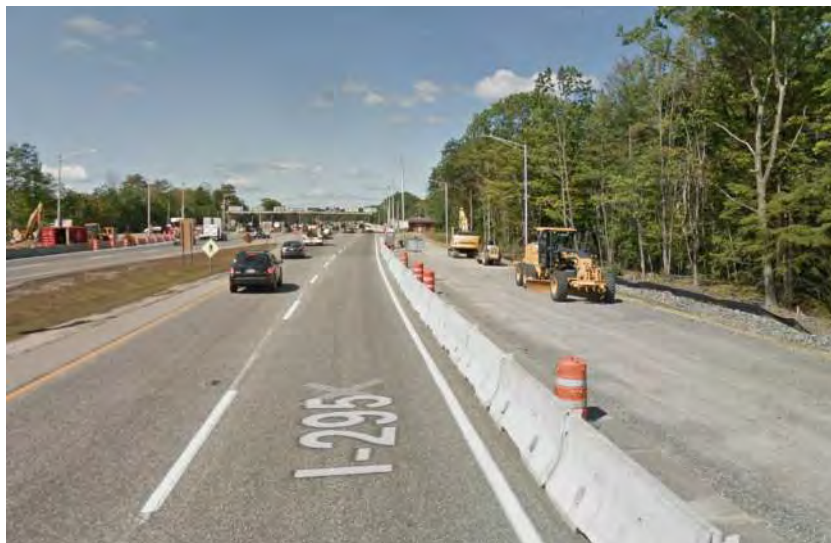
**Photo 1: I-295 WB Toll Plaza** captured by Google Maps<sup>2</sup> in September of 2017 depicts the condition of this location at the time that it was most recently noted as an HCL.

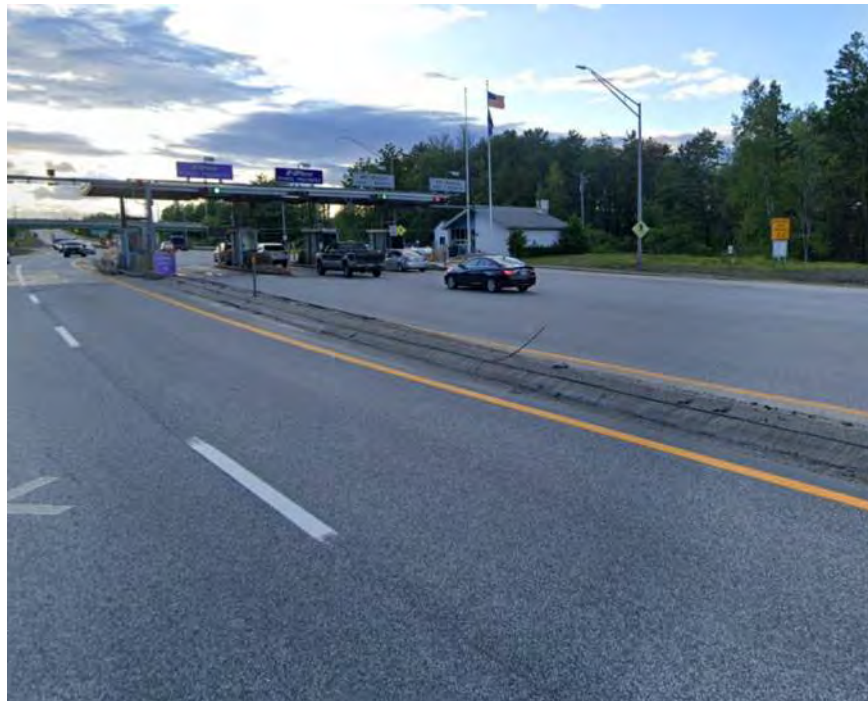
**Photo 1: Exit 45 On Ramp Toll Plaza (2021)**

**Photo 1: Exit 45 On Ramp Toll Plaza (2019)** captured by Google Maps<sup>2</sup> in June of 2019 depicts the condition of this location at the time that it was most recently noted as an HCL.

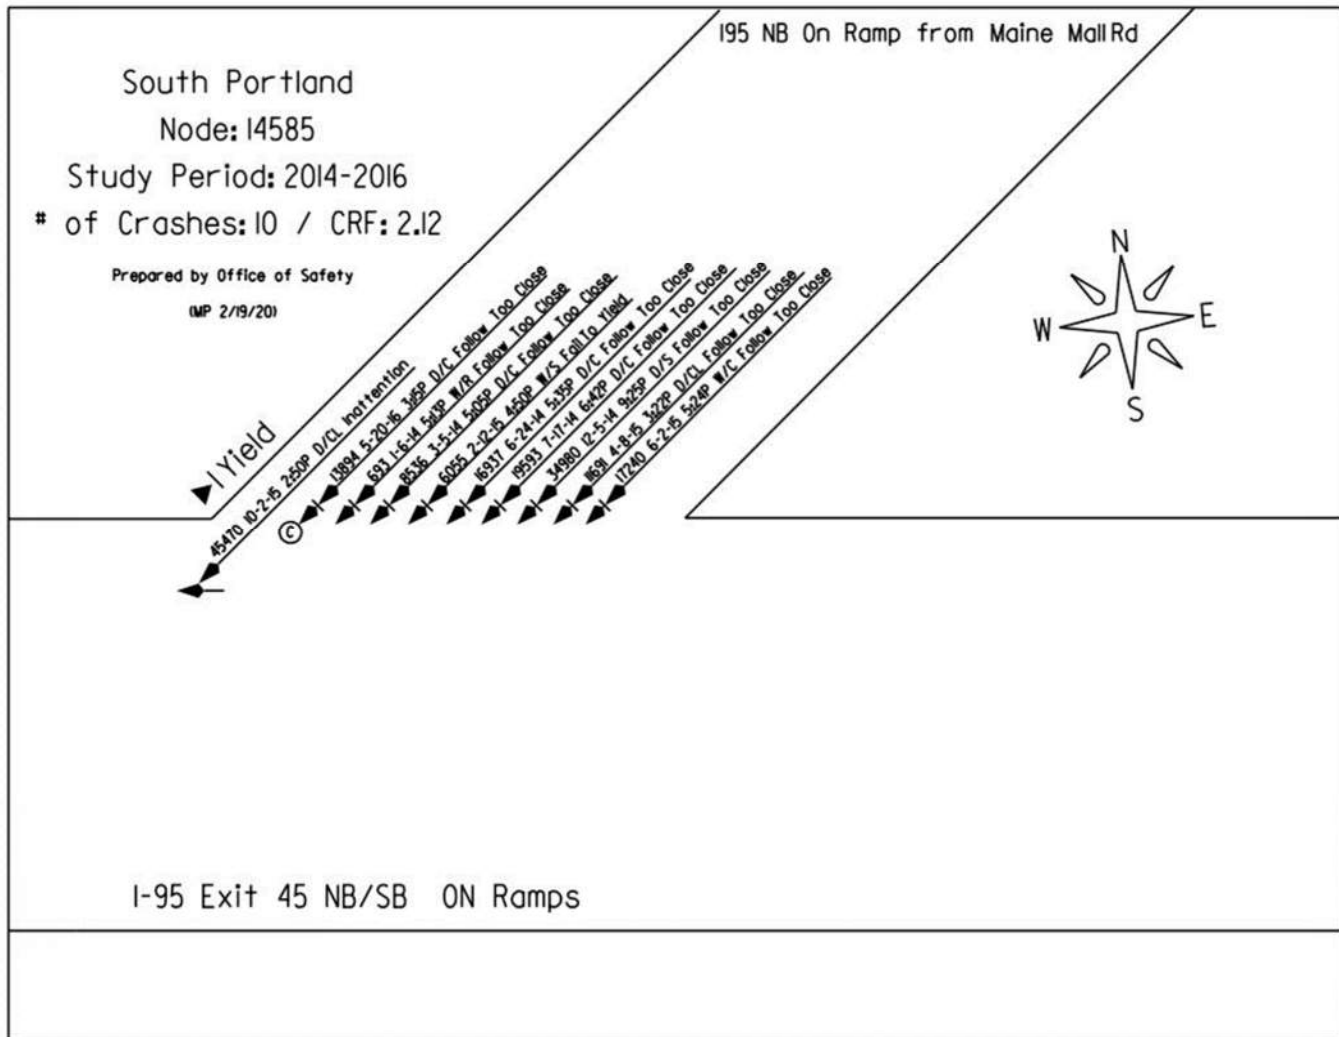
**Figure 2: 2014-2016 Route 703 Merge to Exit 45 On Ramps Crash Diagram** depicts the crash diagram for the merge point of the Maine Turnpike Approach and ramp from Maine Mall Road during the most recent period in which it was identified as an HCL. This location was identified as an HCL for 3 other time periods over the past 10 years.

As shown in **Figure 2**, there were 10 crashes resulting in a 10% injury rate during this analysis period.

- 1 of these crashes was a turning movement crash while the other 9 happened at the ramp from Maine Mall Road approach
- 8 of the 9 crashes at the approach were a result of vehicles following too close
- 5 of these crashes occurred between the months of May and October when there are increased volumes in this area

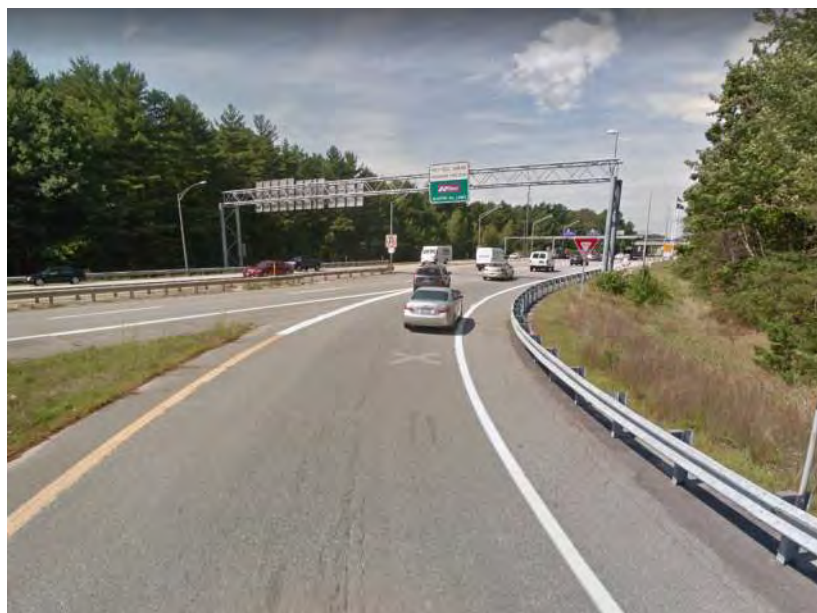
**Photo 2: Route 703 Merge with Exit 45 On Ramps (2016)** captured by Google Maps<sup>3</sup> in August of 2016 depicts the condition of this location at the time that it was most recently noted as an HCL.

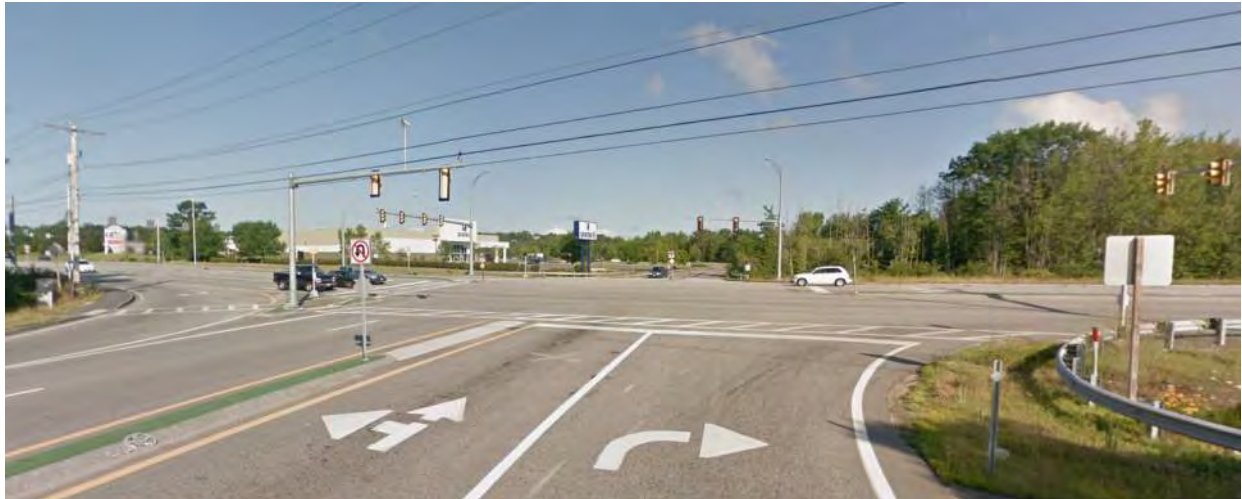
**Photo 1: Exit 45 Off Ramp Intersection (2011)** captured by Google Maps<sup>2</sup> in August of 2011 depicts the condition of this location at the time that it was most recently noted as an HCL.

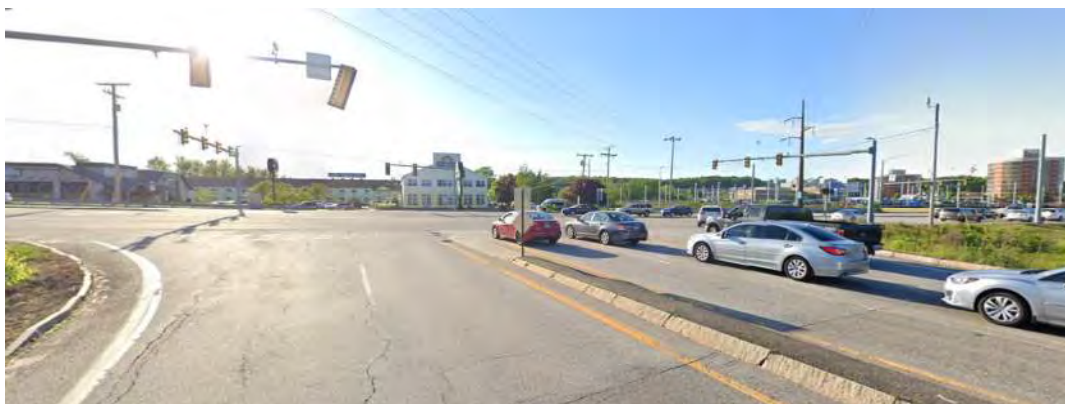
**Photo 3: Exit 45 On Ramps Intersection (2019)** captured by Google Maps<sup>3</sup> in June of 2019 depicts the condition of this location at the time that it was most recently noted as an HCL.

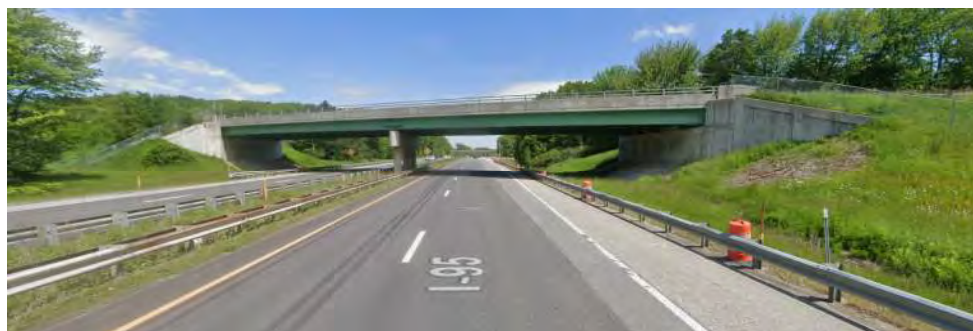
**Photo 1: I-95 NB South of Exit 47 Off Ramp (2019)** captured by Google Maps<sup>2</sup> in June of 2019 depicts the condition of this location at the time that it was most recently noted as an HCL.

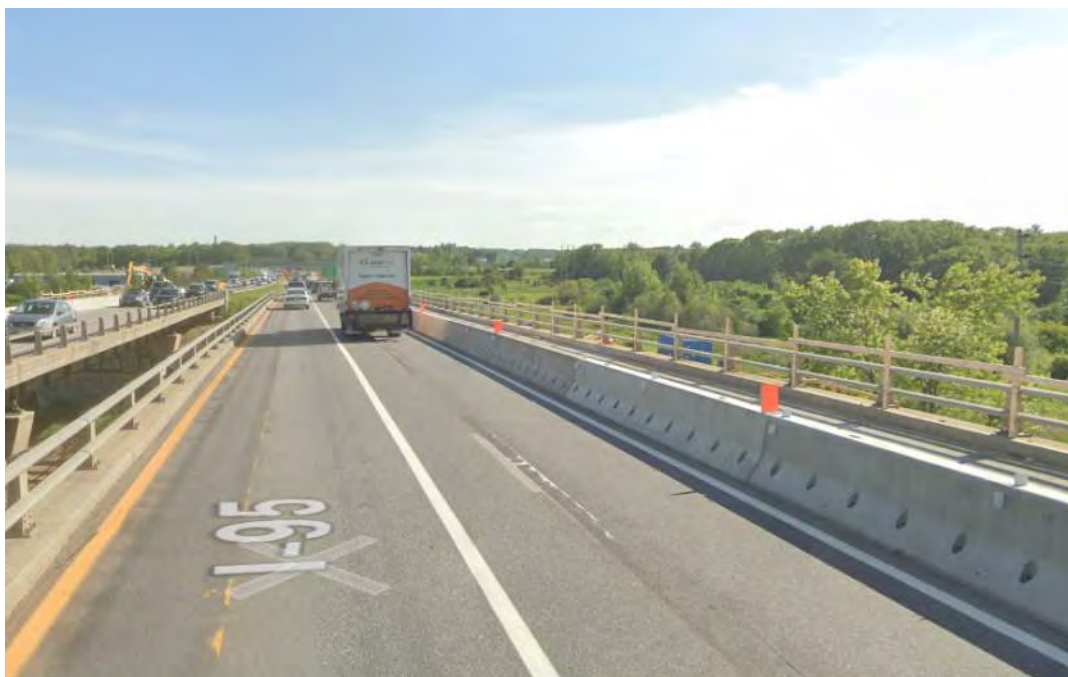
**Photo 1: I-95 SB Just North of Exit 47 Off Ramp (2019)** captured by Google Maps<sup>2</sup> in June of 2019 depicts the condition of this location at the time that it was most recently noted as an HCL.

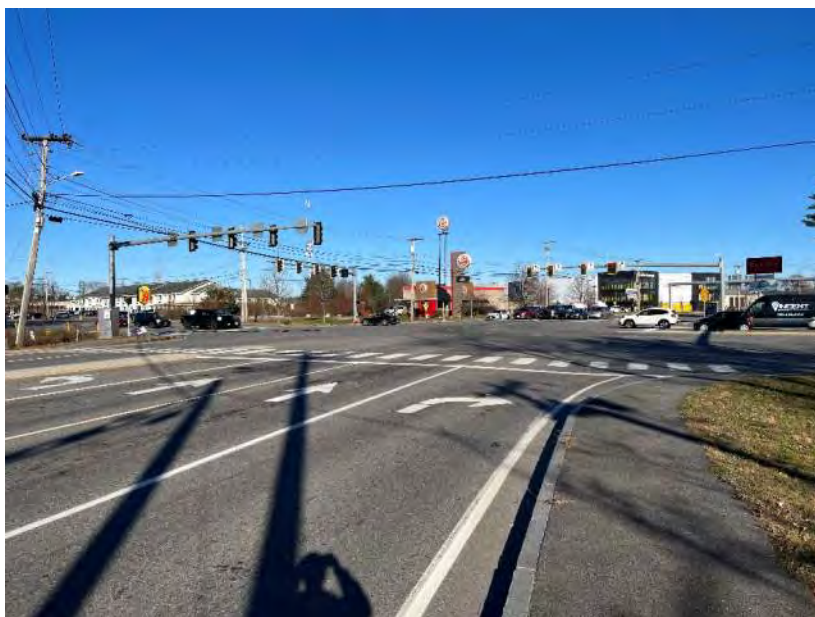
**Photo 1: Exit 48 Intersection (2022)** captured by HNTB in November of 2022 depicts the condition of this location at the time that it was most recently noted as an HCL.

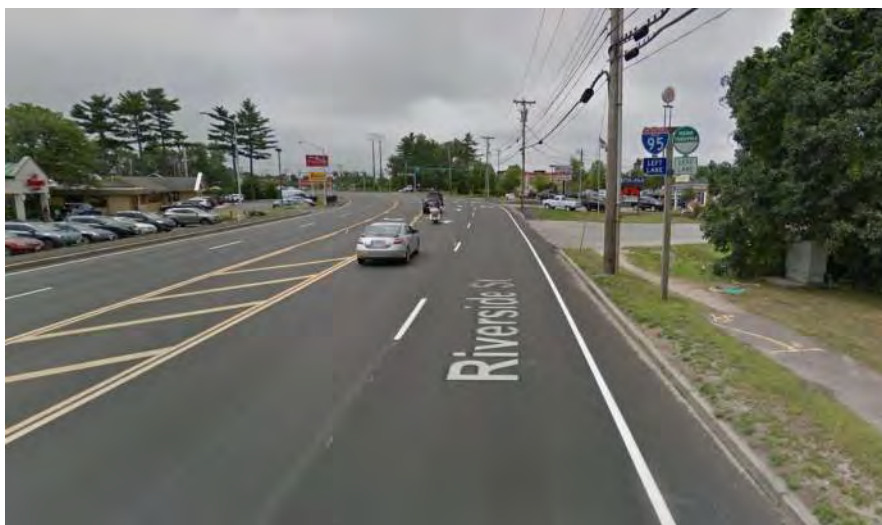
**Photo 2: Riverside Street Southbound Approach (2018)** captured by Google Maps<sup>3</sup> in July of 2018 depicts the condition of this location at the time that it was most recently noted as an HCL.

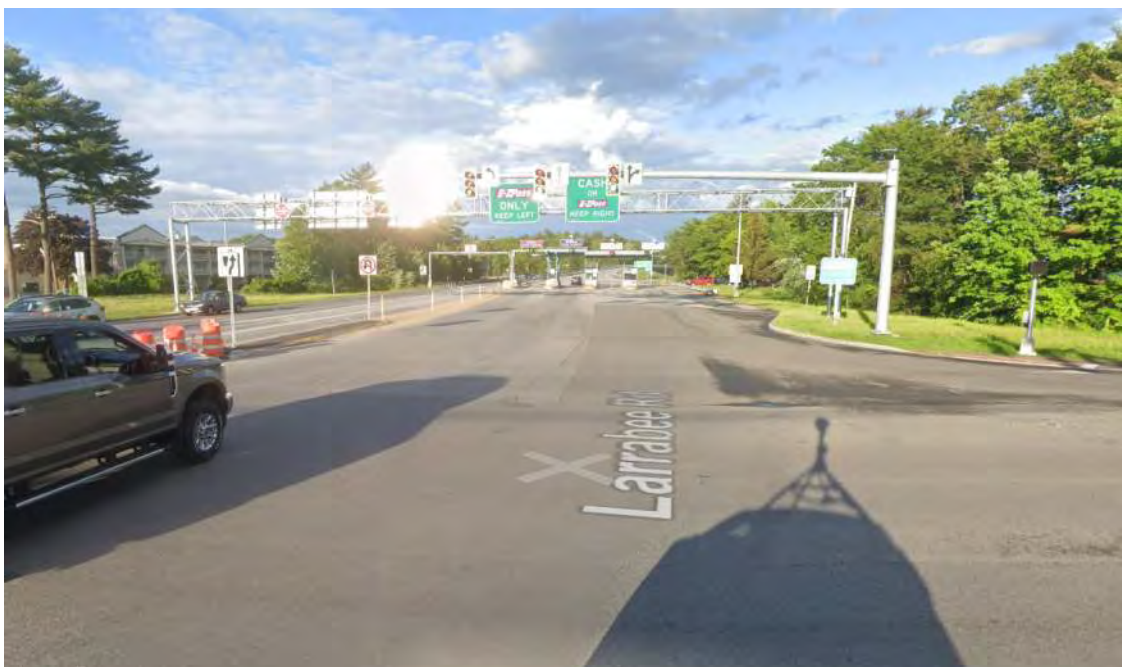
**Photo 3: Exit 48 Toll Plaza Approach (2019)** captured by Google Maps<sup>4</sup> in June of 2019 depicts the condition of this location at the time that it was most recently noted as an HCL.

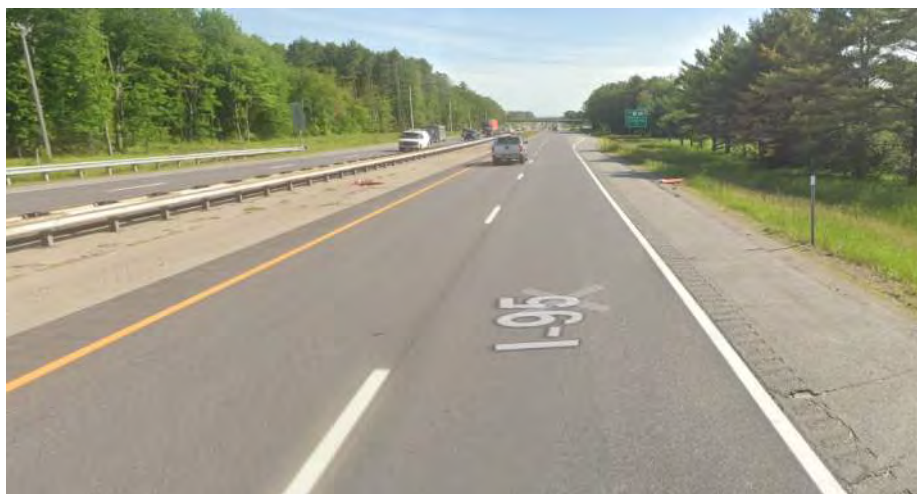
**Photo 1: Exit 48 Southbound Approach (2019)** captured by Google Maps<sup>2</sup> in June of 2019 depicts the condition of this location at the time that it was most recently noted as an HCL.

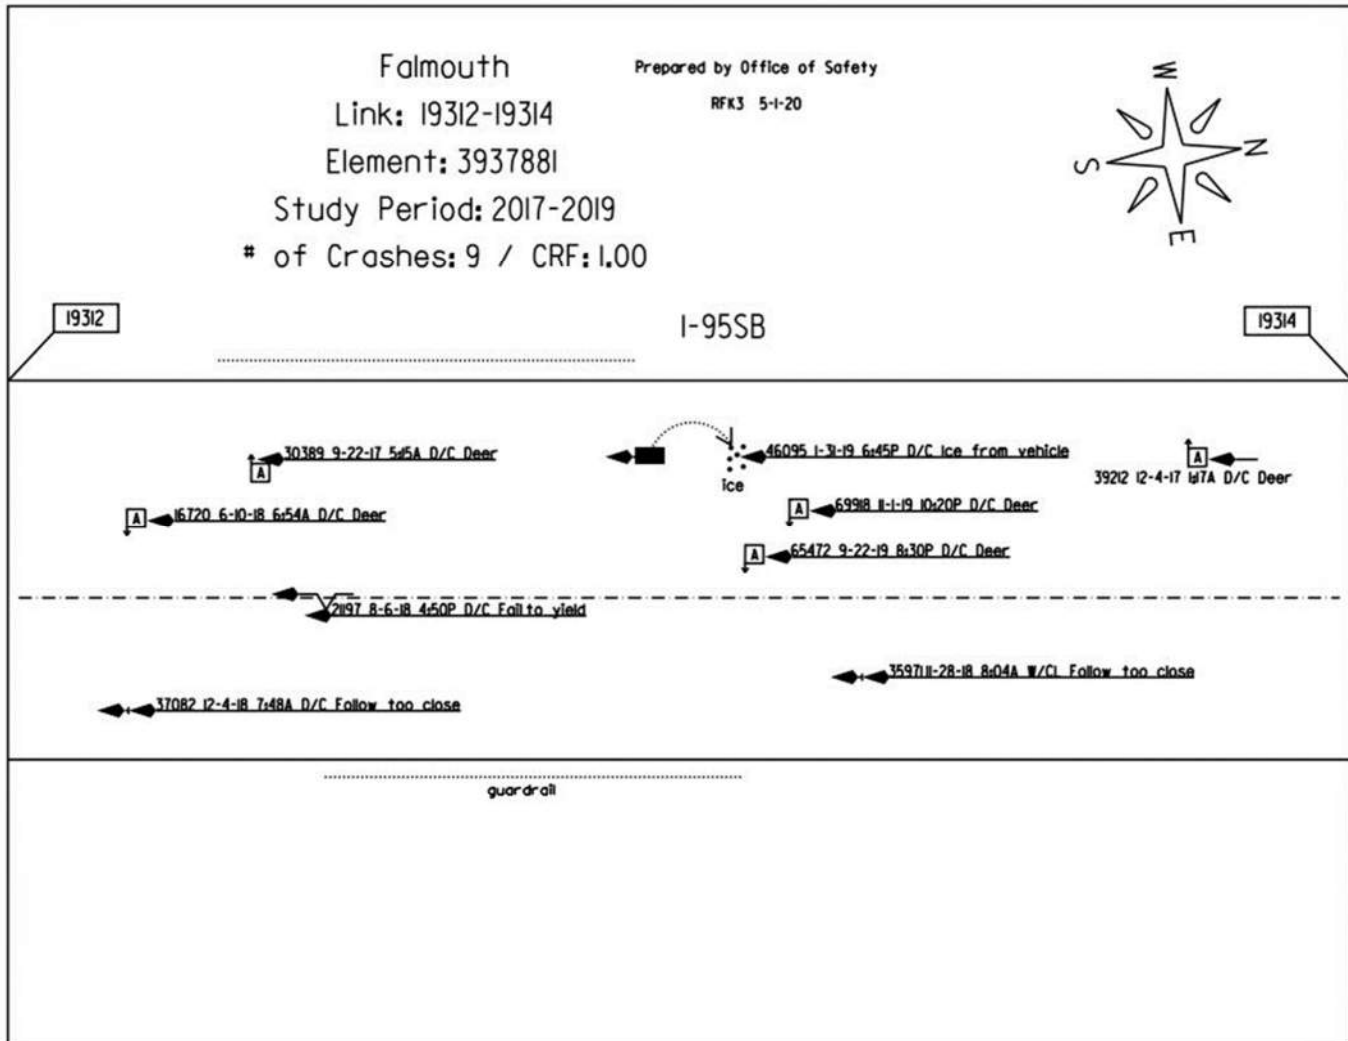
**Figure 2: 2017-2019 Mile Marker 52-53 Southbound Crash Diagram** depicts the most recent available crash diagram for this mainline segment. This location was also classified as an HCL during the 2018-2020 time period over the past 10 years.

As shown in **Figure 2**, there were 9 crashes resulting in a 0% injury rate during this analysis period.

- Collisions with deer was the most common type of crash at this location with 5 crashes
- 2 of the crashes at this location were a result of vehicles following too close
- 5 of the 9 crashes at this location occurred between the winter months of November to January
- All but 1 of these crashes occurred when the roadway was dry and the weather was either clear or cloudy
- There is not a strong correlation between time of day and crash frequency at this location

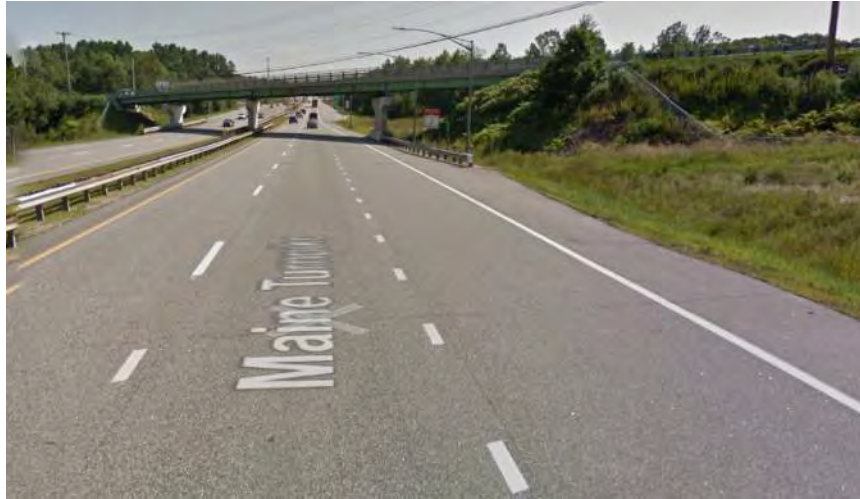
**Photo 1: Just South of Exit 53 Southbound On Ramp** captured by Google Maps<sup>2</sup> in July of 2018 depicts the condition of this location at the time that it was most recently noted as an HCL.

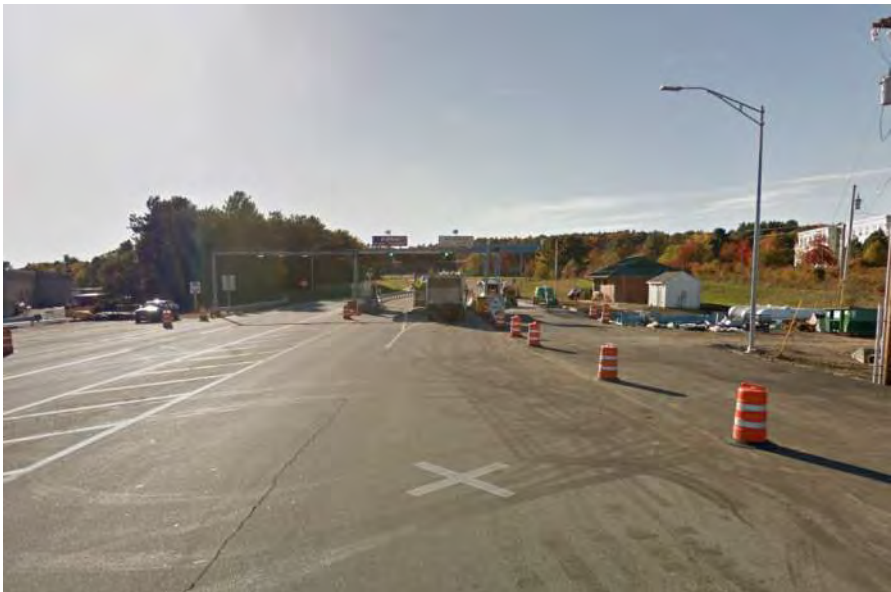
**Photo 1: Exit 53 Toll Plaza (2016)** captured by Google Maps in October of 2016 depicts the condition of this location at the time that it was most recently noted as an HCL.

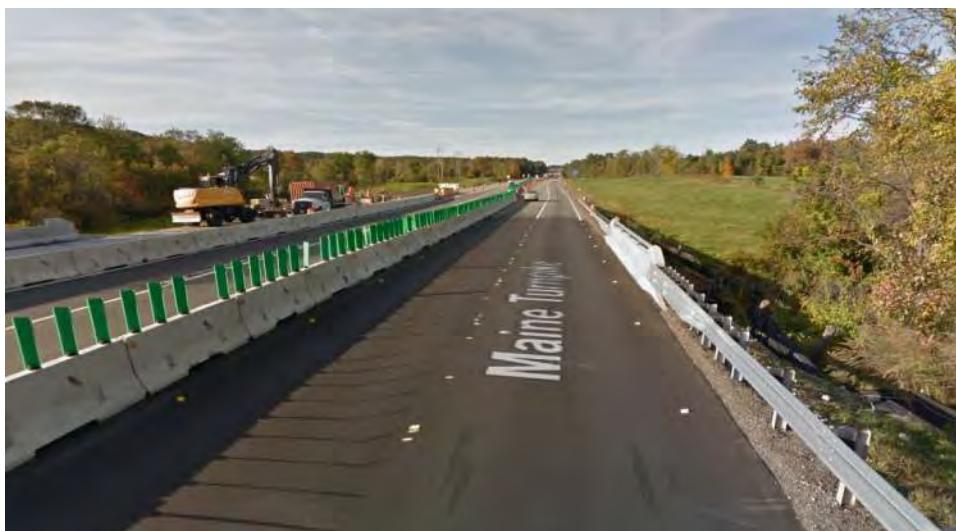
**Photo 1: NB Just North of Hurricane Road (2015)**

**Photo 1: NB Just North of Hurricane Road** captured by Google Maps<sup>2</sup> in October of 2015 depicts the condition of this location most nearly to the time that it was most recently noted as an HCL.

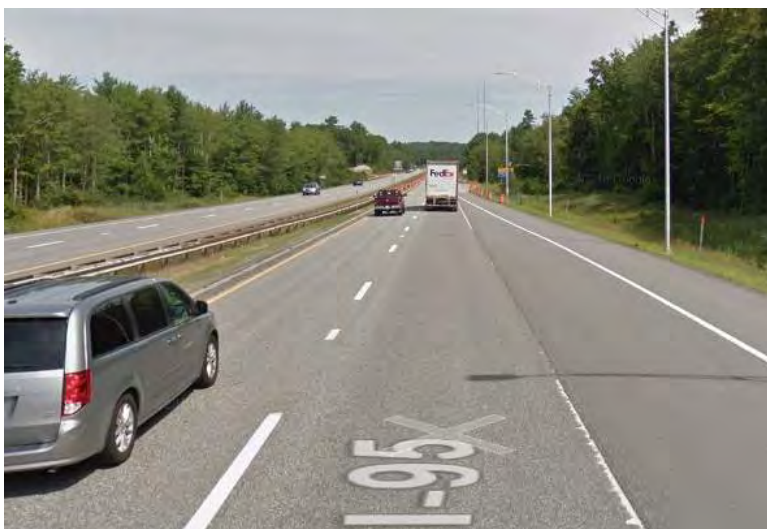
**Photo 2: NB North of Gray Service Plaza (2018)** captured by Google Maps<sup>3</sup> in July of 2018 depicts the condition of this location at the time that it was most recently noted as an HCL.

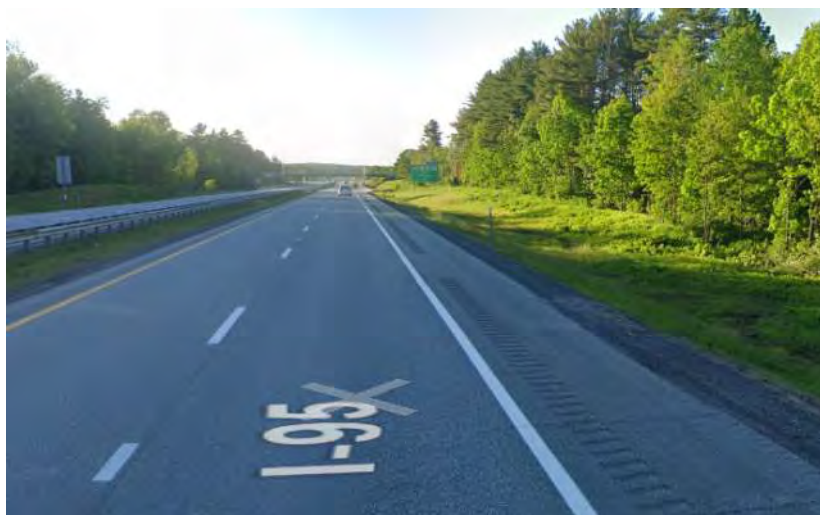
**Photo 1: South of Exit 63 Off Ramp (2019)** captured by Google Maps<sup>2</sup> in June of 2019 shows the condition of this location at the time that it was most recently noted as an HCL.

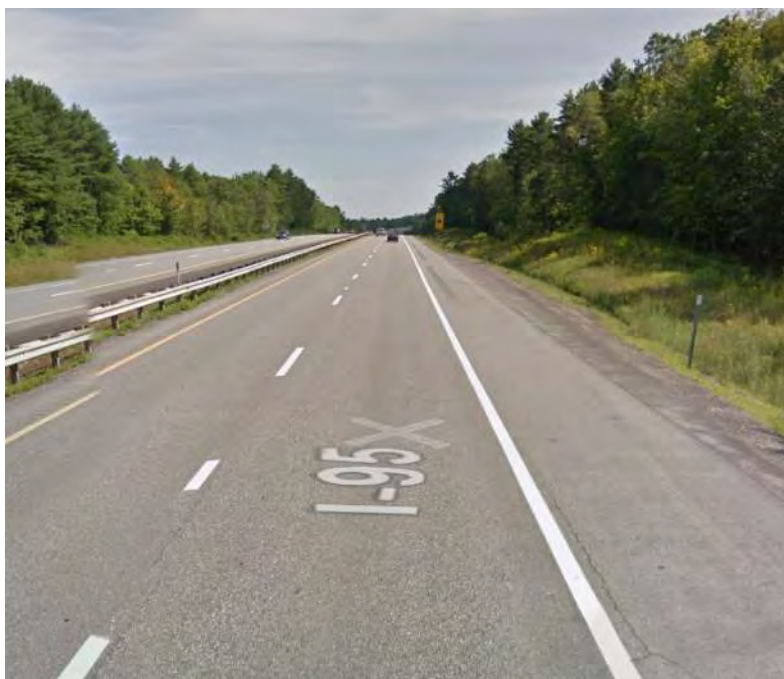
**Photo 2: SB South of Exit 63 On Ramp (2018)** captured by Google Maps<sup>3</sup> in July of 2018 depicts the condition of this location at the time that it was most recently noted as an HCL.

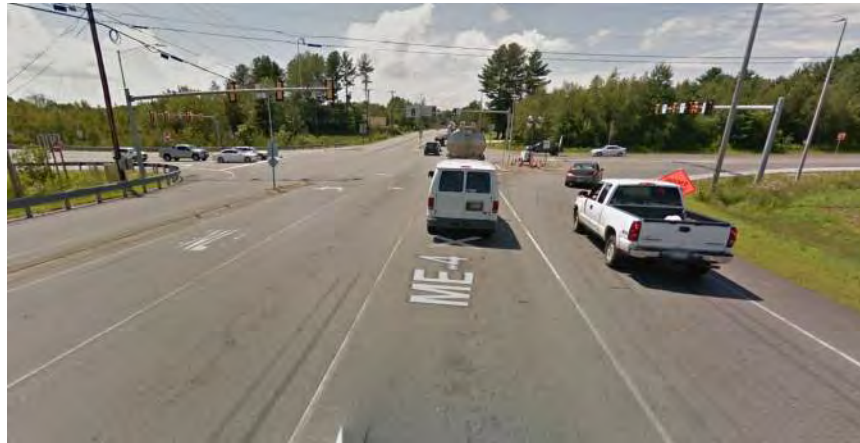
**Photo 2: SB Ramps Intersection (2018)** captured by Google Maps<sup>4</sup> in August of 2018 depicts the condition of this location at the time that it was most recently noted as an HCL. The view in this photo is from the perspective of vehicles approaching from W. Gray Street westbound.

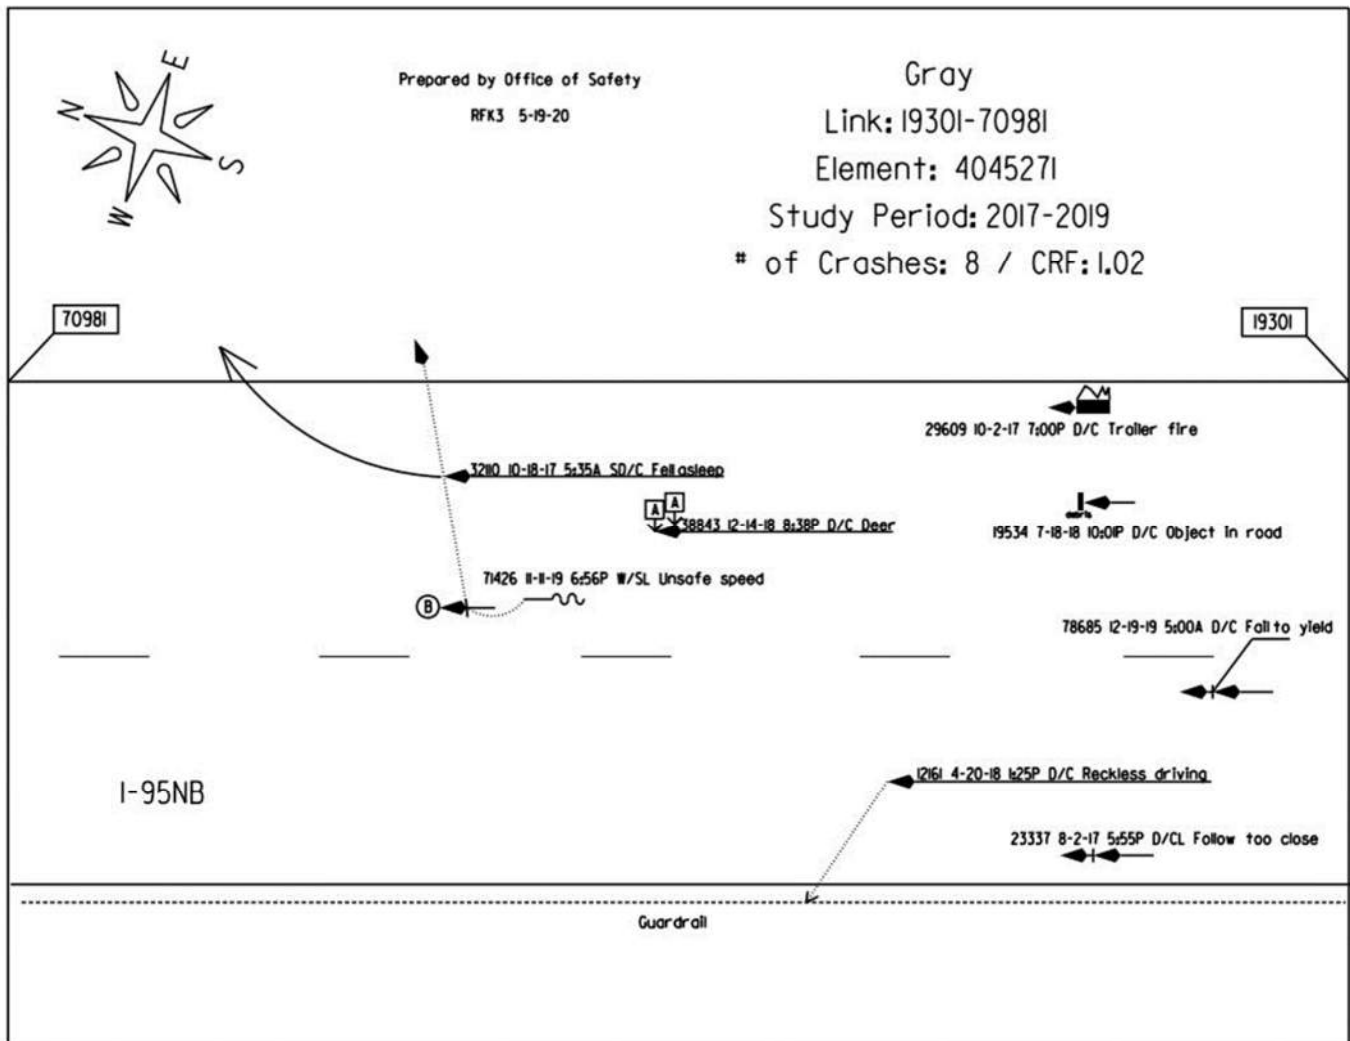
**Figure 2: 2017-2019 Immediately North of Exit 63 NB On Ramp Crash Diagram**

As shown in **Figure 2**, there were 8 crashes resulting in a 12.5% injury rate during this analysis period.

- There are no crash types that repeated along this segment during this time period
- There was 1 crash which involved a heavy vehicle
- 3 of the crashes in this location resulted in vehicles departing from the travel way
  - o 1 of these 3 resulted in a vehicle colliding with guardrail
- 5 of these 8 crashes occurred during the months from October through December
- The majority of the crashes at this location occurred during evening hours

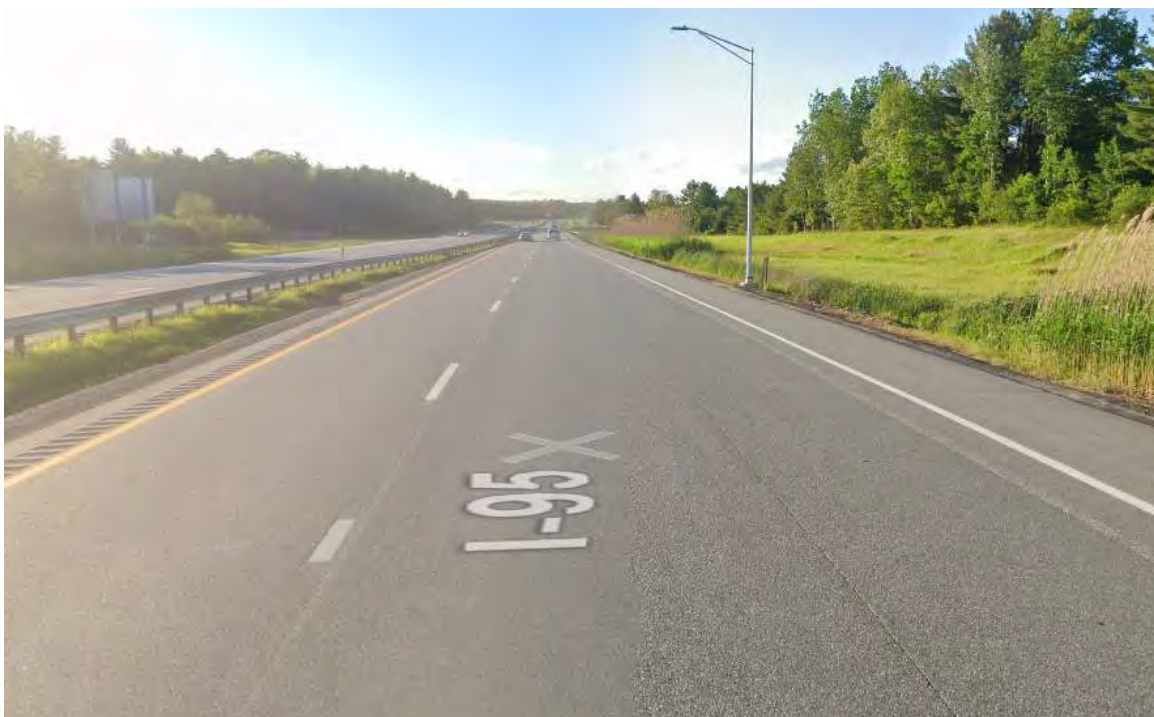
**Photo 1: Just North of Exit 63 NB On Ramp (2019)** captured by Google Maps<sup>2</sup> in June of 2019 depicts the condition of this location at the time that it was most recently noted as an HCL.

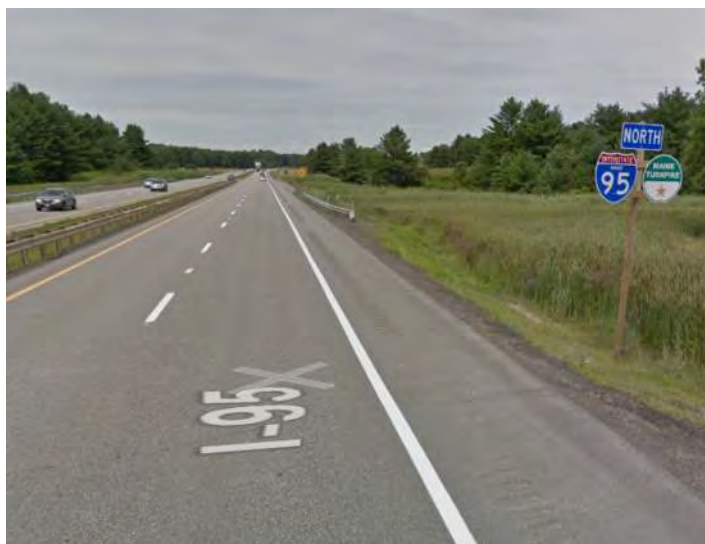
- The most common cause of crash at this location was unsafe speed, which contributed to 4 crashes
- The next most common crash type was collisions with large animals which contributed to 3 crashes
- 8 of these 13 crashes resulted in vehicles departing from the travel way
  - 6 of these 8 crashes resulted in vehicles colliding with guardrail
- There is not a strong correlation between time of year nor time of day and crash frequency at this location

**Photo 2: I-95 NB (2018)** captured by Google Maps<sup>3</sup> in July of 2018 depicts the condition of this location at the time that it was most recently noted as an HCL.

Unsafe speeds, especially during inclement weather, is one of the leading causes of crash at this location. Because of this, the area should be included in a speed study evaluation to determine whether decreased posted speed limits during weather events should be implemented.

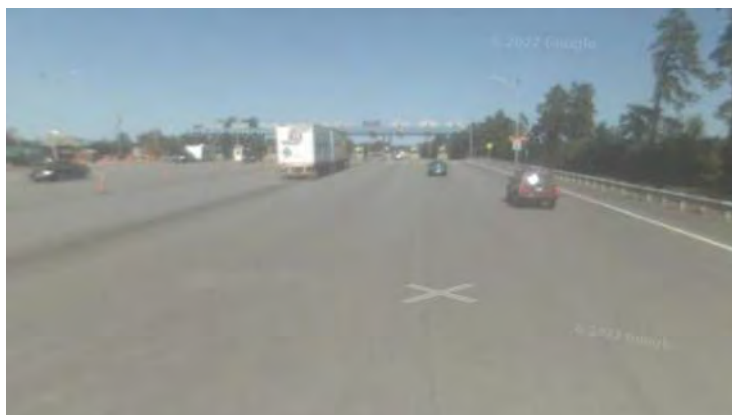
**Photo 2: New Gloucester Toll Plaza NB (2008)**

- The most common cause of crash at this location was inattention which contributed to 3 of the 9 crashes
- The next most common causes were falling asleep, unsafe backing and failure to yield, all which contributed to 2 crashes each
- 2 of these crashes resulted in vehicles departing from the travel way
  - 1 of these 2 resulted in vehicles colliding with guardrail
- There are not strong correlations between time of day nor time of year and crash frequency at this location

**Photo 1: New Gloucester Toll Plaza NB (2008)** captured by Google Maps<sup>2</sup> in October of 2008 depicts the condition of this location at the time most nearly to which it was most recently noted as an HCL.

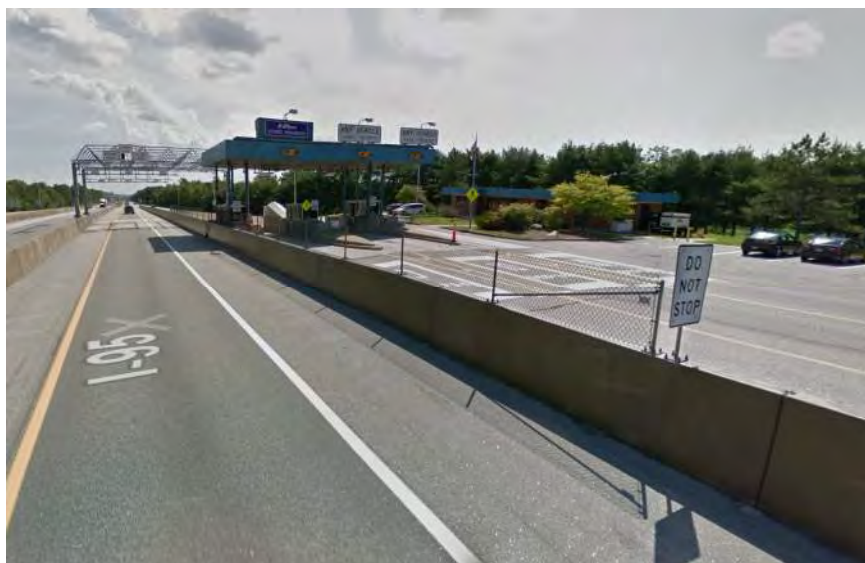
- The leading crash cause at this location was unsafe speed which contributed to 3 crashes
- Animal collisions was the next most common type of crash with 2 crashes
- 1 of these crashes involved heavy vehicles
- 4 of these crashes resulted in vehicles departing from the travel way
- 7 of these 13 crashes occurred during the months of November and December
- 5 of these crashes occurred from approximately 5:00pm to 6:00pm

**Photo 2: NB Toll Plaza (2018)** captured by Google Maps<sup>3</sup> in July of 2018 depicts the condition of this location at the time that it was most recently noted as an HCL.

Unsafe speeds, especially during inclement weather, is one of the leading causes of crash at this location. Because of this, the area should be included in a speed study evaluation to determine whether decreased posted speed limits during weather events should be implemented.

Another leading crash cause at these locations are maneuvers at the toll booth. The surrounding area should be evaluated for implementation of safety measures to bring added attention to the toll booth, such as rumble strips.

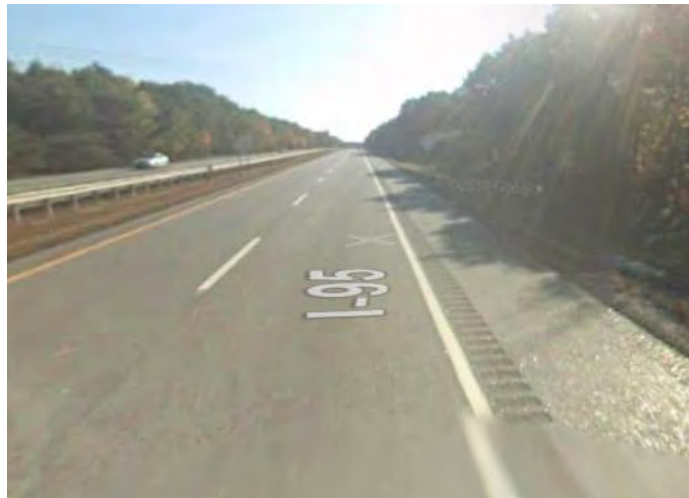
- 5 of these crashes were caused by unsafe speed
- 2 of these crashes involved collisions with animals
- 6 of these crashes resulted in vehicles departing from the roadway and colliding with objects including median guardrail or trees
- 1 of these crashes involved a heavy vehicle
- There is not a strong correlation between time of year and crash frequency at this location
- Many crashes at this location occurred during early morning hours, with 5 crashes occurring between 1:00am and 6:00am

**Photo 3: North of SB Toll Plaza (2008)** captured by Google Maps in October of 2008 depicts the condition of this location at the time most nearly to which it was most recently noted as an HCL.

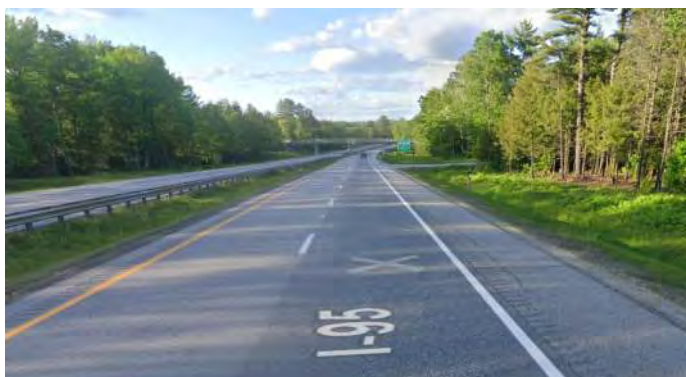
- There were 10 animal collisions at this location, as well as 1 additional crash which was due to avoiding a deer
- The next most common cause of crash at this location was speed, which contributed to 4 crashes
- There was 1 crash at this location that involved a heavy vehicle
- 6 of these crashes caused vehicles to depart from the travel way and collide with objects such as signs or guardrail

**Photo 1: I-95 NB Near Poland Springs Bridge (2019)** captured by Google Maps<sup>2</sup> in June of 2019 depicts the condition of this location at the time that it was most recently noted as an HCL.

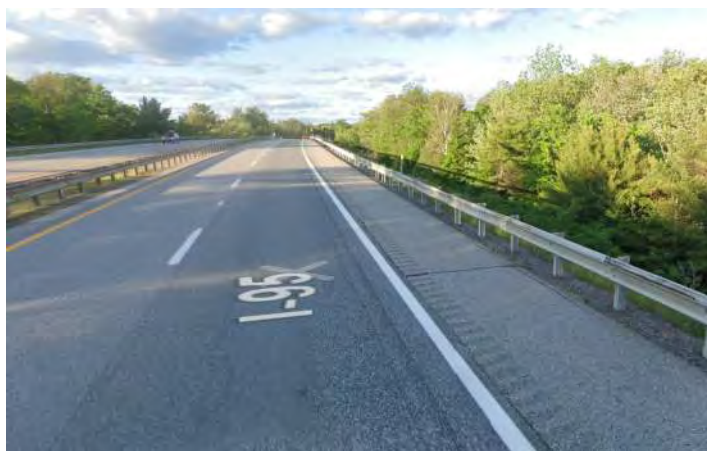
- The leading crash causes at this location were speed, falling asleep and collisions with animals which each contributed to 3 crashes
- 8 of these 12 crashes resulted in vehicles departing the travel way and colliding with guardrail
- 6 of these crashes occurred between the months of June through August
- There is not a strong correlation between time of day and crash frequency at this location

**Photo 2: I-95 NB Just South of Exit 75 (2019)** captured by Google Maps<sup>3</sup> in June of 2019 depicts the condition of this location at the time that it was most recently noted as an HCL.
