# 2022 Systemwide Safety and Capacity Study

June 30, 2023

Maine Turnpike Authority  
2360 Congress Street  
Portland, ME 04102

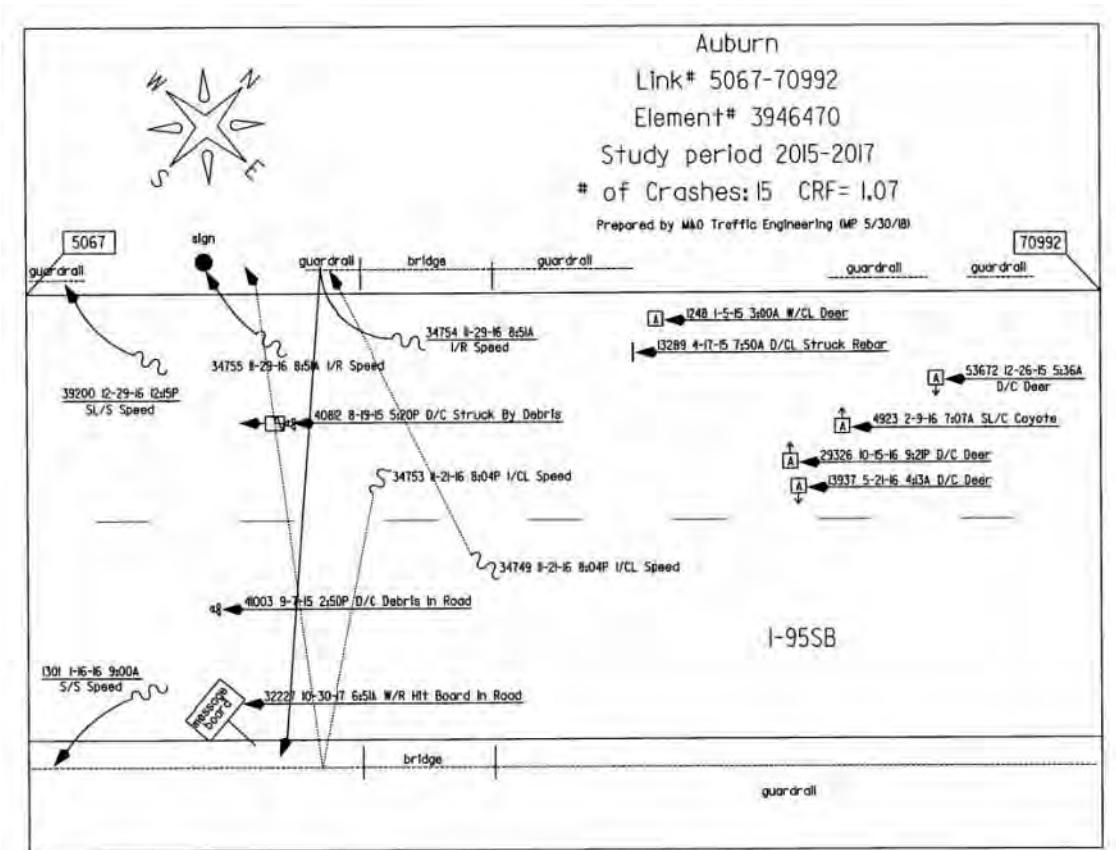
**Figure 2: 2015-2017 Exit 75 SB Off Ramp Approach Crash Diagram**

As shown in **Figure 2**, there were 15 crashes resulting in a 0% injury rate during this analysis period.

- There were 5 animal collision crashes at this location during the time period
- 5 of the crashes at this location were due to speeding
- 4 crashes occurred as a result of vehicles striking various inanimate objects in the roadway
- 6 of the 15 crashes resulted in vehicles departing from the travel way
  - 5 of these 6 resulted in collisions with objects including guardrail, bridge rail and signs
- There is not a strong correlation between time of year and crash frequency at this location

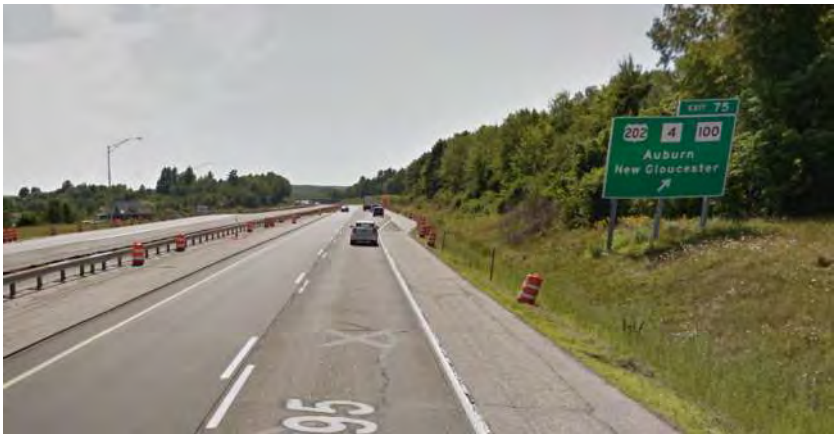
**Photo 1: I-95 SB North of Exit 75 Interchange (2018)** captured by Google Maps in July of 2018 depicts the condition of this location most nearly to the time that it was most recently noted as an HCL.

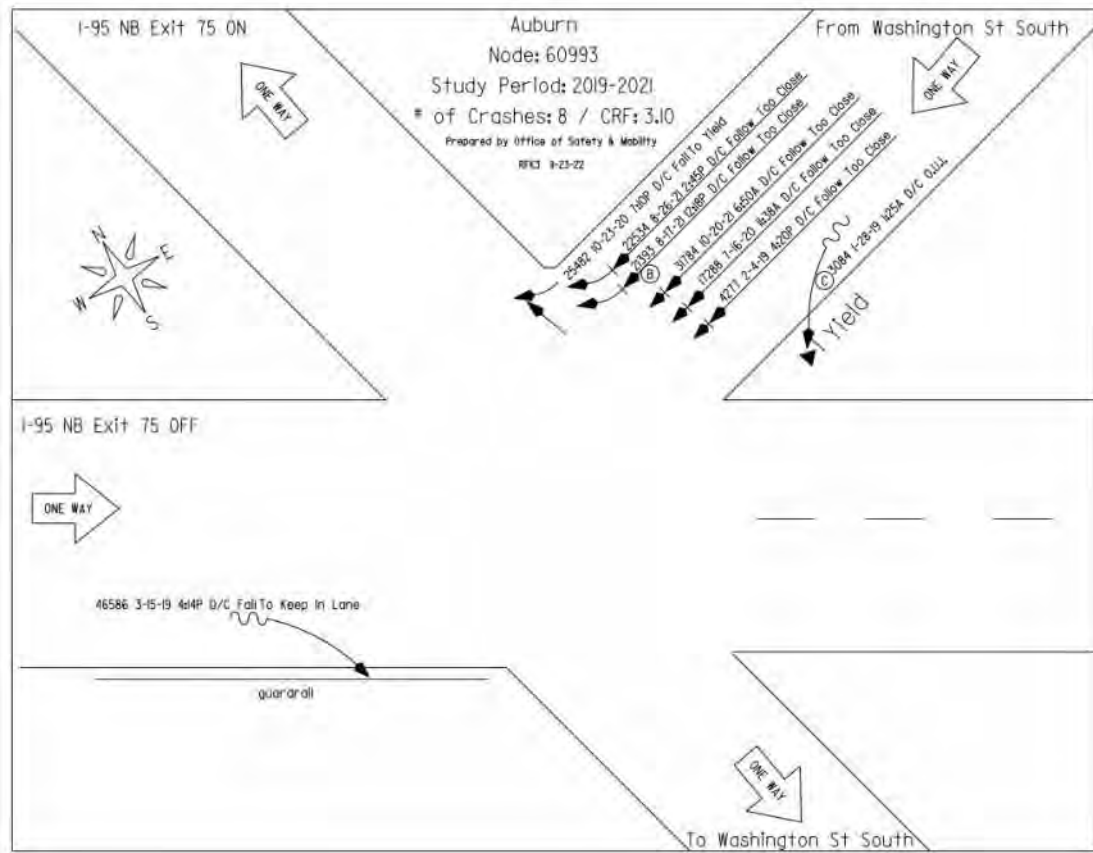
**Figure 2: 2019-2021 Exit 75 Intersection Weave Crash Diagram**

As shown in **Figure 2**, there were 8 crashes resulting in a 25% injury rate during this analysis period.

- All but 1 of these crashes involved vehicles traveling along the Washington Street SB slip ramp
- 5 of these 8 crashes were a result of following too close
- 2 of these crashes were single vehicle crashes which resulted in the vehicles departing from the travel way and colliding with either guardrail or signage
- 5 of these crashes occurred between the months of July and October
- There is not a strong correlation between the time of day and crash frequency at this location

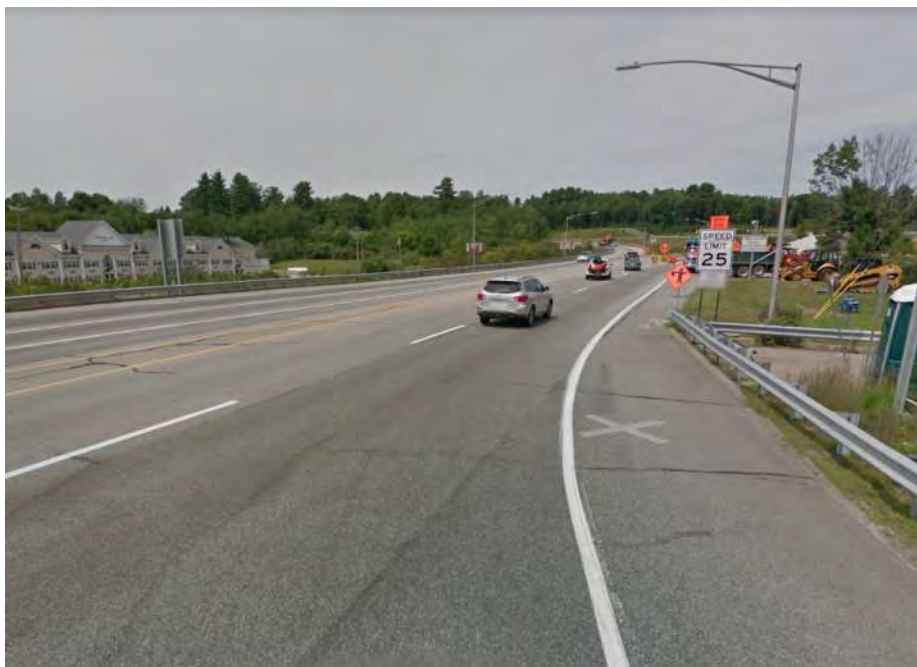
**Photo 1: Exit 75 Ramps Weave (2018)** captured by Google Maps<sup>3</sup> in July of 2018 depicts the condition of this location at the time most nearly to when was most recently noted as an HCL. The view of the photo is from the perspective of vehicles approaching the weave from the Washington Street SB slip ramp.

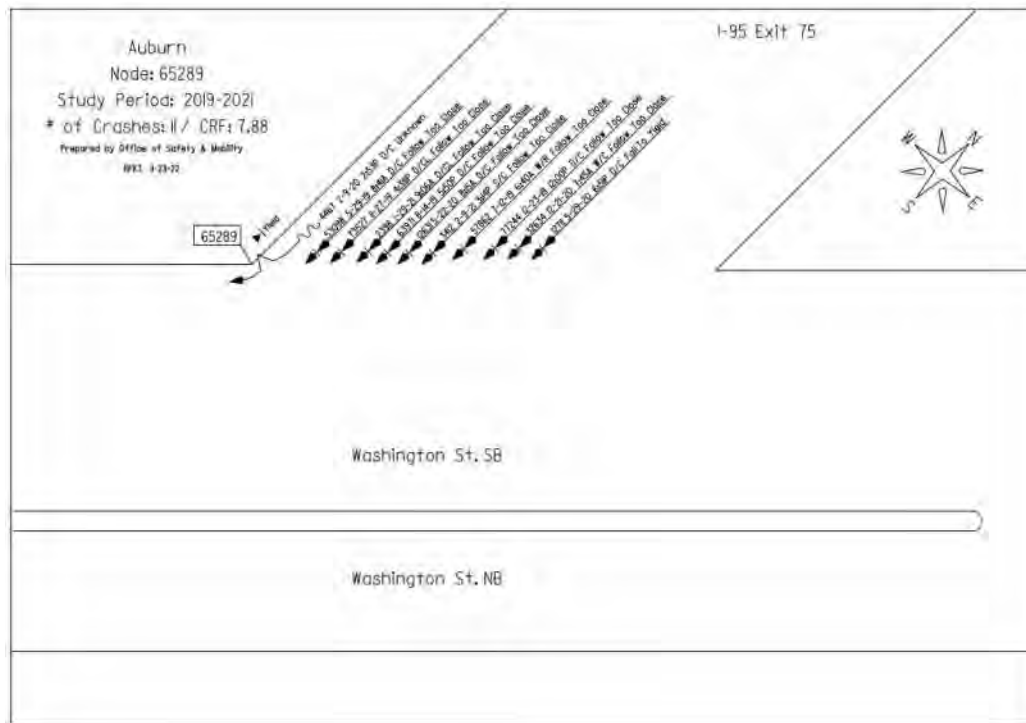
**Figure 3: 2019-2021 SB Off Ramps Slip Ramp Crash Diagram**

As shown in **Figure 3**, there were 11 crashes resulting in a 0% injury rate during this analysis period.

- All of these crashes occurred along the slip ramp
- 9 of these 11 crashes were a result of following too close along the ramp
- 1 of these crashes was a single vehicle crash
  - This crash resulted in the vehicle departing the roadway
- There is not a strong correlation between time of day nor time of year and crash frequency at this location

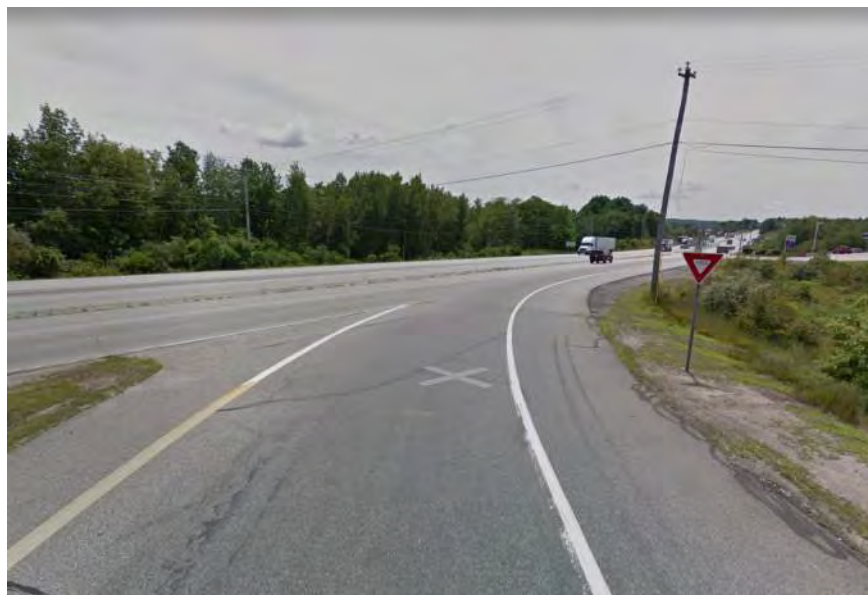
**Photo 2: Exit 75 Off Ramps Slip Ramp Merge (2018)** captured by Google Maps<sup>4</sup> in July of 2018 depicts the condition of this location most nearly to time that it was most recently noted as an HCL. This photo views the location from the view of the slip ramp.

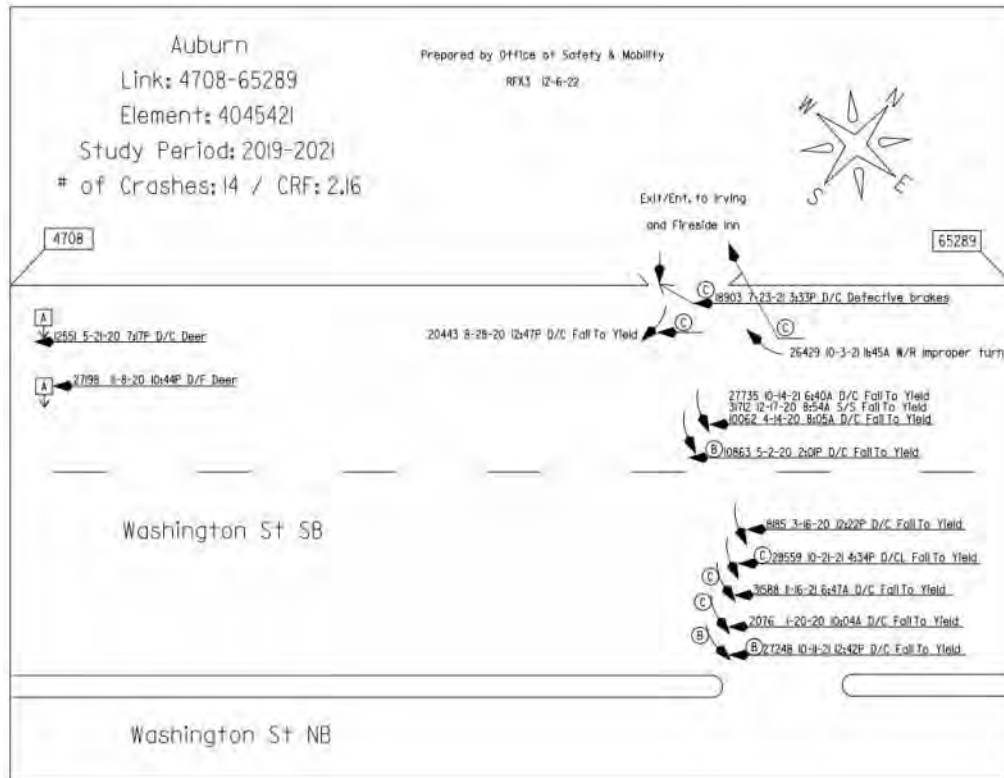
**Figure 4: 2019-2021 Washington Street After Slip Ramp Crash Diagram**

As shown in **Figure 4**, there were 14 crashes resulting in a 57.1% injury rate during this analysis period.

- 9 of these 14 crashes were turning movement crashes between vehicles traveling along Washington Street SB and vehicles attempting to turn left out of the Irving/Fireside Inn Entrance (these were all a result of failure to yield)
  - There was an additional similar type of crash with the only difference being the vehicle exiting the business drive was attempting to turn right
- There were 2 collisions with large animals at this location
- One of the crashes at this location resulted in a vehicle departing from the travel way
- 6 of these 14 crashes occurred in the months October and November
- There is not a strong correlation between time of day and crash frequency at this location

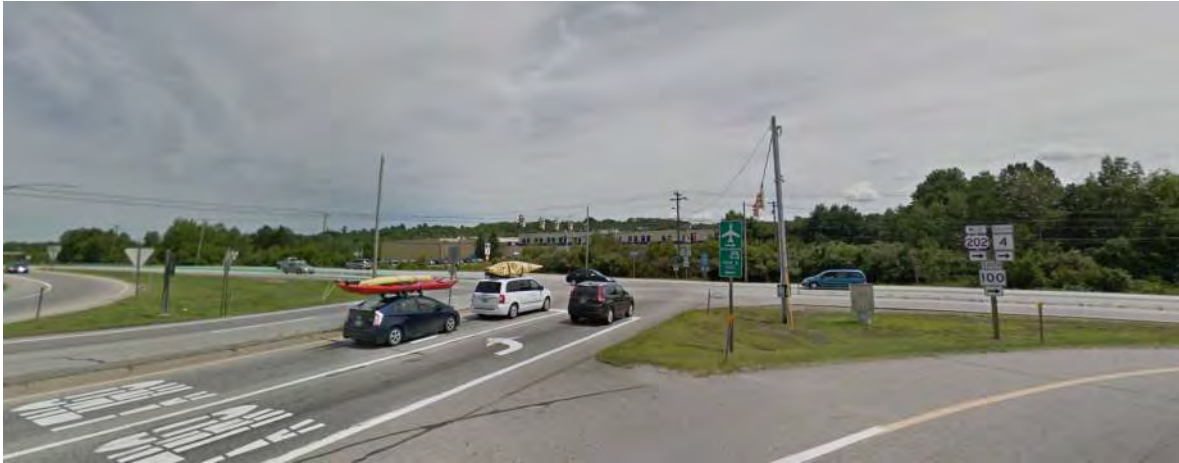
- The most common cause of crash at this location was running red lights which contributed to 8 crashes
- The next most frequent cause was following too close which caused 7 crashes
- 11 of these crashes involved turning movements
  - 5 of these 11 involved vehicles originating from the ramps approach to the intersection
- Heavy vehicles were involved in 2 of these crashes
- There was 1 fatality at this location which was caused by a crash resultant from running a red light between a vehicle from the ramp approach and a vehicle from the Washington Street SB approach
- There is not a strong correlation between time of year and crash frequency at this location
- 12 of these crashes occurred between the times of approximately 3:30pm and 8:00pm

**Photo 4: Exit 75 Intersection (2018)** captured by Google Maps<sup>6</sup> in July of 2018 depicts the condition of this location at the time that it was most recently noted as an HCL.

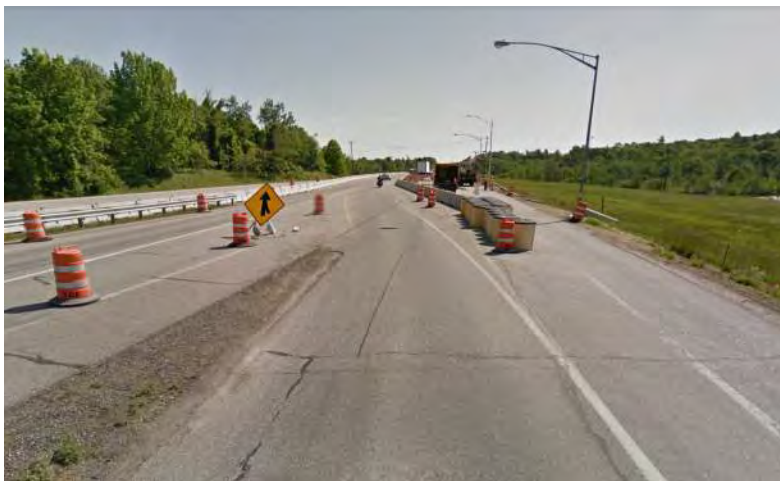
- All but 1 of these crashes occurred along the on ramp portion of the merge
  - The 1 other crash was due to failure to yield between a vehicle originating from the ramp and another from the mainline
- 5 of these crashes were a result of vehicles following too close
- 2 of the crashes were due to inattention
- 5 of these crashes occurred between the months of April and July
- 4 of these crashes occurred between 8:00am and 9:00am

**Photo 1: Exit 75 on Ramp Merge (2012)** captured by Google Maps<sup>2</sup> in May of 2012 depicts the condition of this location at the time that it was most recently noted as an HCL. **Photo 2: Exit 75 on Ramp Merge (2022)** depicts the current condition of the merge point.

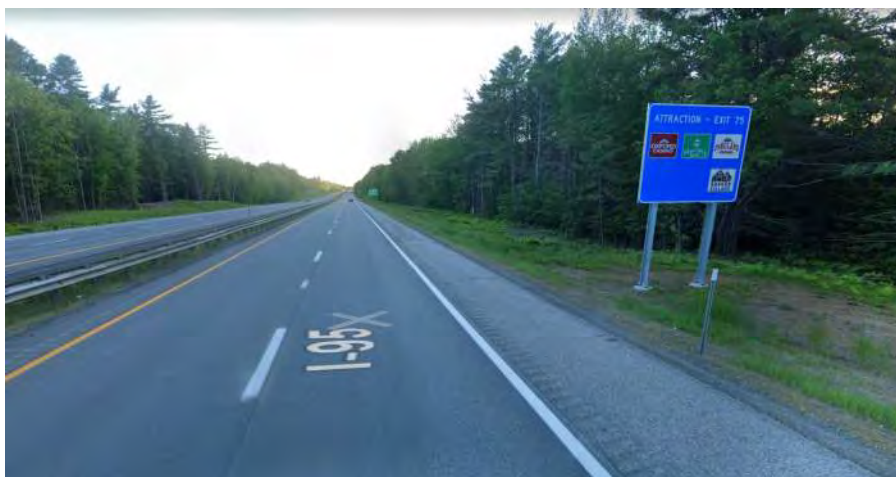
It can be observed from this table that there were 17 crashes at this location with a 0% injury rate during this time period.

**Photo 2: I-95 SB (2019)** captured by Google Maps<sup>3</sup> in June of 2019 depicts the condition of this location at the time that it was most recently noted as an HCL.

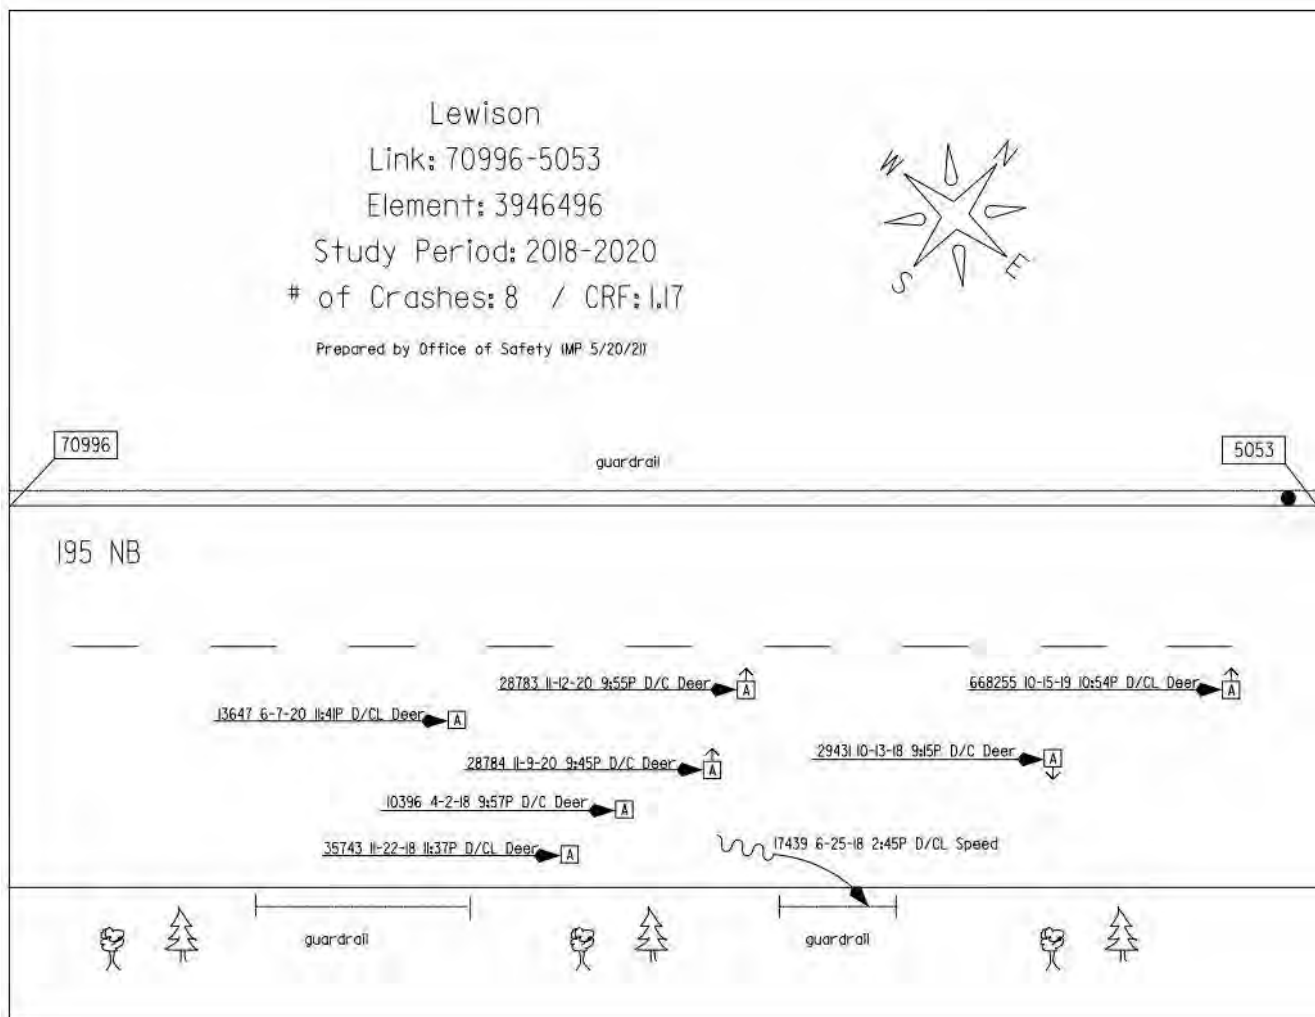
**Figure 2: 2018-2020 I-95 NB Crash Diagram** depicts the HCL for this location during the most recent time span in which it was identified as an HCL. This location was identified as an HCL during 3 other time periods over the past 10 years.

As shown in **Figure 2**, there were 8 crashes resulting in a 0% injury rate during this analysis period.

- All but one of the crashes at this location were collisions with deer
- The only other crash at this location was due to speed and resulted in the vehicle departing the roadway and colliding with guardrail
- 5 of these 8 crashes occurred during the months of October and November
- All of the crashes at this location occurred in the afternoon or evening, with 6 crashes occurring between 9:30pm and midnight

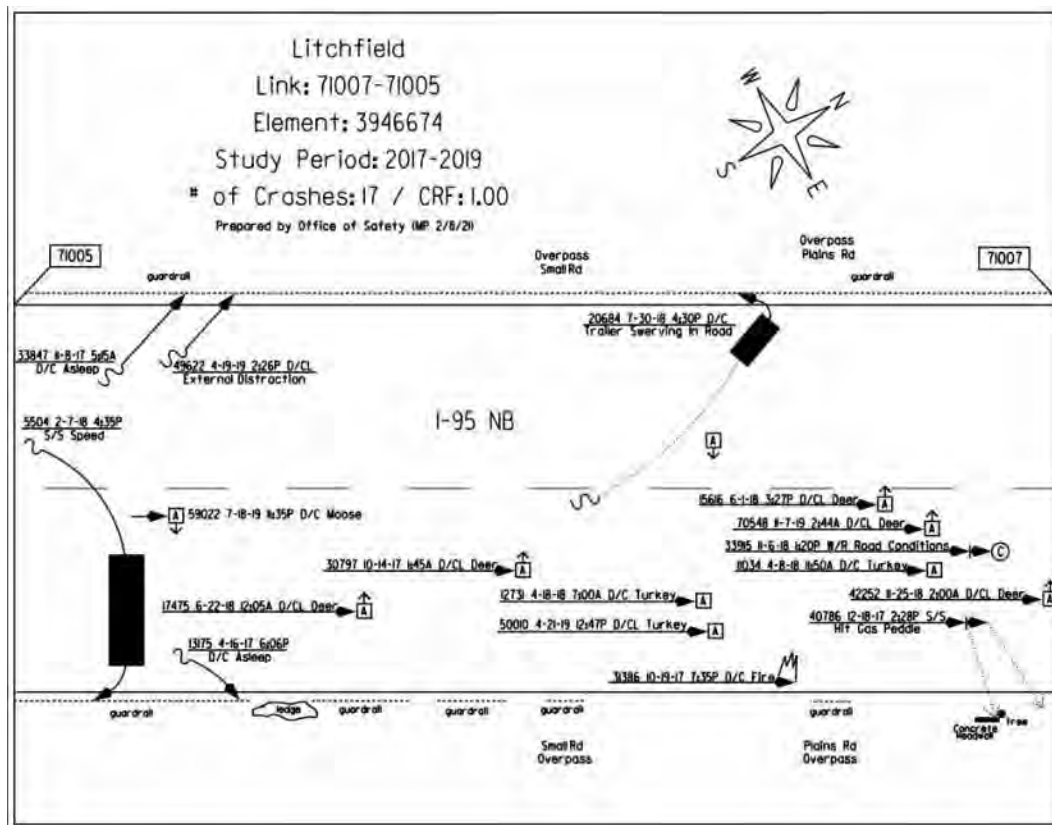
**Figure 2: 2017-2019 NB Segment Near Small Road Crash Diagram** depicts the crash diagram at this location during the time period in which it was most recently classified as an HCL. This location was identified as an HCL during 1 other time period over the past 10 years.

As shown in **Figure 2**, there were 17 crashes resulting in a 5.9% injury rate during this analysis period.

- The most common type of crash at this location was collisions with animals which attributed to 9 crashes at this location
- The next most common cause of crash was vehicle operators falling asleep which caused 2 crashes
- One of the crashes at this location was due to road conditions
- 2 of these crashes involved heavy vehicles
- 6 of these crashes resulted in vehicles departing from the travel way and colliding with objects such as guardrail, concrete headwalls or trees
- April and November were the most common months of crash at this location with 4 crashes occurring within each
- There is not a strong correlation between time of day and crash frequency at this location

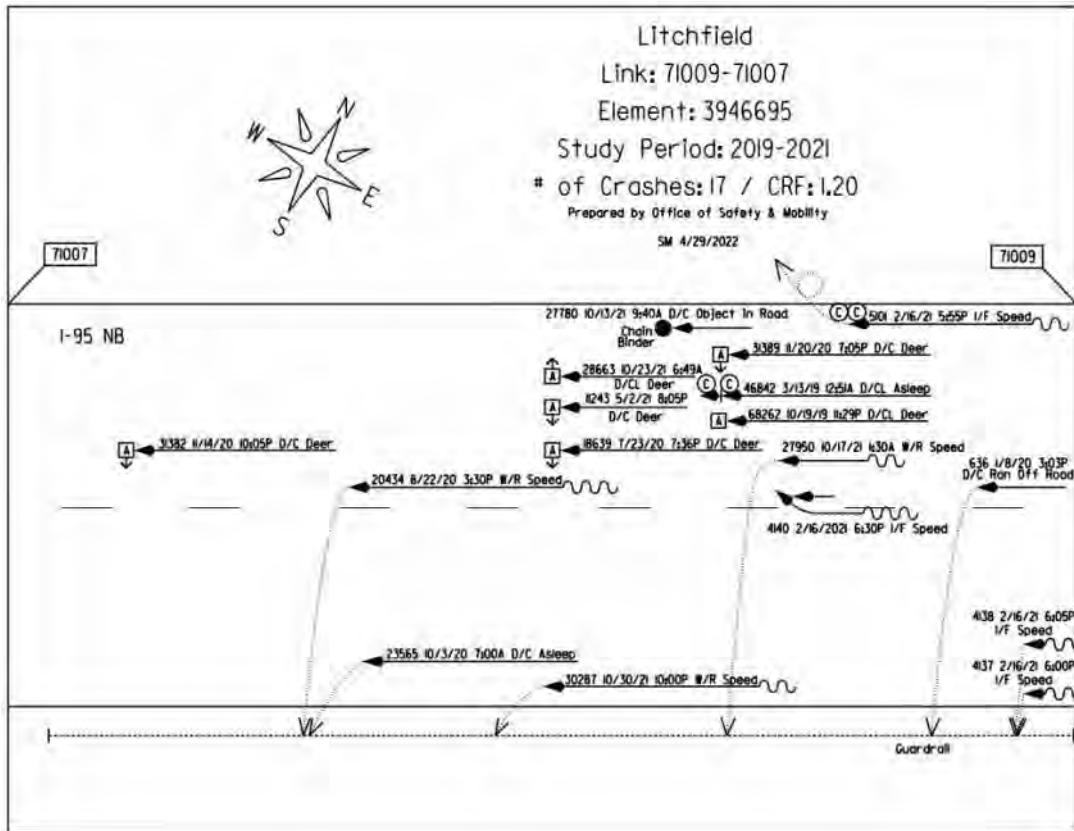
**Figure 3: 2019-2021 I-95 NB Near Stevenstown Road Crash Diagram** depicts the crash diagram for the most recent time period in which this location was identified as an HCL. This is the only time in the past 10 years that this segment was classified as an HCL.

As shown in **Figure 3**, there were 17 crashes resulting in a 11.8% injury rate during this analysis period.

- The most common cause of crash at this location was speeding which contributed to 7 crashes
- There were 6 collisions with animals at this location
- 8 of these crashes resulted in vehicles departing from the travel way
  - 7 of these 8 resulted in a collision with guardrail
- 13 of these 17 crashes occurred between the months of October and February
- 10 of these crashes occurred in the late evening, from approximately 6:00pm through midnight

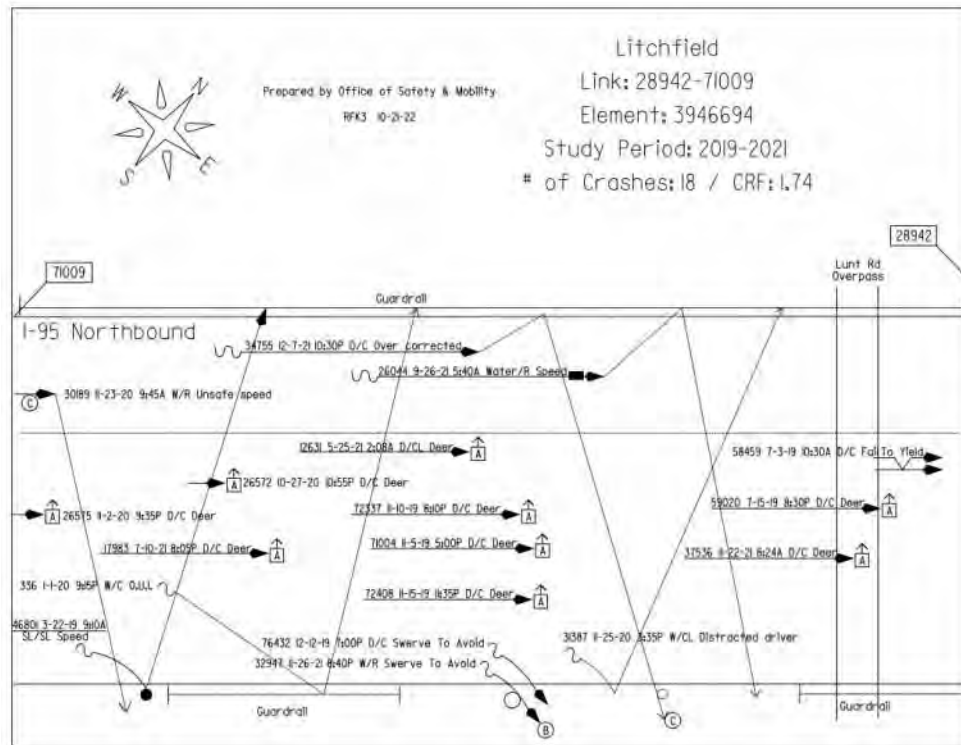
**Figure 4: 2019-2021 I-95 NB Over Lunts Hill Road Crash Diagram** depicts this mainline segment during the most recent time period in which it was identified as an HCL. This segment was identified as an HCL during two other time periods in the past 10 years.

As shown in **Figure 4**, there were 18 crashes resulting in a 16.7% injury rate during this analysis period.

- Of these 18 crashes were collisions with large animals
- The next most common cause of crash at this location was speeding which contributed to 3 crashes
  - One of these speed related crashes also involved water in the travel way
  - 1 of these crashes involved a heavy vehicle
- 8 of these crashes resulted in vehicles departing from the roadway
  - 5 of these 8 crashes resulted in collision with guardrail
- 12 of these crashes occurred between the months of October and January
- The majority of these crashes occurred during the evening hours, with 11 happening between 5:00pm and midnight

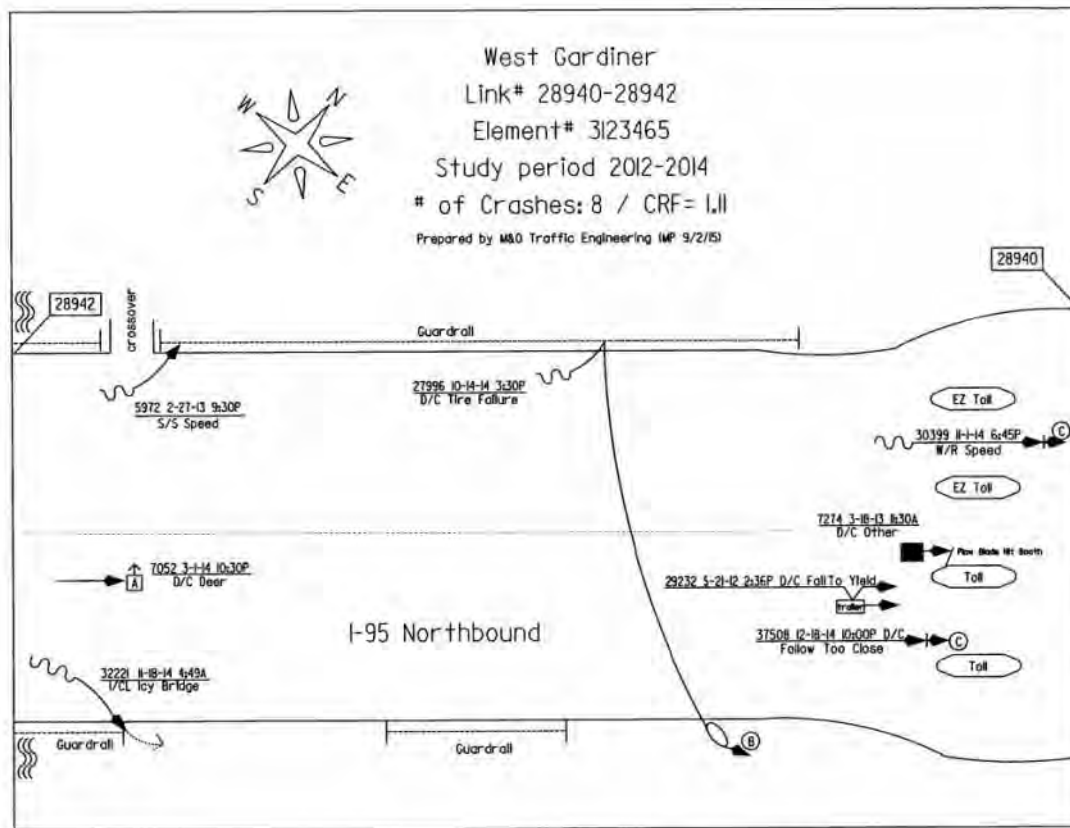
**Figure 2: 2012-2014 NB Toll Plaza Crash Diagram** depicts the crash diagram for the most recent time period in which this location was identified as an HCL. This is the only time over the past 10 years that the location has been classified as an HCL.

As shown in **Figure 2**, there were 8 crashes resulting in a 37.5% injury rate during this analysis period.

- The leading cause of crash at this location was speeding which contributed to 2 crashes
- There was 1 animal collision at this location
- 1 crash was due to the bridge being icy
- There was 1 heavy vehicle involved in these crashes
- 4 of the crashes at this location resulted in vehicles departing from the travel way and colliding with guardrail
- 4 of these crashes occurred between October and February
- Most of these crashes occurred during the evening hours

The toll plaza has not been an HCL since 2014. There are no recommendations at this time.

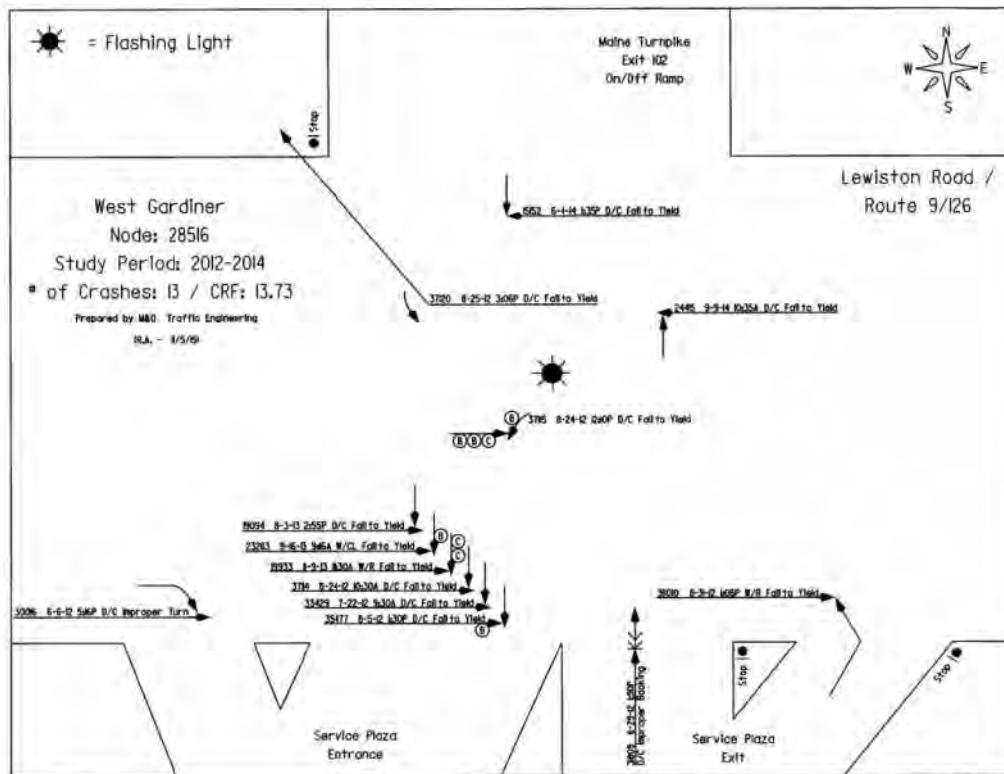
**Figure 2: 2012-2014 Exit 102 Intersection Crash Diagram** depicts the crash diagram for this location during the most recent time in which it was classified as an HCL. This location qualified as an HCL during two time periods prior to this in the past 10 years.

As shown in **Figure 2**, there were 13 crashes resulting in a 30.8% injury rate during this analysis period.

- All but 2 of the recorded crashes at this location were caused by failure to yield
- The majority of crashes at this location involved vehicles traveling along Lewiston Road EB, many of which were collisions between them and vehicle traveling SB from the Exit 102 Ramps
- 1 of these crashes resulted in a vehicle departing the travel way
- 12 of these crashes occurred between the months of June and September
- There is not a strong correlation between time of day and crash frequency at this location

A new roundabout was constructed the year after the HCL was reported in 2014. No further HCL's or significant crash patterns have been reported to date with the construction of the new roundabout. No recommendations at this time.

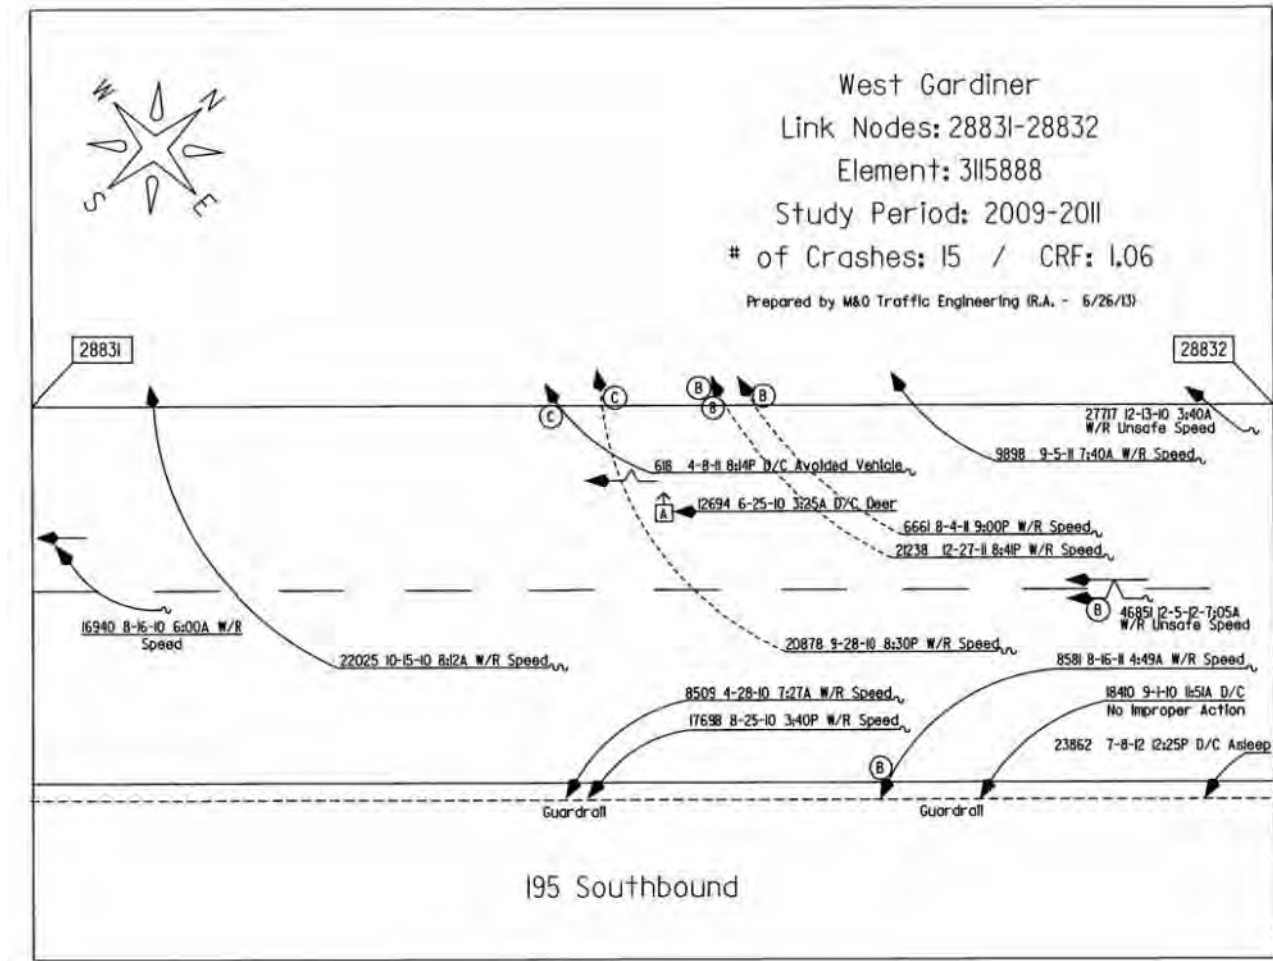
**Figure 2: 2009-2011 I-95 SB Crash Diagram** depicts the most recent available crash diagram for this location. 2012 was the only time period in the past 10 years in which this location was identified as an HCL.

As shown in **Figure 2**, there were 15 crashes resulting in a 40% injury rate during this analysis period.

- 11 of these 15 crashes were due to speeding
- There was 1 animal collision recorded at this location
- 12 of these crashes resulted in vehicles departing from the travel way
  - 5 of these 12 resulted in vehicles colliding with guardrail
- 8 of these crashes occurred between the months of August and October
- Many of these crashes occurred during early morning hours, with 7 crashes occurring between midnight and 9:00am

Speeding dominated the crash patterns for this area with a significant portion either leaving the travel lane or hitting the adjacent guardrail. The most recent recorded HCL was 10 years ago (in 2012) and there have been no reported HCL or significant crash patterns reported since. No recommendations at this time.
