PRESENTED TO THE MAINE TURNPIKE AUTHORITY

# OPERATION AND MAINTENANCE ANNUAL REPORT

## 2012

**HNTB**

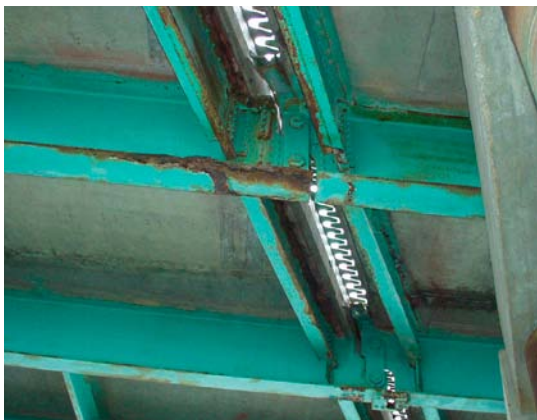
At the York River bridges, the girder framing system includes the use of pin-and-hanger assemblies. Because routine inspection procedures are insufficient to identify defects in the pins, ultrasonic testing of these elements is necessary. A detailed inspection of the pin-and-hanger systems at the York River bridges was completed in December 2011. No serious structural deficiencies were noted during the 2011 inspection.

PIN-AND-HANGER ASSEMBLY AT THE YORK RIVER BRIDGE

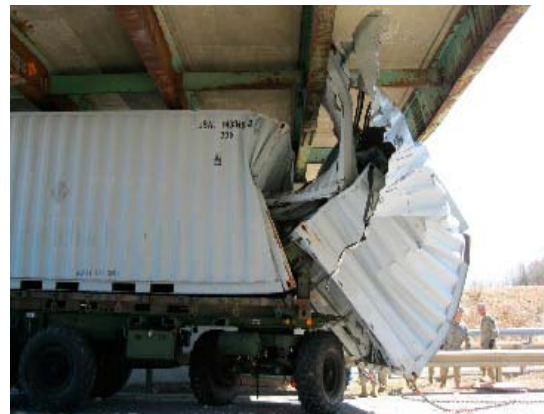
At the request of the Maine Turnpike, HNTB conducted two special inspections in 2012 resulting from bridge strikes by high loads at the following locations:

INTERCHANGE 102 UNDERPASS HIGH LOAD HIT

Based on these inspections, HNTB recommended repairs.

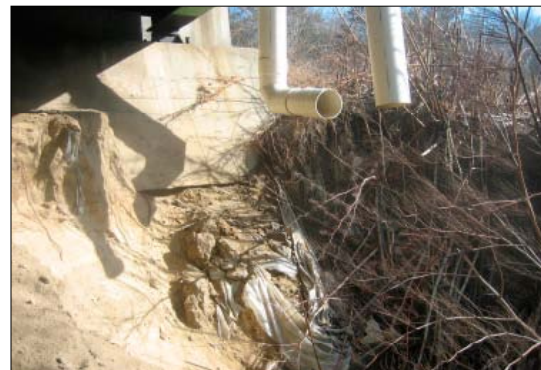
EROSION AT MOUSAM RIVER BRIDGE

Repairs at the Mousam River bridges includes addressing areas of erosion at the north abutment, repairing deteriorated substructure concrete, and minor repairs to the roadway deck expansion joints. This work is anticipated to be complete by October 2012.

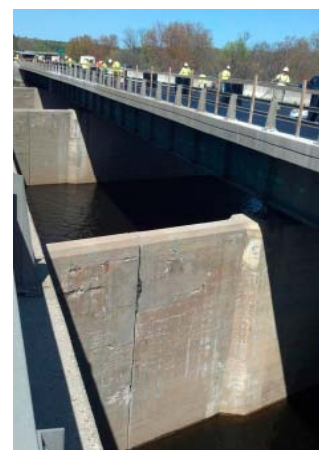
SACO RIVER OVERPASS DECK REPAIR AND RESURFACING

Work at these two bridges, one carrying

northbound traffic and one carrying southbound traffic, completed in August 2012, includes repairing areas of concrete deck deterioration and the removal and replacement of the waterproof membrane and bituminous overlay.

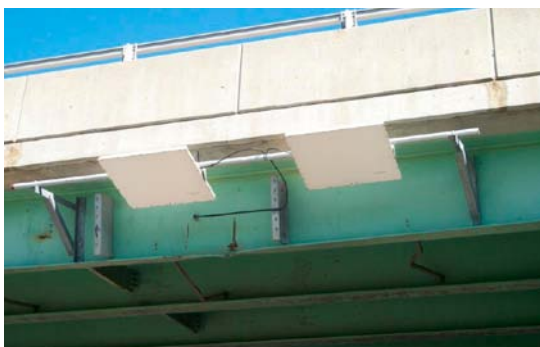
AUBURN INTERCHANGE OVERPASS

This project includes repairs to three girders damaged by two separate over height vehicle impacts that occurred in 2006 and 2007.

The Auburn Interchange overpass repair contract, which was issued for construction in July 2012, is scheduled for completion in October 2012.

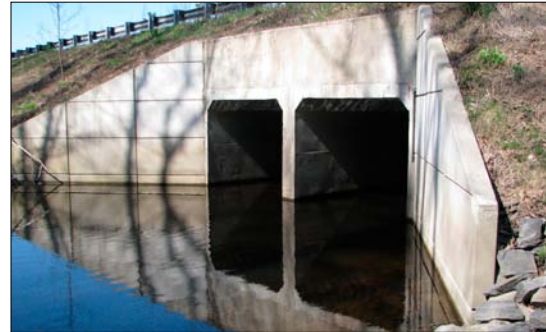
turnpike through box culverts and culvert pipes. All box culverts and pipes 60 inches in diameter or greater are inspected every year. Pipes 36 to 54 inches in diameter are inspected on a five year cycle and were last inspected in 2008. All box culverts and pipes 60 inches in diameter and larger were inspected in 2012 (a total of 89 individual culvert ends), and were found to be in satisfactory condition.

TWIN 8' x 8' CONCRETE BOX CULVERTS CARRY THACHER BROOK BENEATH THE MAINLINE IN KENNEBUNK

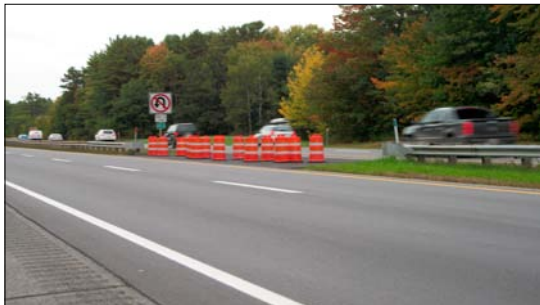
THE GUARDRAIL IMPROVEMENT PROGRAM HAS BEEN COMBINED WITH THE PAVEMENT REHABILITATION CONTRACTS

To date, the median and outside shoulder guardrail from Mile 2.2 to Mile 6.8, Mile 13.4 to Mile 43.2, Mile 62.6 to Mile 85.0, and Mile 92.8 to Mile 109.0 have been upgraded. Over the past several years, the guardrail improvement program has been included with the pavement rehabilitation contracts. Combining the guardrail and pavement work reduces the overall cost of the work by improving the efficiency of the construction.

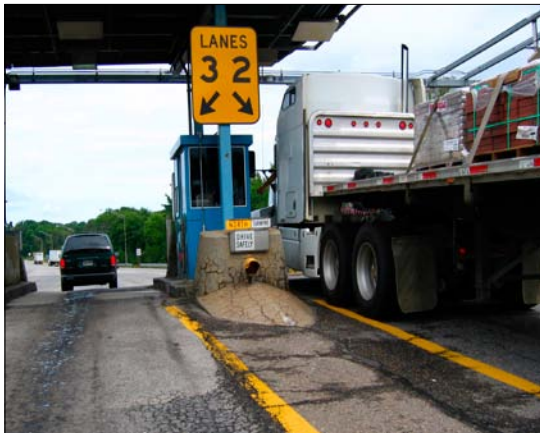
The existing York Toll Plaza was constructed in 1969 and is challenged by both operational and safety issues. Due to these issues, the Authority is in the process of developing a more comprehensive plan for this facility.

THE EXISTING YORK TOLL PLAZA HAS NUMEROUS DEFICIENCIES AND SAFETY CONCERNS

The Authority has studied the feasibility of an open road toll plaza and is in the process of understanding the feasibility of an all-electronic toll collection plaza to replace the current York Toll Plaza. This feasibility study is scheduled to be complete in the spring of 2013. At the completion of this study, the Authority will need to make a definitive

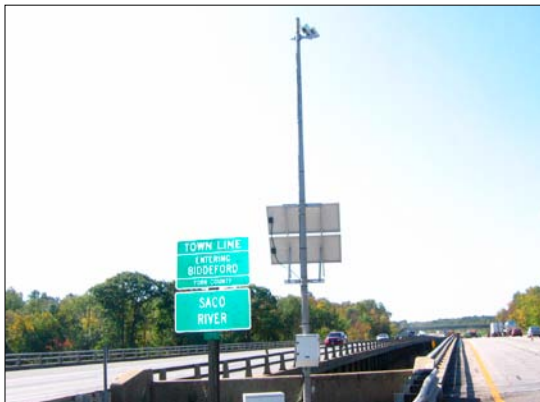
A RWIS WAS INSTALLED ADJACENT TO THE SACO RIVER BRIDGE OVERPASS

The RWIS measures the surface temperature of the road, road state (wet, dry, snow, ice), and roadway friction. These RWIS units provide information that can help maintenance supervisors make cost effective decisions regarding frost, chemical applications, and whether any precipitation on the pavement
