PRESENTED TO THE MAINE TURNPIKE AUTHORITY

# OPERATION AND MAINTENANCE ANNUAL REPORT

## 2019

**HNTB**

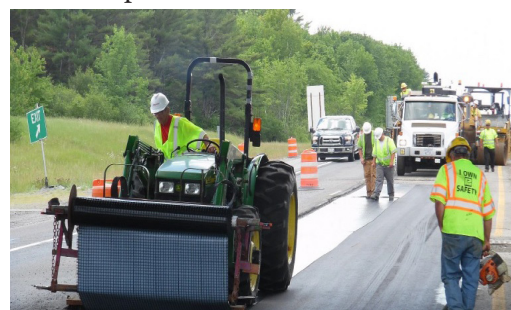
**PAVEMENT REHABILITATION**

Starting in 2014, pavement rehabilitation contracts specified polymer modified asphalt to alter several characteristics of the asphalt, each of which is intended to improve pavement durability, weatherability and performance. This practice has continued into 2019. The areas using this additive will be evaluated to determine if its use is providing adequate benefit. Due to poor condition of the pavement between Mile 49.0 and Mile 51.2, pavement rehabilitation is being performed under various 2019 contracts. The rehabilitation work consists of milling and filling the 12-foot wide lanes and the 4-foot shoulders as required. Additionally, shimming of the mainline travel lanes was performed between Mile 42.0 and Mile 44.3 to provide an adequate surface until the Portland Area Mainline Improvements have been completed.

HNTB recommends MTA continue with the annual maintenance paving program of addressing approximately ten centerline miles per year and the use of polymer modified asphalt surface pavement. With the current priority of adding a third lane north and southbound from Exit 44 to Warren Avenue, and median improvements south to Holmes Road at Mile 43.0, the pavement rehabilitation sequence in this area is being addressed over multiple years.

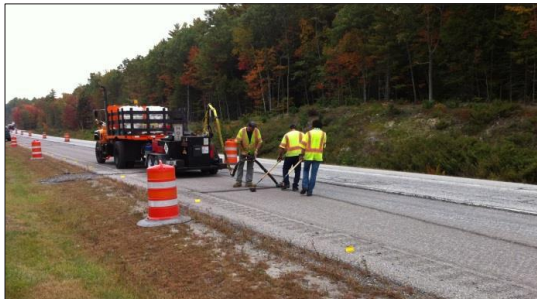
DISPENSED AT OVER 350 DEGREES THE RUBBERIZED ASPHALT SEALANT IS INJECTED DIRECTLY INTO THE PAVEMENT CRACKS

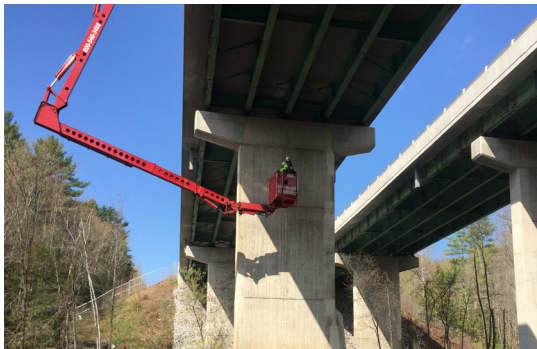
PRESUMPSCOT RIVER BRIDGE HANDS-ON INSPECTION

All Authority-owned bridges and minor spans undergo routine inspections on an annual basis. The purpose of these inspections is to identify potential safety concerns, document areas of deterioration and to record condition ratings for key bridge components. The 2019 routine inspection by HNTB identified that the bridges and minor spans along the turnpike range from fair to very good condition. Structures that have been rehabilitated or reconstructed during the past 20 years were found to be in fair to very good condition, while those that have not been recently rehabilitated were generally noted to be in fair condition.

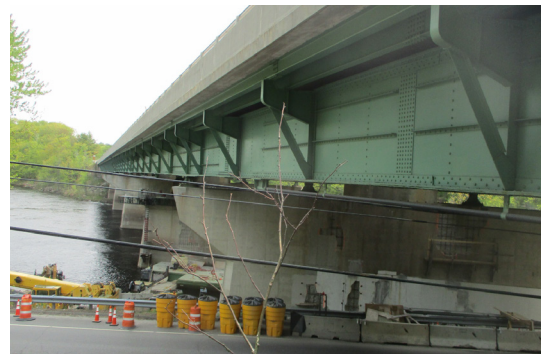
ANDROSCOGGIN RIVER BRIDGE

The Androscoggin River Bridges, each measuring 850 feet long, consist of roadway surfaces supported on stringer and floor beam framing systems. The loads from these roadway framing systems are carried almost entirely by two primary girders.

Because these structures are carried by only two primary girders, the bridge has insufficient redundancy to prevent a progressive collapse of all, or part of, the bridge if one of the primary girders were to fail. As a result, these structures are classified as “fracture critical” and are subject to more rigorous inspection requirements as outlined in FHWA’s Bridge Inspection Standards. To achieve compliance with these inspection standards, the Androscoggin River Bridges

should have a fracture critical inspection completed at least once every 24 months.

The last fracture critical inspection was completed in summer 2017 and identified several minor deficiencies. To address these items, a contract was issued that included repairs to the substructure, bridge deck expansion joints, post-tensioning conduit, and bearings. This work is currently ongoing. The next fracture critical inspection of this structure is scheduled for September 2019.

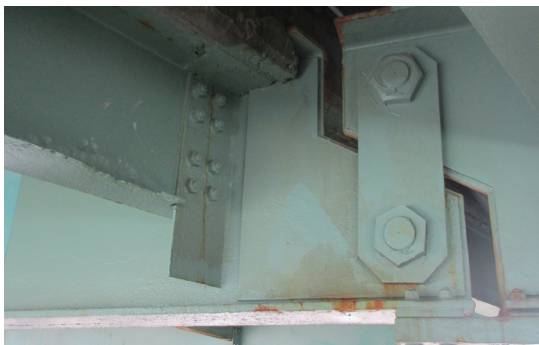
PIN-AND-LINK ASSEMBLY AT THE YORK RIVER BRIDGE

Because routine inspection procedures are insufficient to identify defects in the pins, ultrasonic testing of these elements is necessary. A detailed inspection and ultrasonic testing of the pin-and-link systems at the York River Bridges was completed in December 2011. No serious structural deficiencies were noted during the inspection. The next detailed inspection of the pin-and-link assemblies was scheduled for 2016, however, a 2015 rehabilitation contract involved disassembling, reassembling, and painting the pin-and-links. This was an acceptable detailed inspection procedure and therefore, ultrasonic testing was not performed. The next detailed inspection including ultrasonic testing should be scheduled for summer 2020. The five-year inspection frequency is based on engineering judgement whereas the FHWA does not have a required frequency for these components.

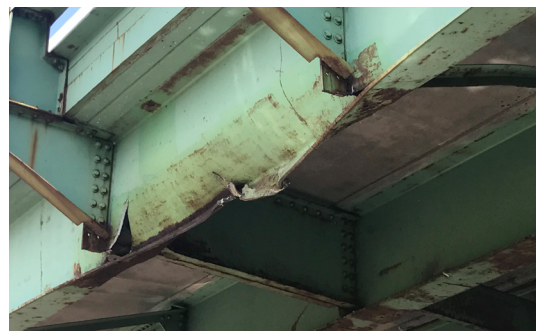
SOUTH PORTLAND INTERCHANGE UNDERPASS, MILE 44.9

The South Portland Interchange Underpass at Mile 44.9 was struck by an articulating boom lift being carried on a flatbed trailer on July 15, 2019. HNTB conducted a special inspection and concluded that the damage significantly reduced the load carrying capacity of the damaged fascia girder.

A temporary maintenance of traffic plan was put in place using drums to shift traffic away from damaged girder. Whereas the bridge is scheduled for replacement beginning in 2020 no repairs are proposed. Instead, the existing temporary steel barrier located along the edge of the bridge deck will be relocated to ensure

traffic remains shifted away from the area of damage until the bridge is removed from service.

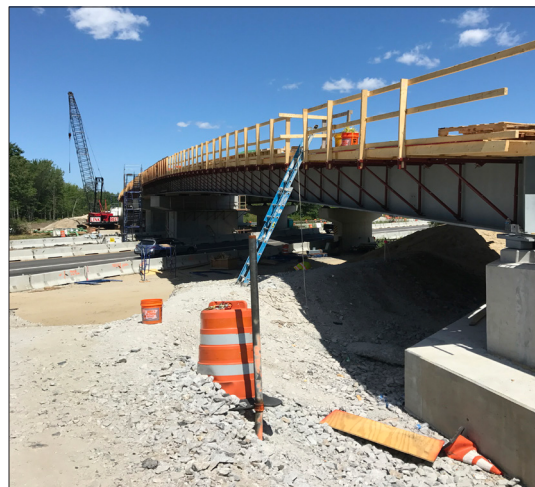
CUMMINGS ROAD UNDERPASS, MILE 44.6

The work includes demolition of the existing

two-lane bridge and the construction of a new four-lane bridge.

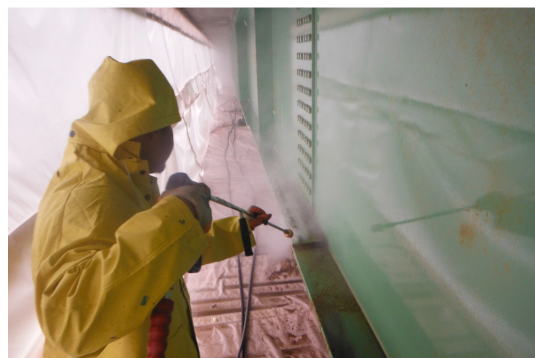
BRIDGE PAINTING

During project development, the cost of repainting existing steel girders versus replacing the steel girders should be considered for all bridge rehabilitation projects. This analysis

should consider cost, the load capacity of the existing girders, and the condition of the existing paint system.

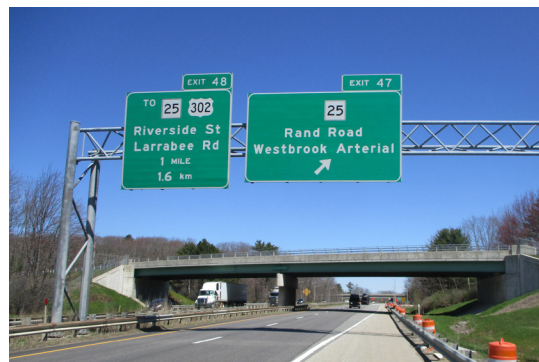
OVERHEAD SIGN BRIDGE MAINLINE NB, MILE 47.0

The Authority is responsible for 115 sign structures, with structure types that include overhead sign bridges, mast-arms, space frames, VMS on butterfly supports, and bridge-mounted signs. These structures carry regulatory, route marker, warning, and specialty signage. Routine or ground inspection of the Authority's sign structures is conducted yearly as part of the routine bridge inspection and no significant issues have been observed.

In addition to the routine inspections, a hands-on inspection of the Authority's 43 overhead sign structures and two space frames was conducted by HNTB in early-2015. A concern noted during these inspections was missing and broken sign clips on multiple sign structures. The sign clips were then incrementally replaced over the 2015 construction schedule.

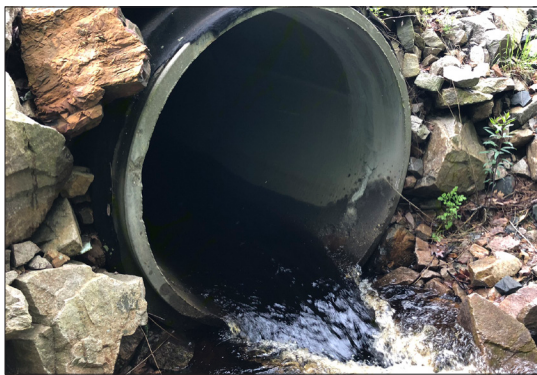
Common issues observed in the metal pipe ends are rusted flow lines, disconnected joints, and disconnected metal flared end sections. Common issues observed in the reinforced concrete pipe ends are inlets and outlets that are either partially or completely obstructed by heavy vegetation or debris and buried inlets and outlets. These conditions lead to erosion issues on the side slope which may eventually impact the roadway.

We recommend the locations rated "Poor" in the detailed Annual Inspection Report be monitored by the Authority. Locations that can reasonably be repaired by the Authority's Maintenance forces should be repaired. Areas that are not feasible for repair by the Authority's Maintenance forces should be programmed for repair. These repairs include the complete removal of the deteriorated metal pipe ends and their replacement with high density polyethylene or reinforced concrete pipe, along with slope and drainage channel stabilization. Drainage repairs should be included in the pavement rehabilitation contracts.

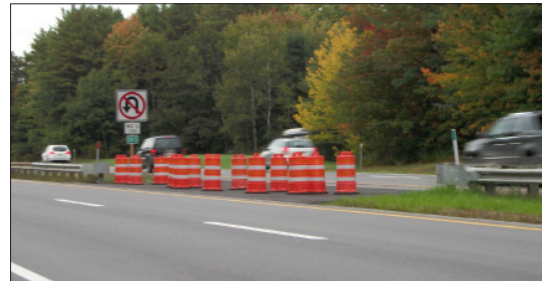
GUARDRAIL UPGRADES

The FHWA has a September 29, 1994 policy, and subsequent memorandums in 2005, 2010, 2014, and 2016, that all roadside hardware (guardrail) installed on the National Highway System comply with the crash testing and evaluation criteria contained in the Manual for Assessing Safety Hardware (MASH) or its predecessor the National Cooperative Highway Research Program (NCHRP Report 350 - published in 1993). FHWA further suggested that the non-crashworthy hardware be removed or replaced with crashworthy roadside hardware at the earliest possible opportunity in concert with the maintenance of the roadway.

HNTB recommends that guardrail continue to be monitored and repaired as needed. Upgrades such as adjusting guardrail height are still needed as a regular activity and should be reviewed yearly for possible inclusion in the paving rehabilitation contracts. We also recommend that any entity installing or maintaining roadside safety hardware, including Authority Maintenance forces and contractors, be trained for completing this work in accordance with the manufacturer's instructions.

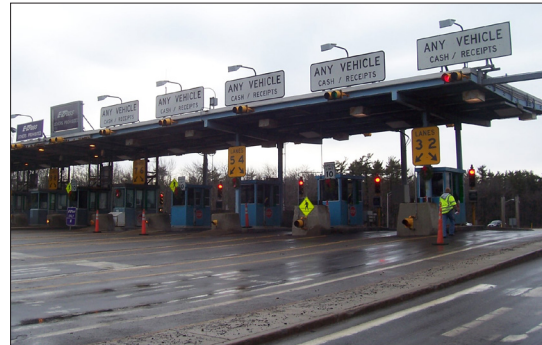
EXISTING YORK TOLL PLAZA - CONSTRUCTED IN 1969

The Authority secured the needed permits to construct a new ORT Plaza at Mile 8.8

approximately one mile north of the existing plaza. Construction of this new plaza began in the fall of 2018 and is scheduled for completion in the summer of 2021.

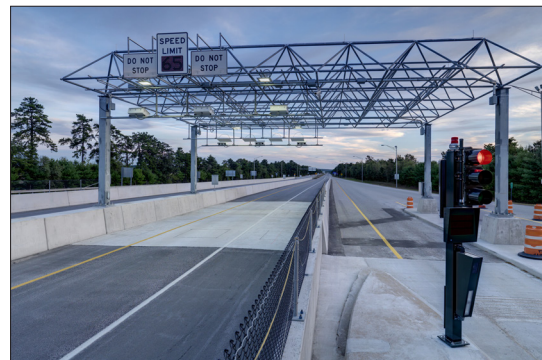
NEW GLOUCESTER TOLL PLAZA ORT, MILE 67.0

In April 2013, the Authority opened the ORT lanes at the New Gloucester Toll Plaza and all the cash toll collection equipment was replaced. Several elements were replaced or rehabilitated as a part of this work including the slabs. As a result, this plaza is rated in good condition.

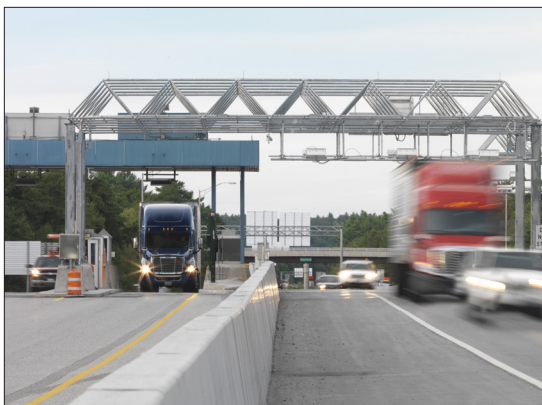
NEW GLOUCESTER TOLL PLAZA

The Authority operates its Electronic Toll Collection (ETC) system as a closed-barrier toll system from the York Toll Plaza north to the New Gloucester Toll Plaza, and as an open-barrier toll system from the New Gloucester Toll Plaza north to the turnpike terminus in Augusta. The open-barrier toll system allows free travel between interchanges within the limits of the mainline barrier toll plazas on the northern section of the turnpike. All trips between Exit 75 in Auburn and Exit 86 in Sabattus are toll-free. It is estimated that toll-free trips account for roughly 2% - 3% of all trips on the Maine Turnpike north of Exit 7. The trips on the Maine Turnpike between the I-95 Piscataqua River Bridge and Exit 7 are also free and account for about 17% of trips on the entire Maine Turnpike.
